Assessing the effectiveness of restoration actions in the Nisqually Delta

Report To: National Fish and Wildlife Foundation,
Puget Sound Marine Conservation Fund. #2006-0180-017

US GEOLOGICAL SURVEY, WESTERN ECOLOGICAL RESEARCH CENTER

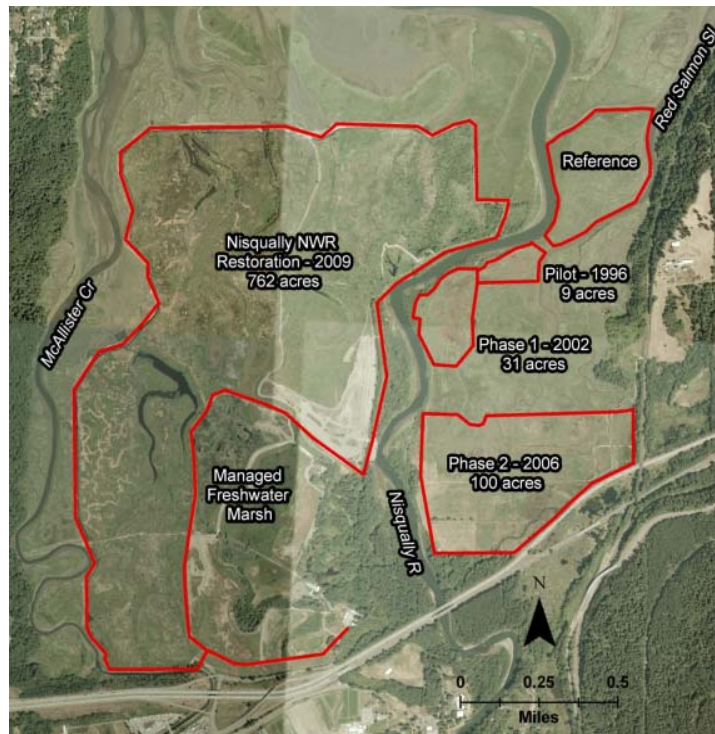
FIGURE 1. ESTUARINE RESTORATIONS IN THE NISQUALLY DELTA

In the fall of 2009 the U. S. Fish and Wildlife Service Nisqually National Wildlife Refuge (Refuge) restored tidal flow to over 760 acres of historical tidelands. On the east side of the Nisqually River, the Nisqually Indian Tribe (Tribe) completed restoration projects on tribal lands starting in 1996. Together, these restorations amount to over 900 acres of estuarine restoration in the Nisqually Delta and represent the single largest estuary restoration project in the Pacific Northwest (Figure 1). These collective restorations represent one of the most significant advances to date towards the restoration and recovery of Puget Sound. The restorations have the potential to increase salt marsh habitat in south Puget Sound by 50%, restore more than 21.4 miles of historical tidal sloughs and channels, and re-establish tidal flow to approximately 2.3 miles of historical floodplain and delta. In addition, the Refuge has enhanced 246 acres of managed freshwater ponds, creating a mosaic of estuarine habitat types to benefit salmonids (such as the threatened and the avian community alike).

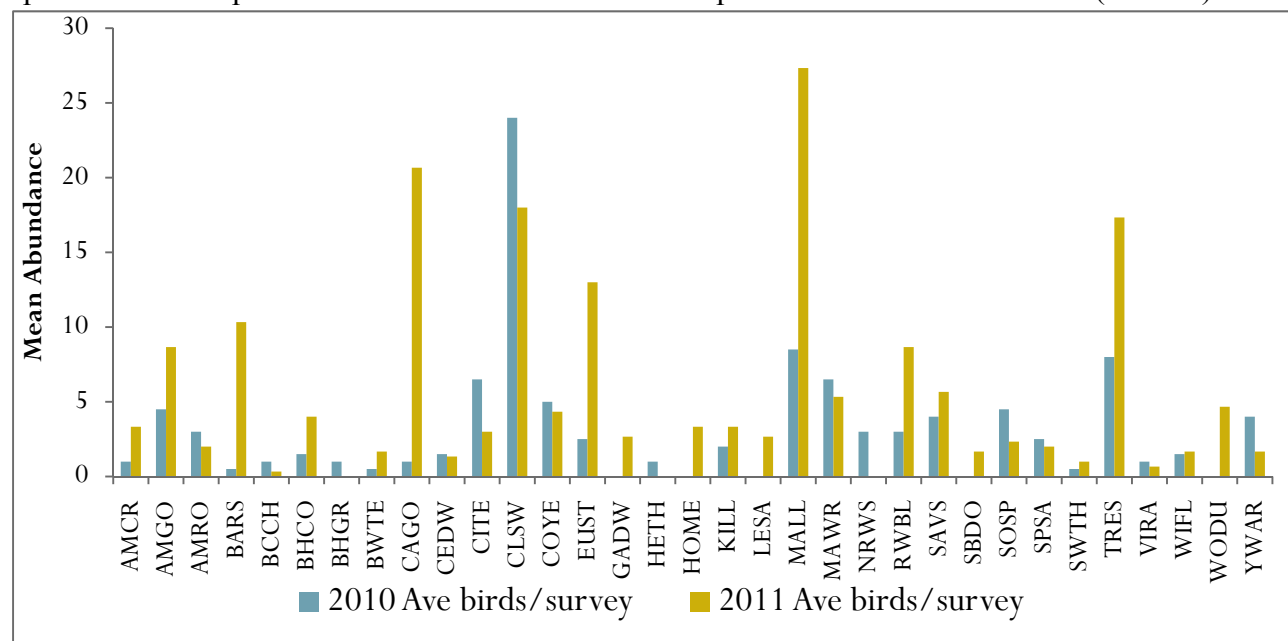
FIGURE 8. AVERAGE ABUNDANCE OF BIRD FROM VCP SURVEYS IN 2010 AND 2011. SPECIES CODES FOLLOW THOSE IN TABLE 2.

Cliff Swallows were the most abundant passerine observed both years, averaging 24 individuals per survey in 2010 and 18 individuals per survey in 2011 (Figure 8). Cinnamon Teal, Common Yellowthroat, Mallard, Marsh Wren, and Tree Swallows had average abundances at or greater than 5 individuals per survey in 2010. Mallard, American Goldfinch, Barn Swallow, Canada Goose, European Starling, Marsh Wren, Red-winged Blackbird, Savannah Sparrow, and Tree Swallows had average abundances greater than 5 individuals per survey in 2011. The average number of birds detected at each monitoring station per survey increased from 35 to 64 between 2010 and 2011 ($SD \pm 7.66$ and 36.18 , respectively), although many of the larger counts in 2011 can be attributed to groups of waterfowl with young.

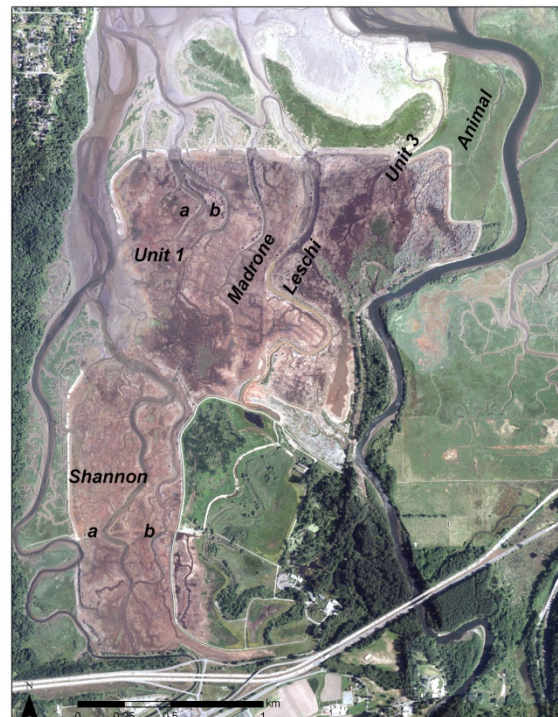
FIGURE 9. NISQUALLY ESTUARY MAJOR CHANNELS, JULY 2010.

We used a combination of remote sensing, shallow water bathymetry, and on-the-ground GPS surveys of channel cross sections to assess channel development in major channel systems within the Refuge (Figure 9). Channels were mapped using color infrared aerial photographs base layers, which were previously flown, mosaicked, and georeferenced to existing imagery (UTM NAD 83). Major channel features were delineated, digitized in ArcGIS, and analyzed over time (pre-restoration compared to post-restoration aerials), and changes in channel length and sinuosity were completed in ArcGIS. Three dimensional metrics of channels included channel cross-sections, which were repeated annually to detect change and a bathymetric coverage was completed in 2010 and will be used as a baseline from which future comparisons can be made.

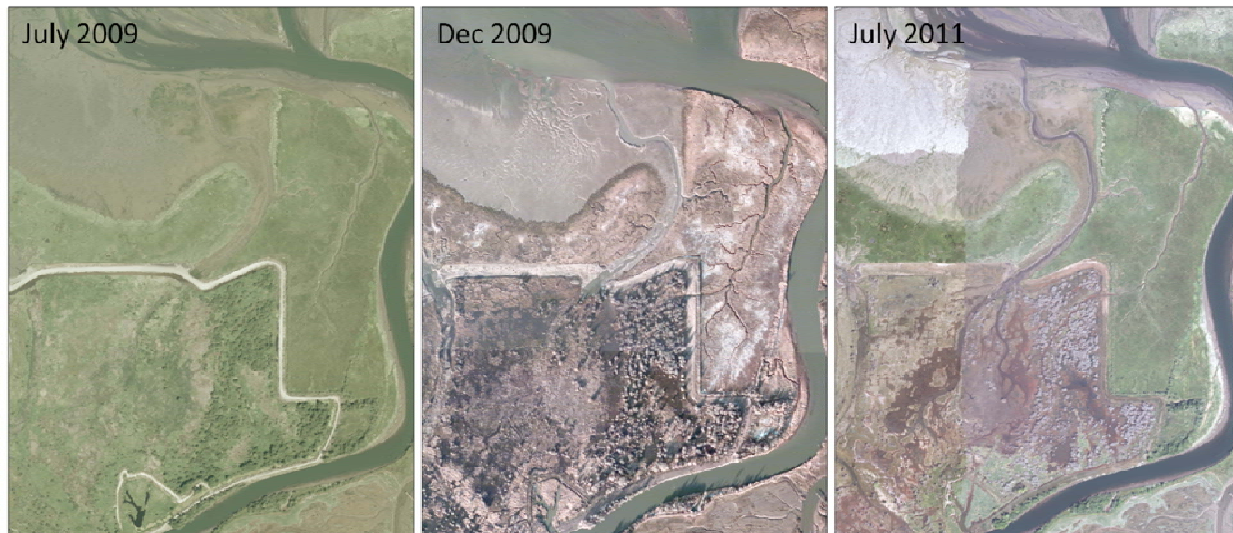
FIGURE 12. TRUE COLOR AERIAL PHOTOGRAPHS SHOWING CHANNEL DEVELOPMENT AT RESTORED UNIT 3 TIDAL CHANNEL.

We did not compare the smaller primary channels within the restoration because within the Refuge restoration, channels initially had undefined banks and were filled with sediment and vegetation such as cattail (Figure 10), making channel delineations difficult, except for the largest channels. Over time, we've observed the Refuge restoration transition from a diked freshwater marsh with vegetation-choked channels to more estuarine conditions as the relic plants decompose in the now tidally influenced restoration. With time, we expect channels to develop naturally as in Unit 3 where the July

2011 aerial photograph shows more defined channels that now drain former areas of low-lying shallowly pooled water (Figure 12). These digitized channel maps and calculations form a basis for future comparisons of channel metrics as the restoration progresses.

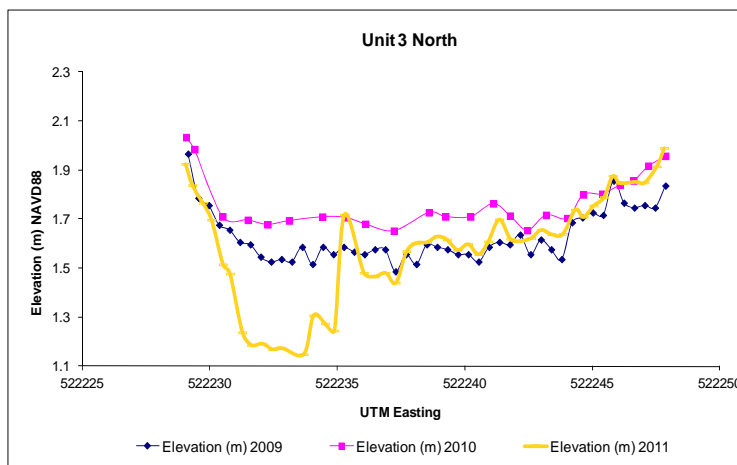
FIGURE 13. CHANNEL CROSS-SECTION FROM UNIT 3 NORTH IN 2009 (BLUE), 2010 (PINK) AND 2011 (YELLOW).

Channel cross-sections were completed pre-restoration (Summer 2009) and post-restoration (October 2010) at the North, Middle, and South monitoring stations of Shannon, Unit 1, Leschi, and Unit 3 channels (Figure 13) and funded by baseline monitoring. This grant funded the field work for 2011 channel cross-sections. We detected increased elevations in the channel cross section data from Unit 3 North after the first year following restoration (Figure 13). The increase in elevation may be due to vegetation mats within the middle of the channel loosening and floating up as they begin to die back in response to estuarine conditions. In the second year, many of these vegetation mats had decomposed and washed away with tidal exchange, and we detected approximately 40 cm of scour in our 2011 channel cross section survey (Figures 13, 14).

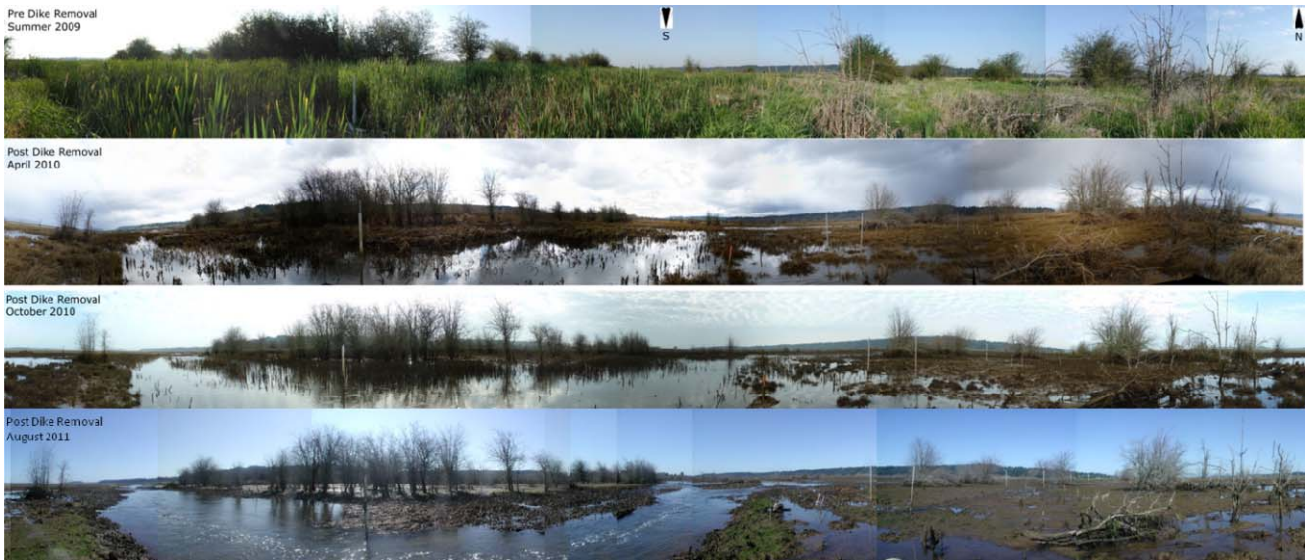
FIGURE 14. PANORAMIC PHOTOPOINT OF UNIT 3 NORTH SHOWING CHANNEL DEVELOPMENT.

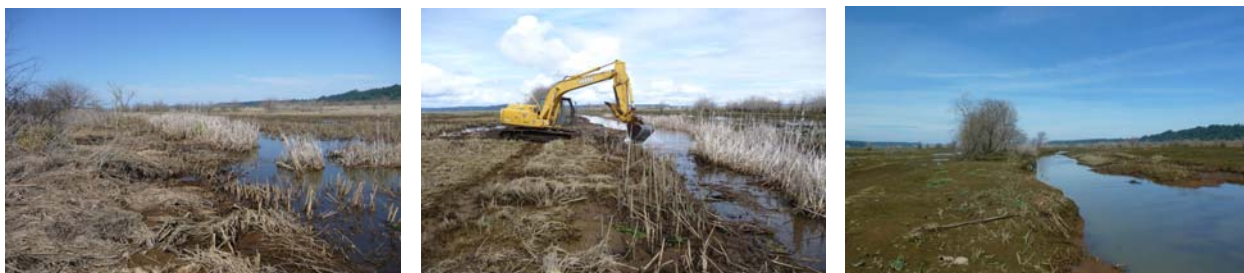
FIGURE 16. PHOTOGRAPHS OF LESCHI SLOUGH BEFORE, DURING, AND AFTER DREDGING

Major adaptive management triggers were identified as part of the Refuge Monitoring Framework (Ellings 2008): including ponding with obvious and extensive fish kills. Although no fish kills were ever observed or detected, some shallow ponding was observed in the southern portion of Leschi Slough that indicated poor tidal drainage. As a pro-active measure, the Refuge dredged the southern portion of Leschi Slough in Sept 2010 (Figure 16). We captured the channel bathymetry prior to dredging (Jul 2010) and after dredging (Sep 2010), and analyzed the elevation difference between the coverages (Figure 17). Our bathymetry results show deepening of the channel not only in the southern portion of the slough, but also scour throughout the length of the channel. The dredging likely increased tidal flows through a bottleneck area that had been slowed down by remnant vegetation. As a result, tidal exchange throughout the channel has been enhanced, which has likely helped scour unconsolidated sediments and deepen the entire stretch of Leschi Slough. Readings from a handheld water quality multiprobe (YSI), also indicated improved dissolved oxygen and salinity from pre-dredge (DO at 6 mg/L; salinity at 1 ppt) to post-dredge (DO at 10 mg/L; salinity at 21 ppt) condition.

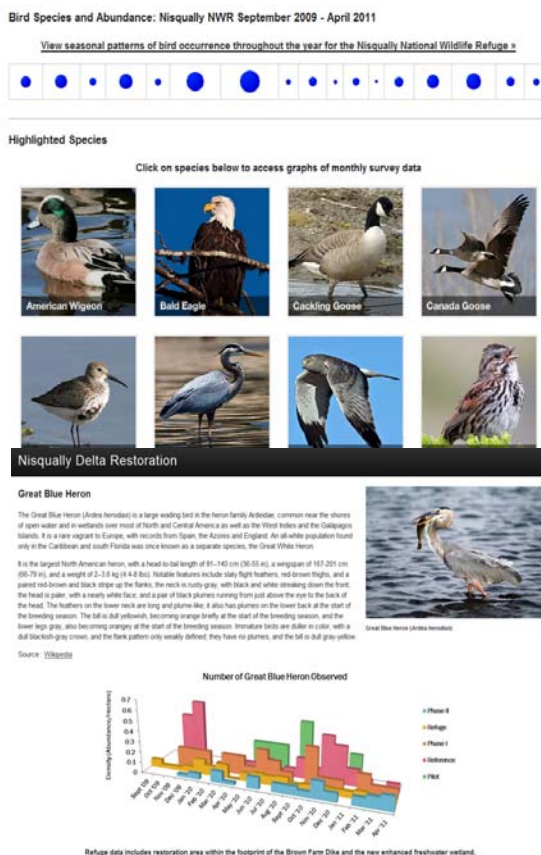
FIGURE 21. BIRD UPDATES ON
 WWW.NISQUALLYDELTA RESTORATION.ORG

- Water quality and level: Continuously updated data displaying current tide depth (MLLW), salinity, and temperature.
- Weather Station: Continuously updated temperature, wind, humidity, rain, and barometric pressure data from the restoration.
- Birds: Updated in spring 2011 with new visuals for displaying bird species abundance; and more specific graphs of abundance and distribution for focal species (Figure 21).
