Guadalcanal Tidal Marsh Restoration: 2007 Annual Report

Guadacanal Tidal Marsh Restoration: 2007 Annual Report

Data Summary Report

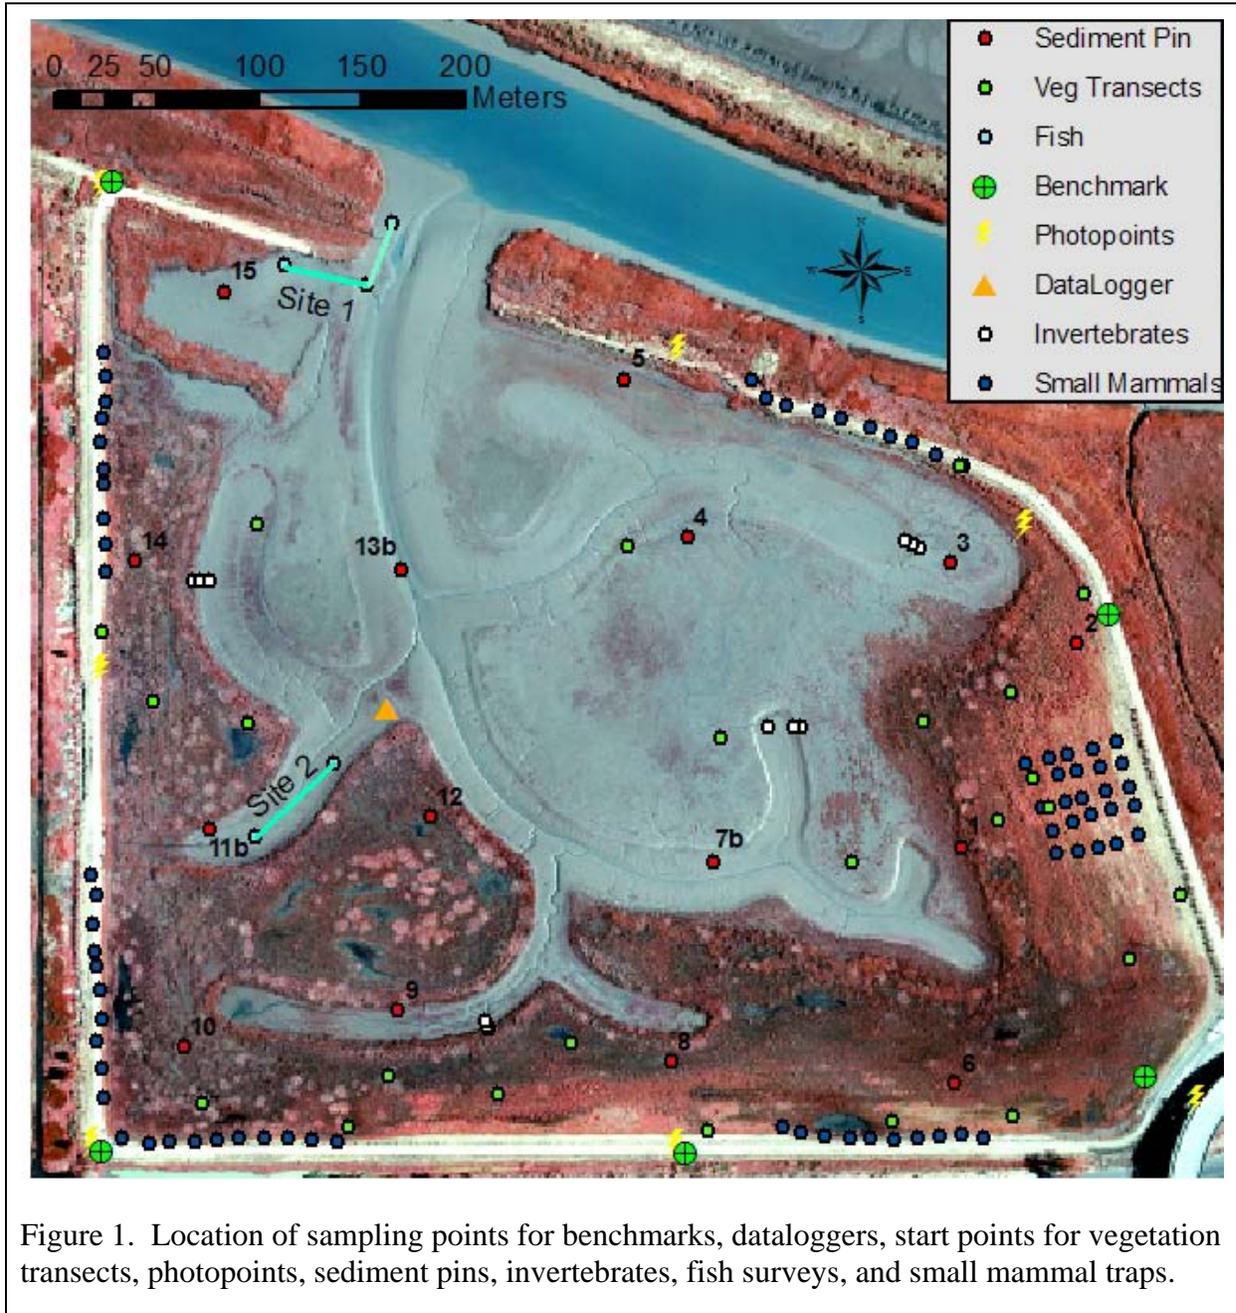
Biological monitoring parameters included vegetation (transect surveys, quadrat surveys, land cover classifications), benthic invertebrates (sediment core samples), fish (beach seine and bag seine efforts), birds (observations), and small mammals (Sherman traps; Figure 1, Table 1).

Benchmarks were installed by USGS–WERC in September 2004 throughout the site (Figure 1) and were resurveyed in November 2005 (Shoreline Engineering & Restoration).

Digital panoramic photographs were taken annually from seven permanent points within the project (Figure 1) to track qualitative changes and to provide reference points for levee erosion, channel width changes, and changes in vegetation. Photographs were first taken in June 2000 to

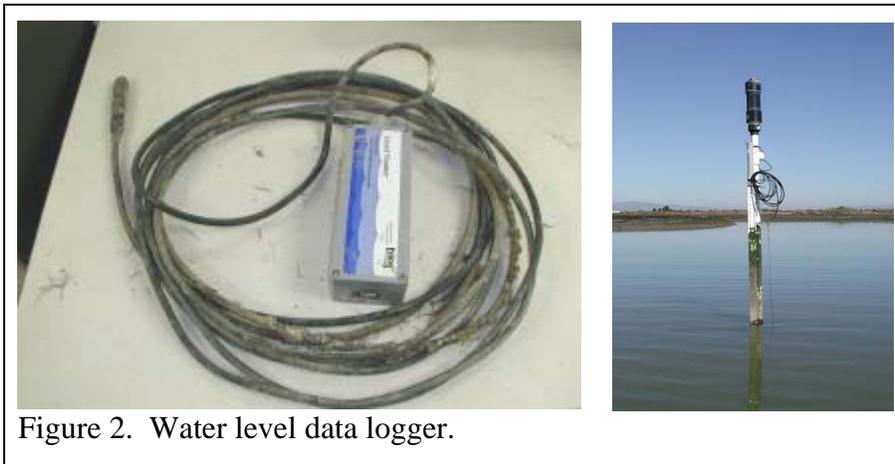
Figure 2. Water level data logger.

Water levels were monitored continuously with water level data loggers to examine the water depth and flow rates. Our tidal station system (R-2100e, Telog Instruments, Inc., New York; Figure 1, Figure 2) included a pressure transducer that was placed near the sediment surface, and a datalogger that converted water pressure to water depth and recorded data every 15 minutes. Data were downloaded every 60 days using a palm pilot (Palm IIIxe, Palm Inc.) or laptop (Solo, Gateway Inc.). Spot checks were conducted periodically to test for sensor drift or errors by simultaneously recording datalogger readings to an adjacent staff gage that had been surveyed to a known benchmark. Water levels are then converted to water surface elevations.

Two water level loggers were initially installed in October 2001. These loggers produced nearly identical hydrographs, so that when the eastern logger failed in November 2006, it was not replaced. We monitored sedimentation by recording the distance from the sensor to the sediment during each logger download session.

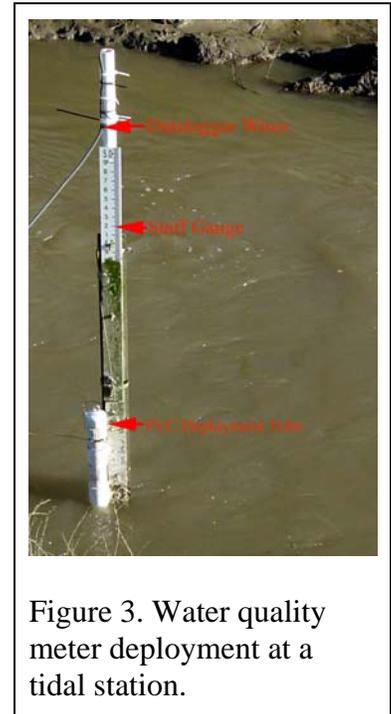
Figure 3. Water quality meter deployment at a tidal station.

We used a Hydrolab Minisonde water quality meter (Hydrolab-Hach Co., Loveland, CO; Figure 3) to record changes in pH (0.1 pH), conductivity (converted to salinity using the 1978 Practical Salinity Scale), dissolved oxygen (% saturation and mg/L), turbidity (10

NTU), temperature (°C) and salinity (ppt). Data was collected quarterly in a continuous 48 hr deployment at Guadacanal's west datalogger. Prior to deployment, the meter was cleaned and calibrated to standard solutions and programmed to log at 15 min intervals during the 48 hr period. Upon retrieval of the water quality meter, readings were taken in distilled water before and after cleaning to check for any possible fouling effects.

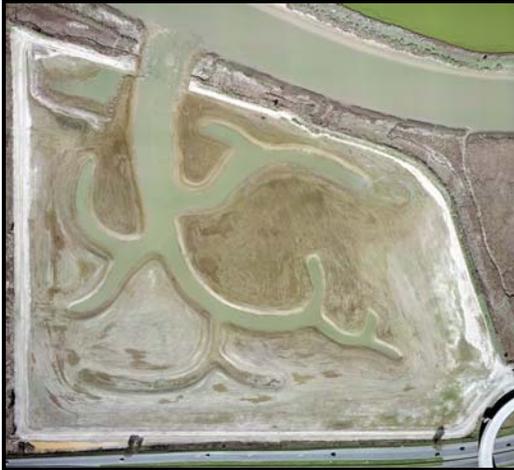
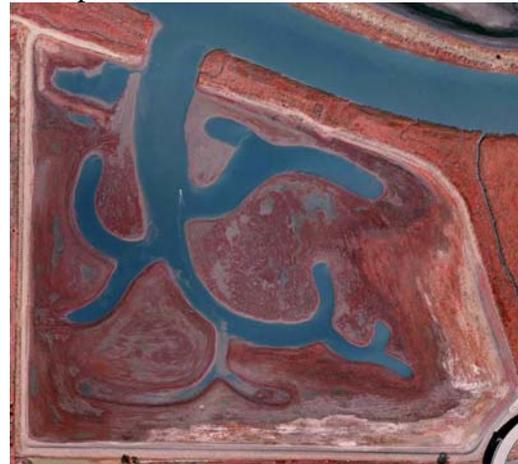
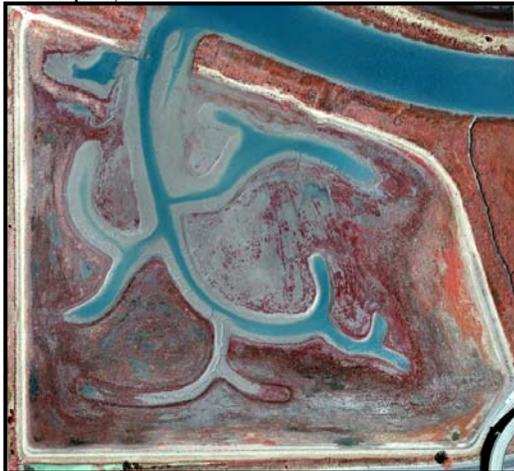
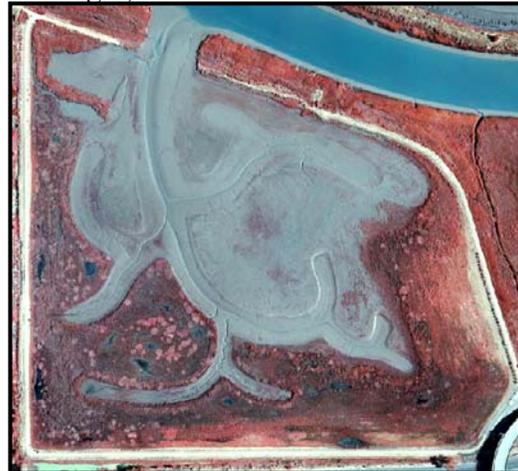
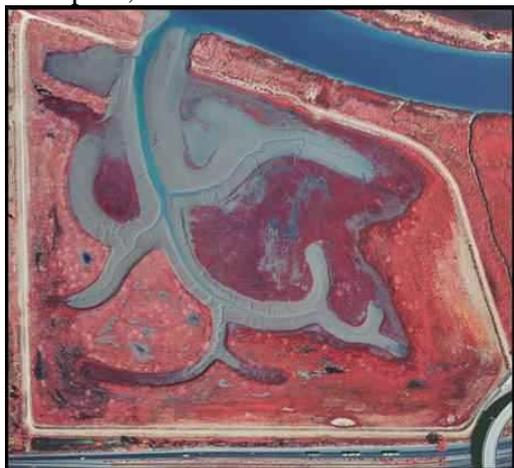
Figure 4. Color infrared aerial photographs of the Guadacanal Restoration Project in (a) February 2002, (b) September 2003, (c) September 2004, (d) August 2006 and (e) September 2007. In 2004, sediment dispersal patterns show the narrowing of the main channel. In 2006 and 2007, the aerial photographs show further sediment accumulation at the channel edges.

Aerial photographs provide useful information in characterizing restoration changes over time. The Guadalcanal aerials documented sediment accretion over the past 5 years. The 2004 aerial shows initial sedimentation and narrowing of the main channel. Further sediment accumulation at the channel edges and algae colonization on the mudflats is evident from the 2006 and 2007 aerial photographs (Figure 4). Sediment dispersal patterns observed from this imagery were confirmed and quantified by sediment pin and bathymetric data.

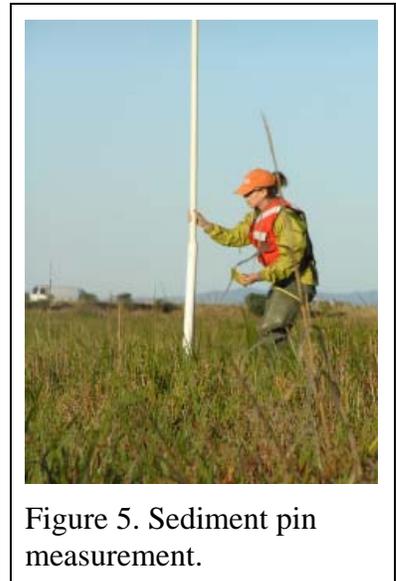
Plastic poles (PVC) pounded into the substrate (sediment pins) are an inexpensive method to assess sedimentation patterns (Siegel 1998, Takekawa et al. 2002; Figure 5). Sediment pins were installed at 14 locations across Guadacanal (mudflat to high marsh zones) following construction and before the levee was breached. An additional sediment pin (SP 15) was added to the project in 2006 to capture sediment and the elevation was surveyed in September 2006 (Figure 1). Sediment elevations

were calculated by subtracting the length of the sediment pin from the elevation of the sediment pin top. A graduated (cm) vertical rod with a flat base was used to determine distance between the pin top and the sediment surface. The average of two readings taken at opposite sides of the sediment pin was reported. Over time, a shorter sediment pin length indicated sediment accumulation, while a longer sediment pin length indicated sediment loss. Sediment pins were taken from February 2002 to September 2007.

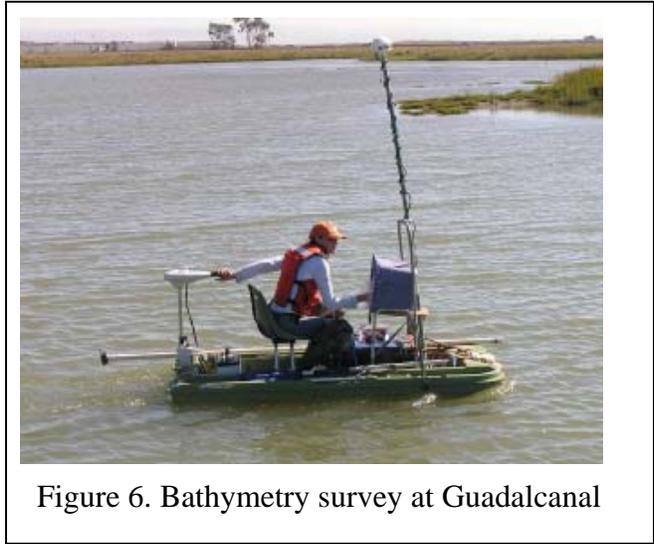
Figure 6. Bathymetry survey at Guadacanal

We conducted a bathymetric survey in September 2006 and surveyed the project along both north-south and east-west transects at 25m intervals. We validated our bathymetry elevation recordings using several methods. Prior to data collection, we calibrated the system using a bar check plate and a graduated pole, and adjusted the sound

velocity for salinity and temperature differences. Post processing included a comparison with sediment pin elevations to grid cell elevations generated by the bathymetry map.

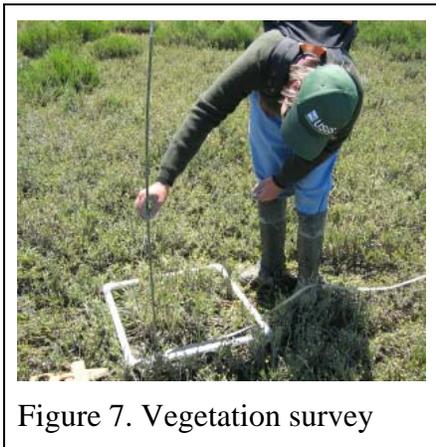
Figure 7. Vegetation survey

A 20 m point intercept transect was measured from the center of each vegetation plot (n = 24; Figure 1, Figure 7) in a random direction to determine percent cover of plant species. Plant

species were identified and measured for height at 0.5 m intervals along each transect. Percent canopy cover was calculated by dividing the number of “hits” over the total number of point-intercepts (Bonham 1989). In addition, a 0.5 m² quadrat was placed along transects at 0, 10 and 19.5 m. Quadrat measurements consisted of species identification, ocular estimates of percent cover, maximum height and

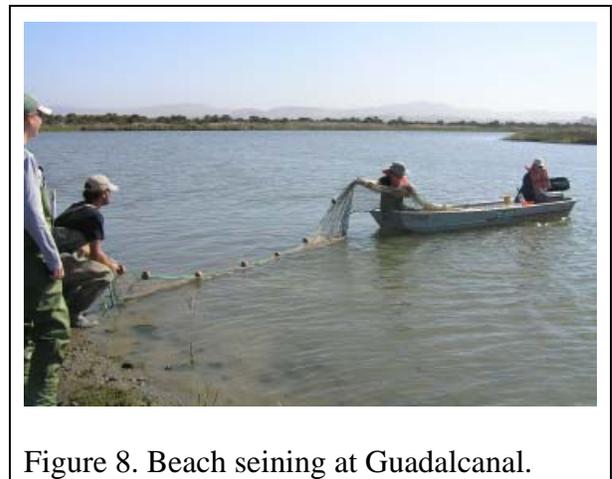
Figure 8. Beach seining at Guadacanal.

identified to species, enumerated, measured (standard length and total length; carapace length for crabs), and released on site.

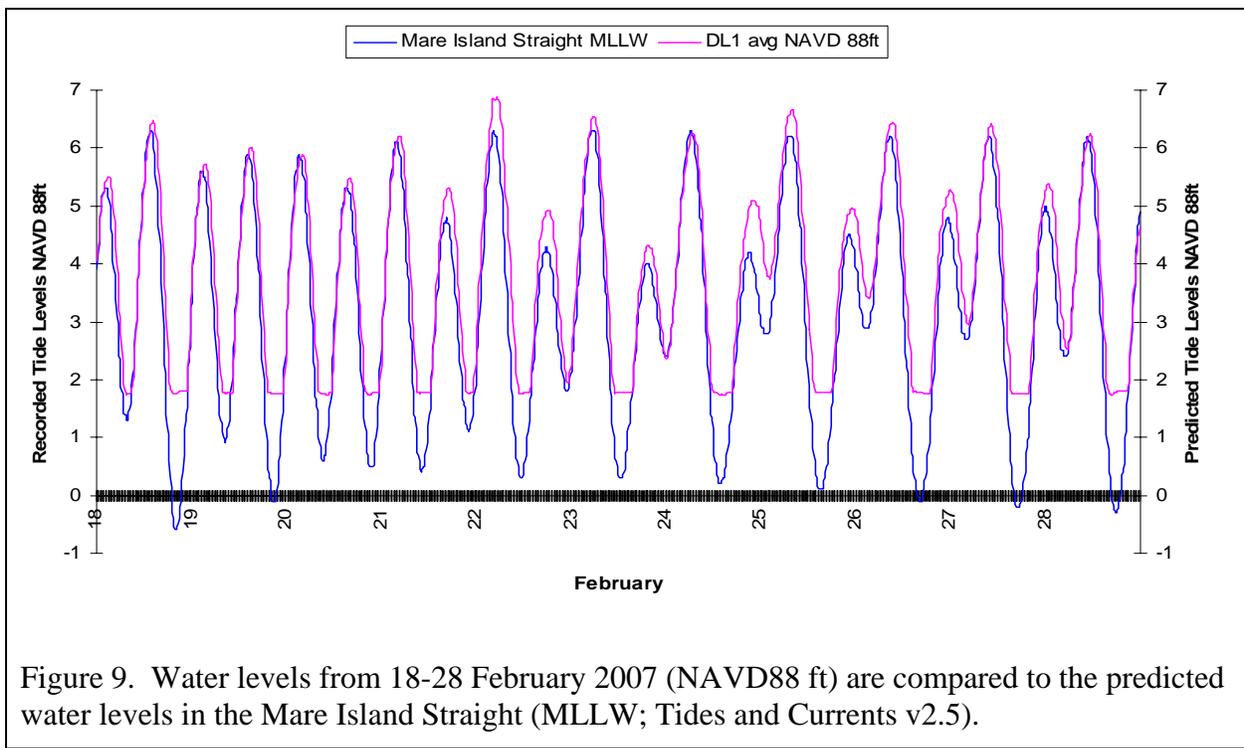
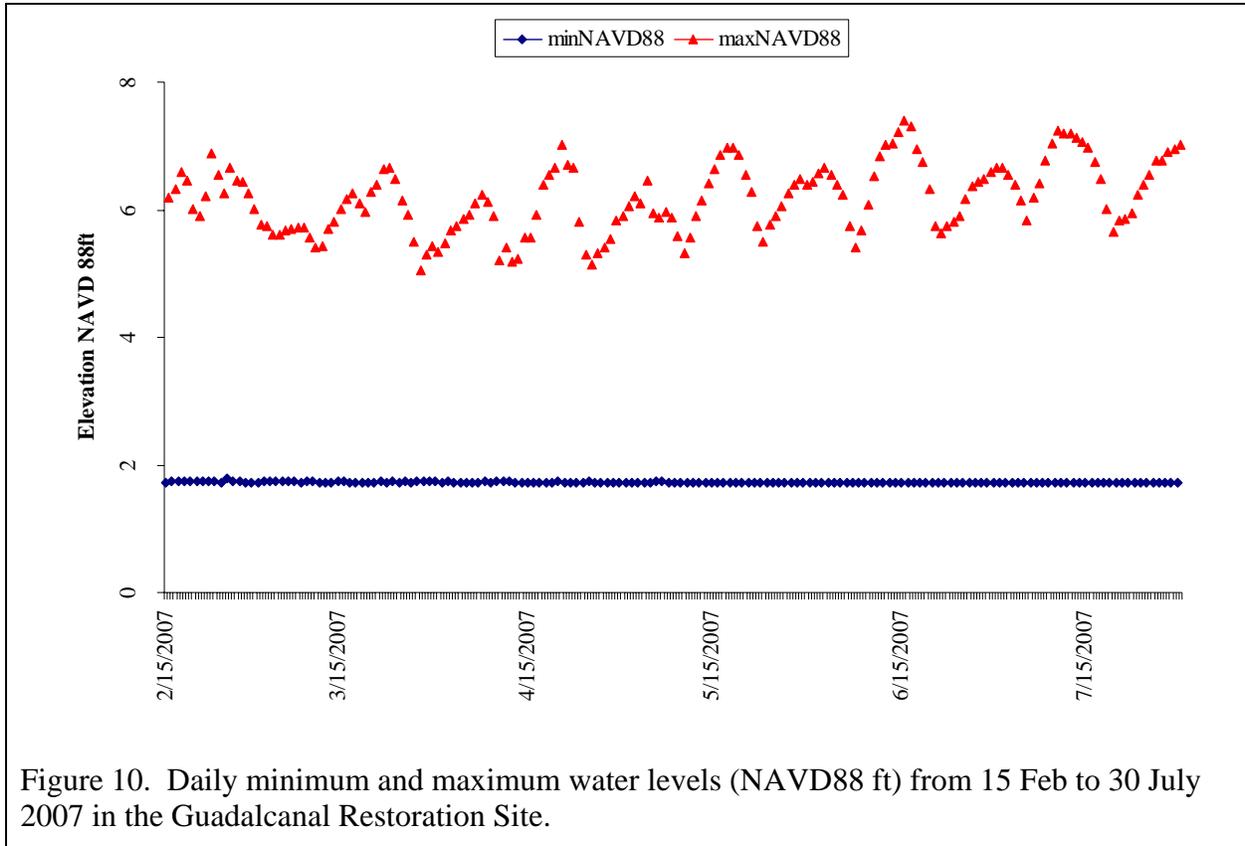
Figure 10. Daily minimum and maximum water levels (NAVD88 ft) from 15 Feb to 30 July 2007 in the Guadalcanal Restoration Site.

Water level elevations were used to identify patterns of tidal cycles through time and to determine tidal datum, such as the mean higher high water (MHHW). Guadalcanal is fully tidal and experiences tidal amplitude, period and range similar to that of the predicted levels for Mare Island Strait (Tides and Currents Pro; Nautical Software, Inc.; Figure 9). Sedimentation within the main channel limited daily minimum water levels to 1.8 ft NAVD88 at the location of the datalogger (Figure 10). The average daily tidal range from January to July 2007 was 4.2 ± 0.1 ft NAVD88. The highest recorded tide level occurred during the extreme high tide and flooding event on 1 Jan 2006 at 9.2 ft NAVD88, compared to the highest water level in 2007, which occurred on 15 Jun 2007 at 7.4 ft NAVD88.

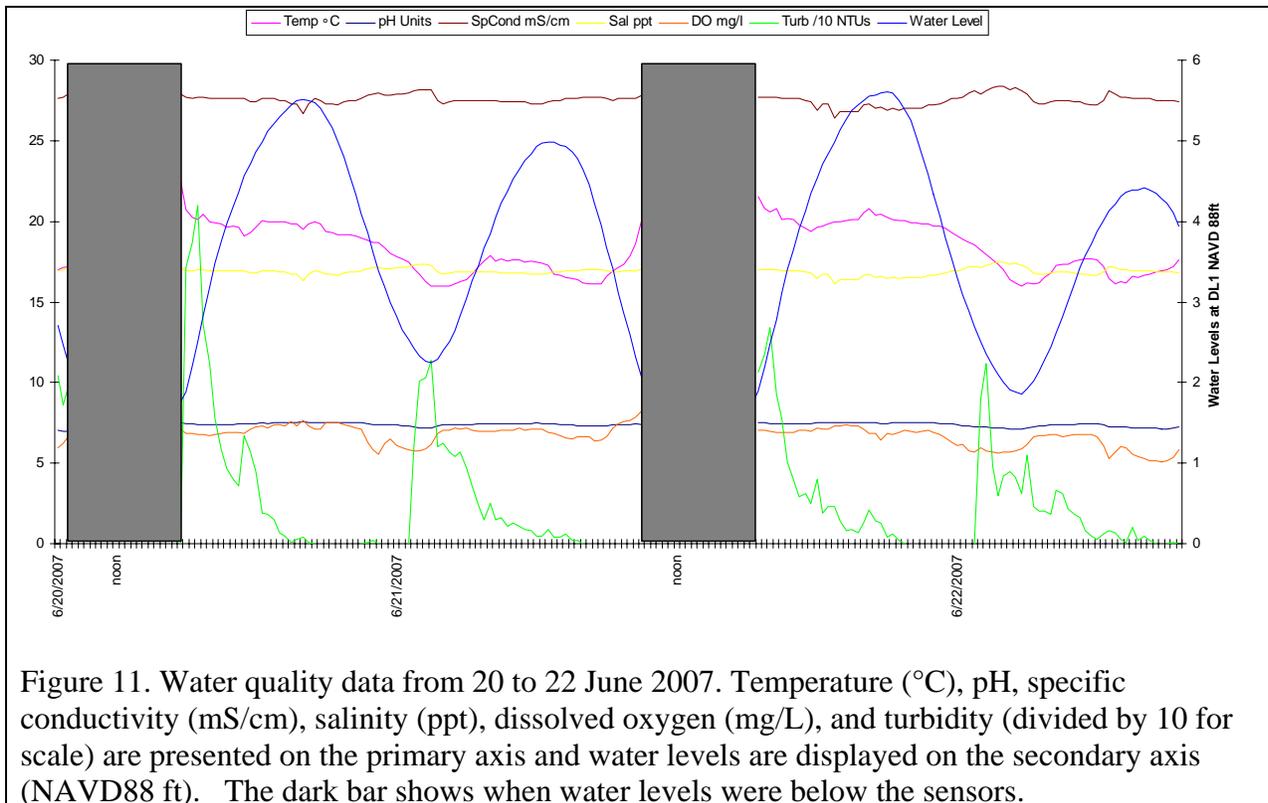
Figure 11. Water quality data from 20 to 22 June 2007. Temperature (°C), pH, specific conductivity (mS/cm), salinity (ppt), dissolved oxygen (mg/L), and turbidity (divided by 10 for scale) are presented on the primary axis and water levels are displayed on the secondary axis (NAVD88 ft). The dark bar shows when water levels were below the sensors.

Percent DO did not vary across seasons, but seemed to be more closely linked with temperature (Table 2). At times in the summer months, the percent DO was oversaturated with readings greater than 100%, likely due to high rates of algae photosynthesis during daylight hours. Mean dissolved oxygen has increased from 1.4 mg/L pre-breach to 6.7 ± 0.1 mg/L and is now within the range found at a restored tidal wetland (Tolay Creek, March 2000) of 5.3 to 10.3 mg/L. Post-breach DO levels remained consistently above 5 mg/L, a threshold used by the California Regional Water Quality Control Board as an indicator of aquatic health. Prolonged levels below 5mg/L can impair the development of fish larvae and other invertebrates (CWT 2004).

The mean pH did not vary appreciably from pre-breach in 2000 (7.1 ± 0.2) and post-breach in 2007 (7.6 ± 0.2). Recorded pH values are within the recorded range for this estuary (6.8 to 8.6; Siegel 1998).

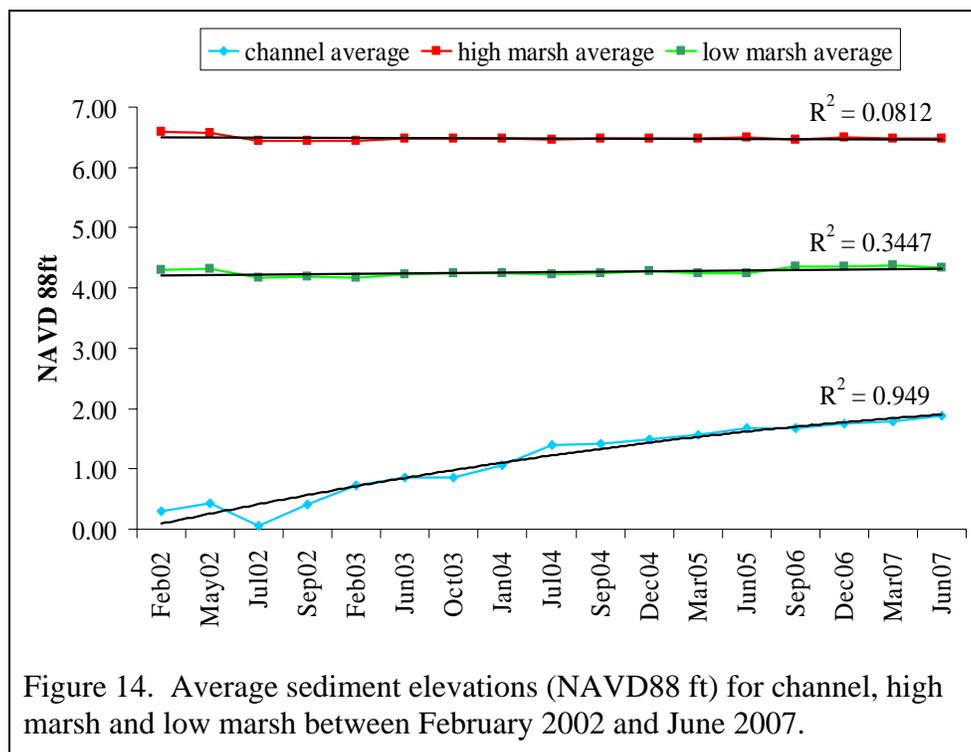
Figure 14. Average sediment elevations (NAVD88 ft) for channel, high marsh and low marsh between February 2002 and June 2007.

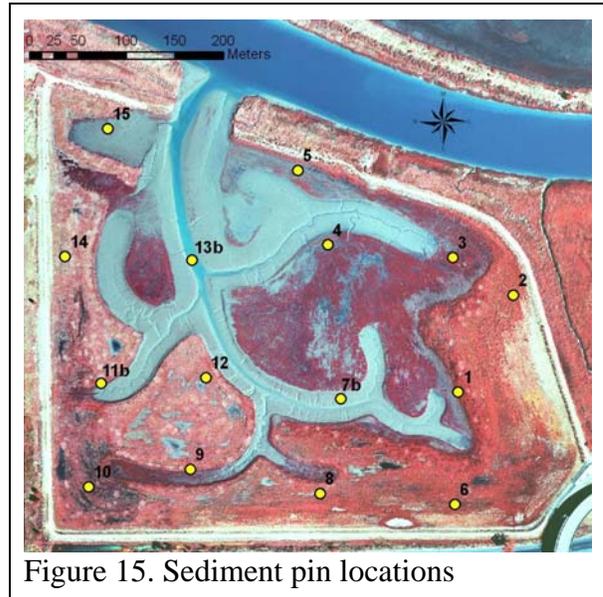
Figure 15. Sediment pin locations

Sedpin 7b, located in the channel, accrued the most sediment (114.6 cm) from Feb 2002 to Sept 2007 (Figure 15; Figure 16). Sedpin 6, located in the marsh plain, had the greatest elevation loss (-4.0 cm), where soils may have settled. Sedpin 5, located in the low marsh area, lost 3.84 cm of elevation. From Sep 2006 - Sep 2007 the channel gained 9.7 ± 2.9 cm of sediment but the high marsh (0.8 ± 0.2 cm) and low marsh (0.7 ± 0.6 cm) remained relatively stable.

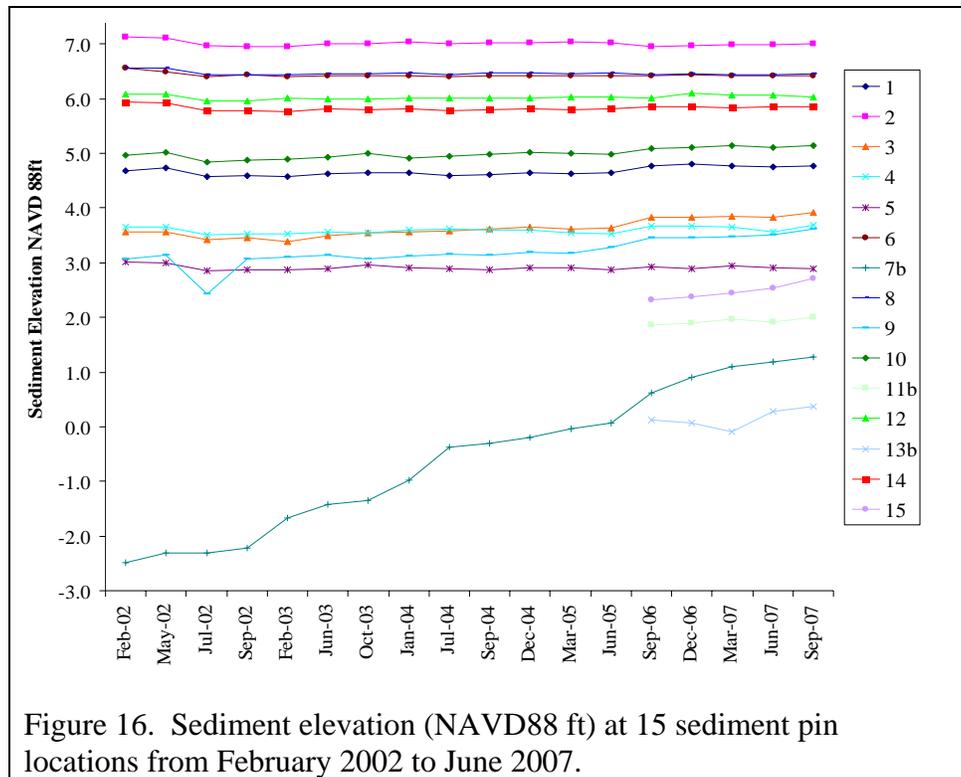
Figure 16. Sediment elevation (NAVD88 ft) at 15 sediment pin locations from February 2002 to June 2007.

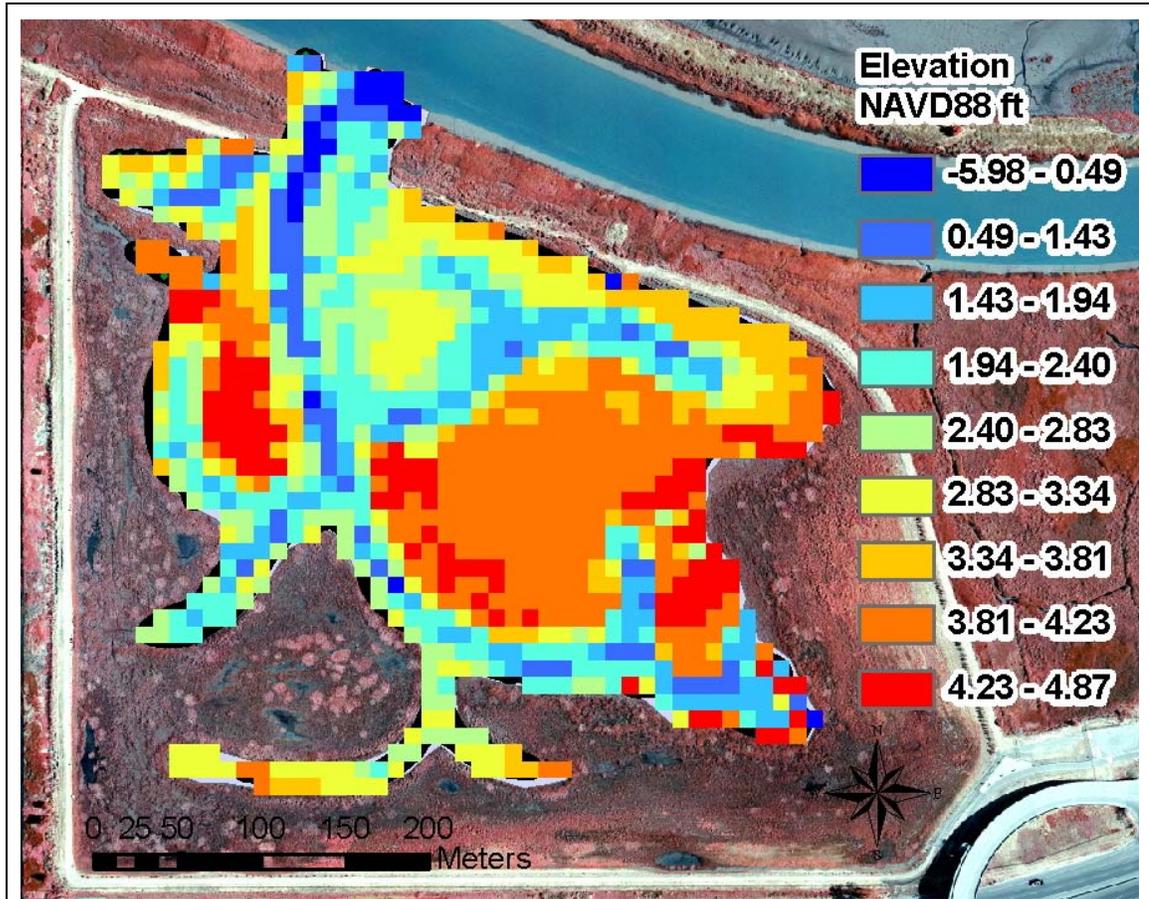
The bathymetric map showed the large mudflat at the center of the project (elevation ranged from 3.3 to 4.9 ft NAVD88) and the primary channels (1.8 to -6.0 ft NAVD88), but it also captured more discreet areas of sediment accretion in the project (Figure 17) where sediment pins are lacking. Areas of high elevation include the mudflat on the west side of the project and northwest of sedpin 4. The southernmost channels are much shallower (2.4 to 4.2 ft NAVD88) compared to other channel elevations. Sedpin 9, which is located within the southernmost channel, showed a gain of 16.5 cm with a year (Sept 2006 to Sept 2007).

Figure 17. Bathymetric survey at Guadalcanal in September 2006 show sediment surface elevations (NAVD88 ft).

As an indication of interpolation accuracy, elevation ranges from the bathymetry grids were compared to actual sediment elevations at sediment pin locations. The difference between sediment surface elevations measured by sediment pins and bathymetry interpolations was 6.6 ± 4.3 cm. Sources of error may be attributed to difference in survey timing, accuracy of sediment pin measurements, local effects of sediment pins on accretion or erosion (Takekawa et al. 2002), penetration of the measuring rod into soft sediments, subsurface reflectance of the echosounder in soft, unconsolidated substrates, and interpolation of the datapoints to 10 m grids.

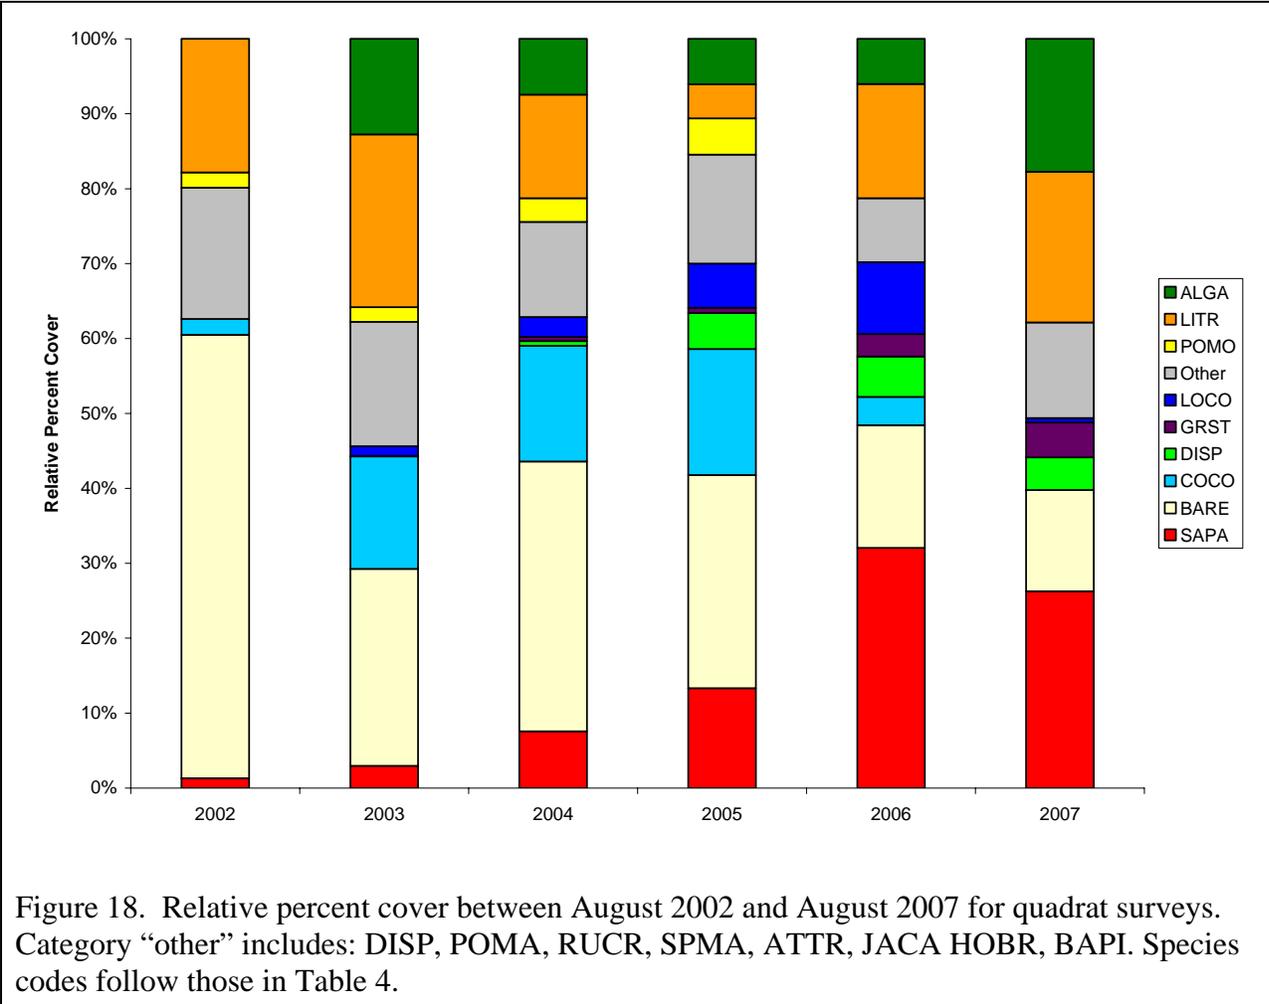
Figure 18. Relative percent cover between August 2002 and August 2007 for quadrat surveys. Category “other” includes: DISP, POMA, RUCR, SPMA, ATTR, JACA HOBR, BAPI. Species codes follow those in Table 4.

Post breach surveys showed that the relative percent cover of pickleweed increased from 1% in 2002 to 32% in 2006 but decreased slightly to 26% in 2007 (quadrat surveys method; Figure 18). There has been an increase in percent cover of algae from 0% in 2002 to 18% in 2007, which is also visible from the aerial photos (Figure 4). In point intercept surveys, similar patterns were observed for pickleweed where relative percent cover increased from 2% in 2002 to 41% in 2007 (Figure 19).

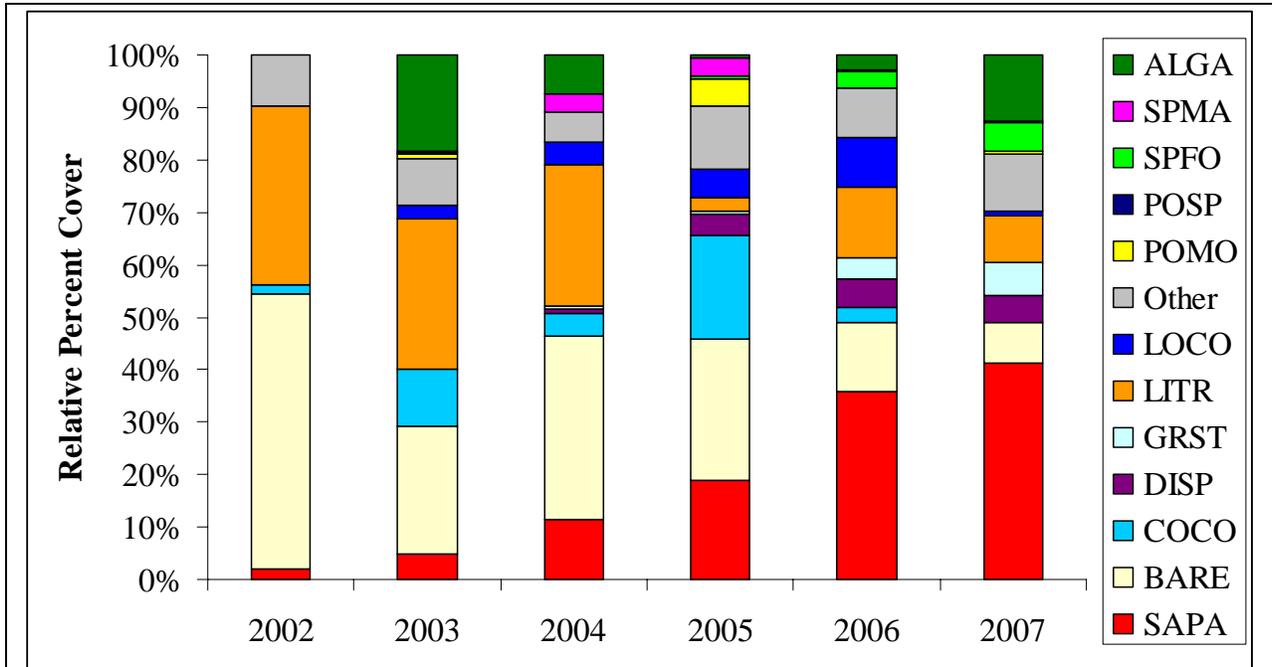
Figure 19. Relative percent cover between 2002 and 2007 for point intercept surveys. Surveys were conducted in August, except in 2005 when surveys were conducted in May, prior to the contract termination. Category “other” includes: POMA, RUCR, ATTR, JACA HOBR, BAPI. Species codes follow those in Table 4.

Between 2003 and 2005, non-native plants had greater percent cover than native species. In 2006 and 2007 native species percent cover increased from 14% in 2005 to 28% in 2006 and to 27% in 2007 (Figure 20). At the same time, percent cover of non-natives declined from 19% in 2006 to 7% in 2007 such that native species are now almost four times more abundant than non-natives. Non-native species included brass buttons (*Cotula coronopifolia*), which declined (Figure 19, Figure 20)

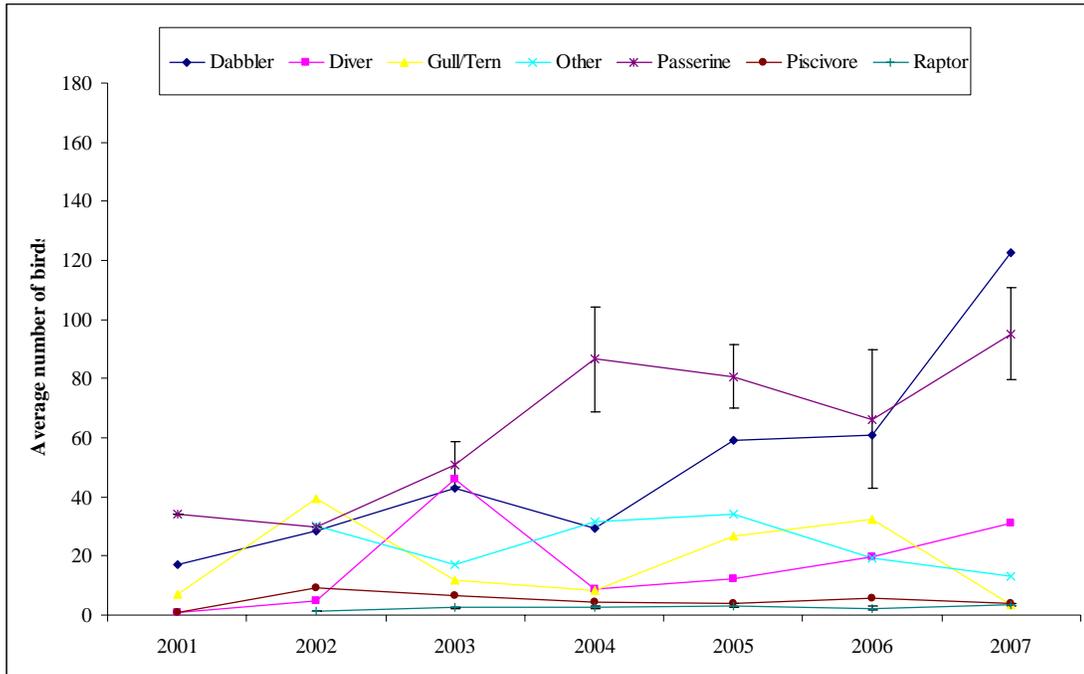
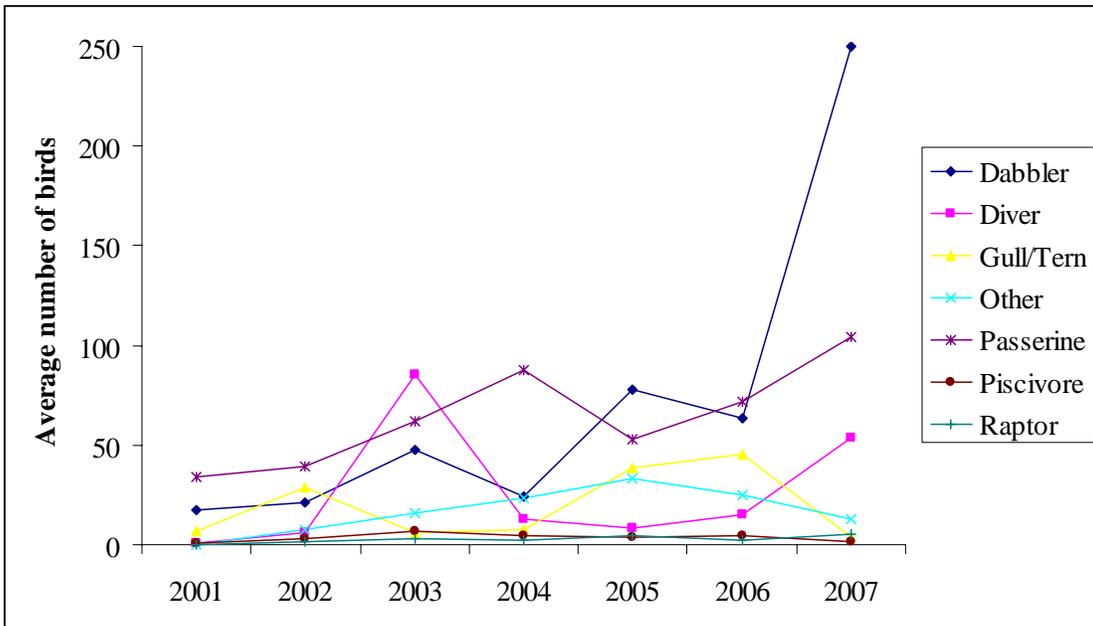
Figure 21. Average number of birds per survey (mean \pm SE) detected (a) over all months and (b) during the migratory season (August-February).

The average number of shorebirds increased from a single low tide survey in 2001 (428) to their peak of abundance in 2004 ($2,132 \pm 1,319$) but then decreased to $1,120 \pm 344$ in 2005, 598 ± 121 in 2006 and 725 ± 293 in 2007 (Figure 22). We also detected seasonal differences in bird abundance. In general, shorebird numbers peaked during fall through the spring (August - February) in all years with the exception of 2004 (Figure 22). Dabbling ducks and diving ducks also experienced slightly higher abundance during the fall through spring migratory seasons (Figure 21).

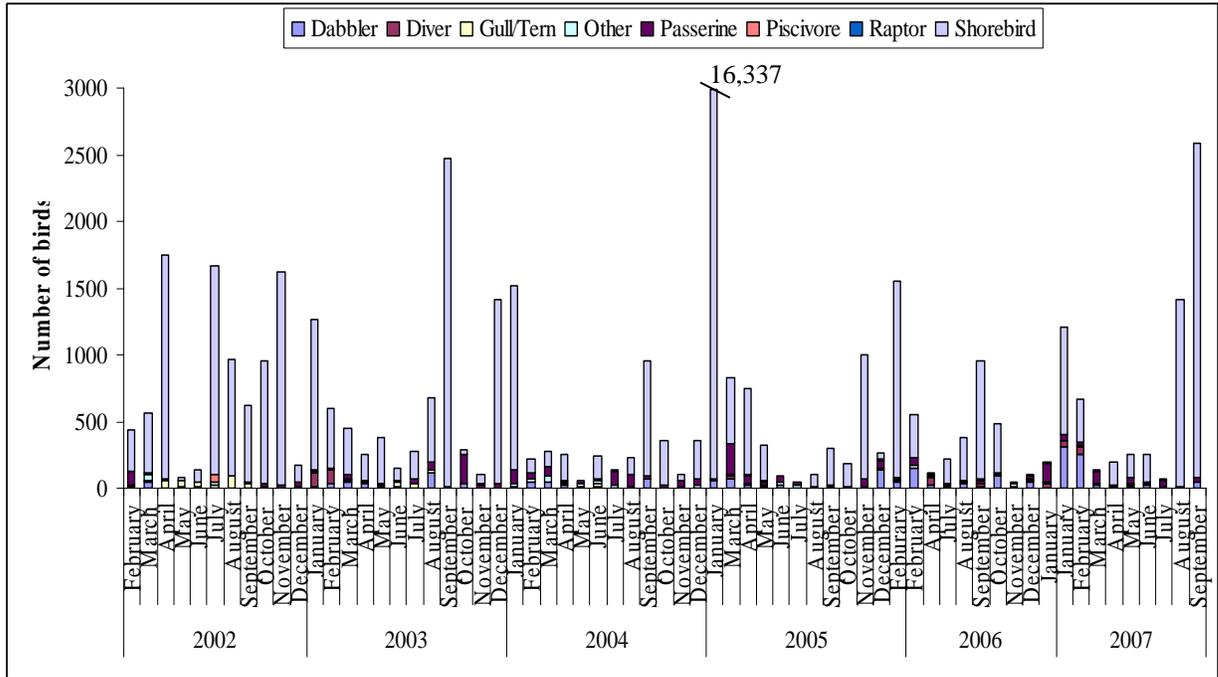
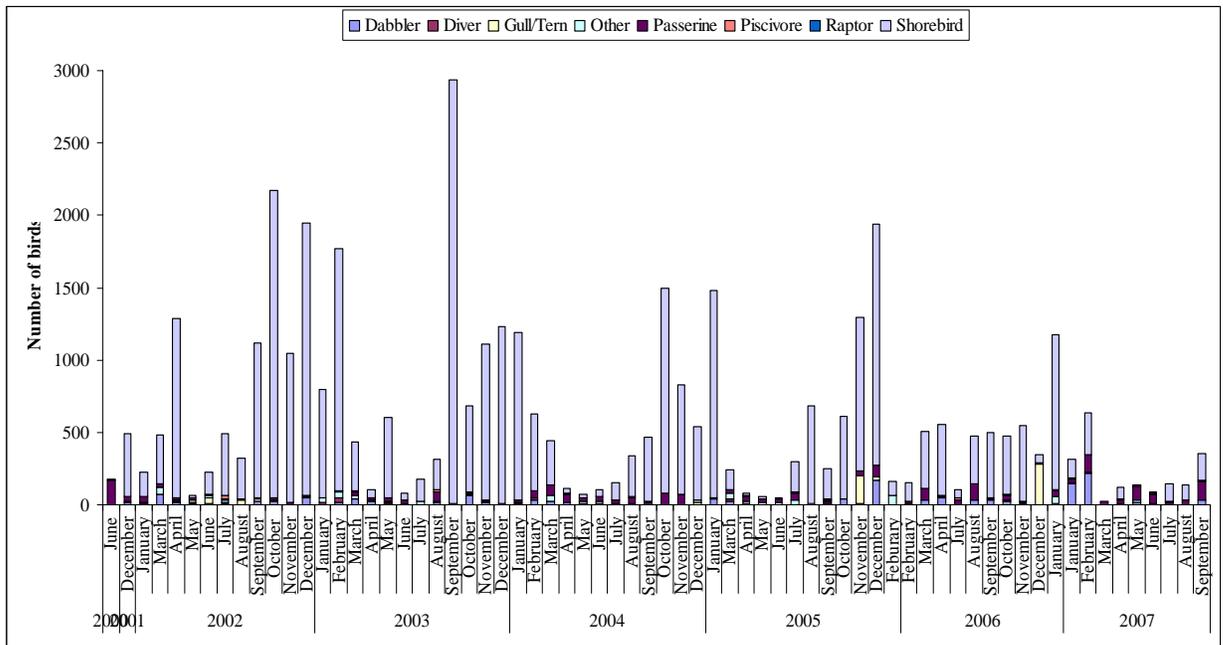
Figure 23. Monthly bird abundances by guild during (a) high tide and (b) low tide at the Guadalcanal Restoration Project.

Since bird composition and abundance vary with tide (Takakawa et al. 2002), we conducted avian surveys at both high and low tide in 2002. We observed a greater abundance of birds during high tide in 2004 (high tide=1,753 birds/survey; low tide=531 birds/survey), 2005 (high tide=703 birds/survey; low tide=650 birds/survey) and 2007 (high tide=753 birds/survey; low tide=218 birds/survey; Figure 23). We detected a decline in the number of birds observed at low tide since 2002, which coincides with the breach of Pond 3 to the north of Guadalcanal.

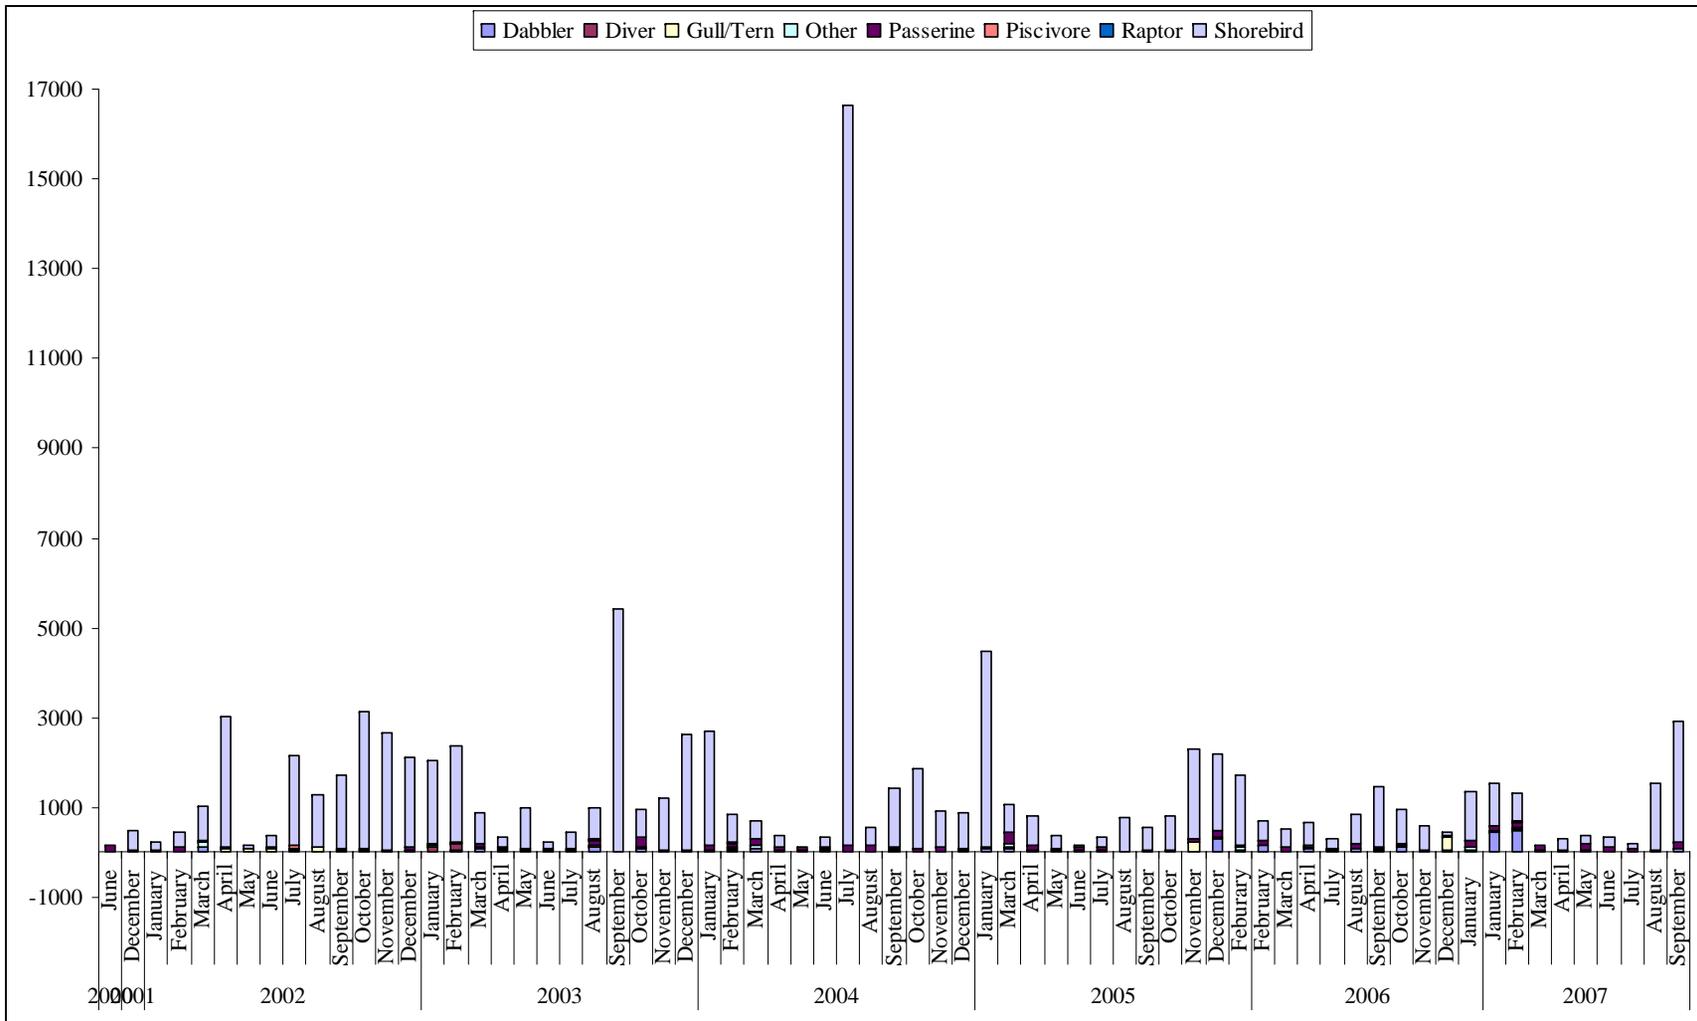
Figure 24. The total number of birds observed at Guadalcanal presented by guild and month.

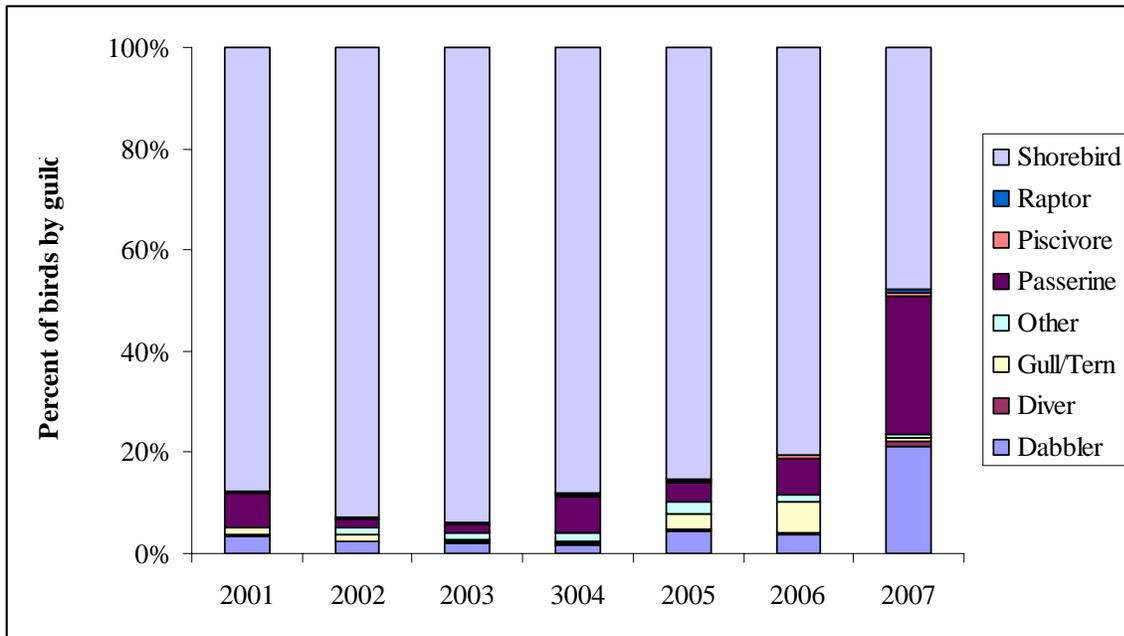
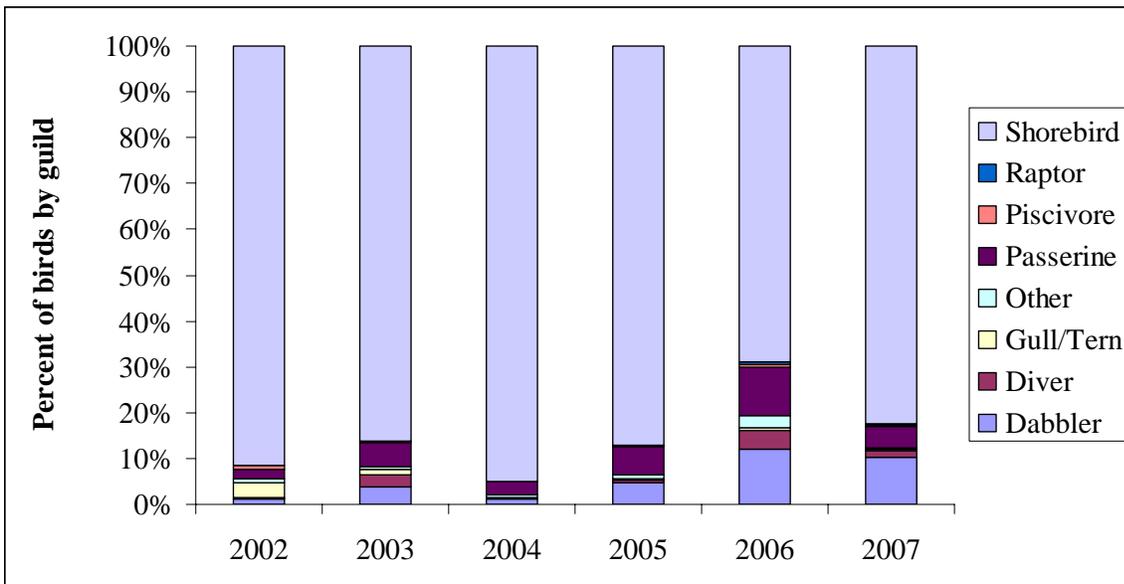
Figure 25. Annual percentage of birds detected per survey at (a) high tide and (b) low tide.

Shorebirds were the most abundant guild recorded at both high and low tide, comprising over 80% of the relative abundance from 2001-2006 and declined to 48% in 2007. Passerines relative abundance has increased from 7% in 2006 to 27% in 2007 (Figure 24). The greatest number of birds recorded at a single high tide survey on 8 July 2004, was 16,624 individuals (14,080 of which were western sandpipers), with shorebirds comprising 99% of all birds (Figure 25).
