Guadalcanal Tidal Marsh Restoration: 2007 Annual Report

Guadacanal Tidal Marsh Restoration: 2007 Annual Report

Data Summary Report

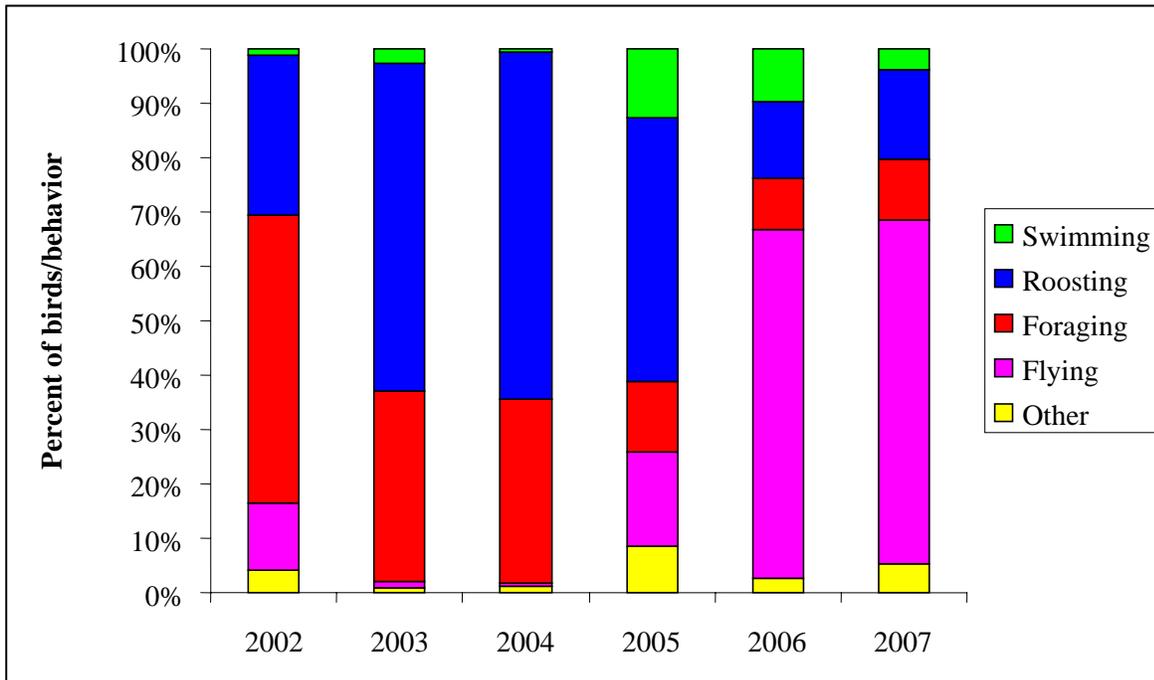
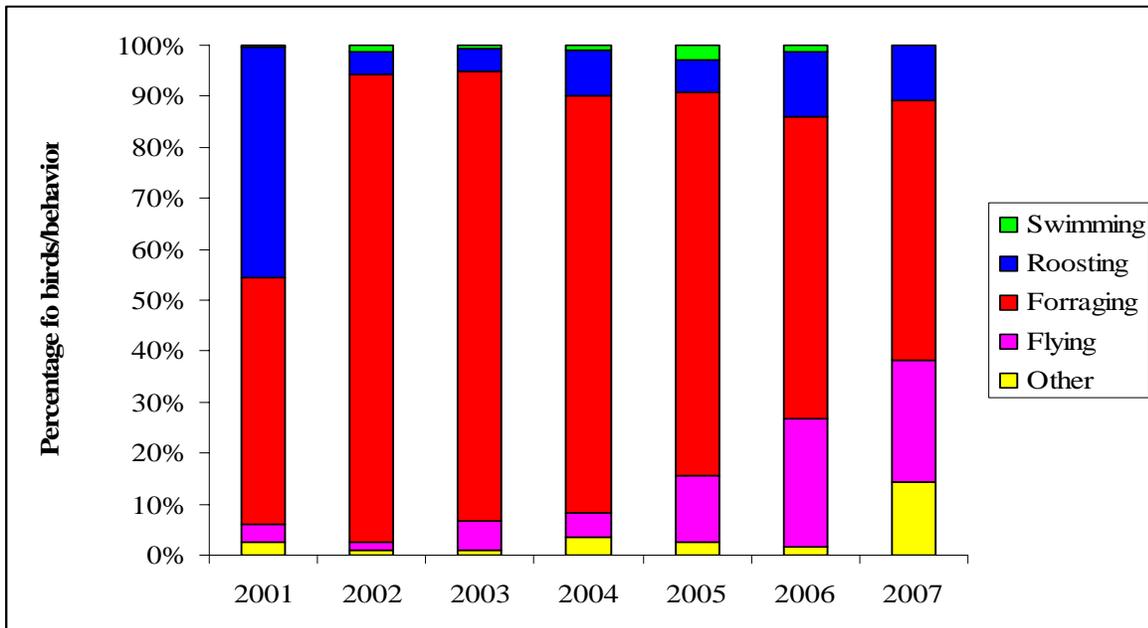
Figure 26. Percentage of behaviors observed by birds at (a) high tide and (b) low tide. “Other” behavior includes: aggression, alert, calling, courtship display, carrying food, carrying nest material, preening, and unknown.

Observation of bird behavior was conducted during surveys and we examined the percent occurrence of roosting, swimming, foraging, and other behaviors at high and low tide and between survey years (Figure 26). During high tide surveys, there was a decrease in roosting and foraging behaviors in the past 3 years and a significant increase birds recorded flying (from 1% in 2003 and 2004 to 18% in 2005 to approximately 64% in 2006 and 2007; Figure 26a). Field observations have noted large numbers of shorebirds flying from the north (Pond 3, Dutchman Slough) across the project to the south (Triangle ponds, San Pablo Bay). This may be due to physical changes in the adjacent Pond 3 where five new breaches were constructed in the spring of 2006. The breaches in Pond 3 have increased sedimentation, providing a large area of mudflat habitat for foraging shorebirds in Pond 3. In a single low tide survey in 2001, there were equal numbers of birds recorded roosting and foraging; however, in subsequent years the prominent behavior at low tide has been foraging due to the exposed mudflat (Figure 26). In the past 6 years we have also recorded a steady increase in birds flying over Guadalupe at low tide as well (from <6% in 2001-2004, to 13% in 2005 to approximately 25% in 2006 and 2007. Direction of bird flight was not recorded during low tide surveys. The relative percent of birds observed foraging also declined during high tide (from 53% in 2002 to approximately 33% in 2003 and 2004 to 13% in 2005 and approximately 10% in 2006 and 2007) and low tide (from 48% in 2001 to >75% in 2002-2005 to 60% in 2006 and 51% in 2007).
