Ni-les'tun Tidal Wetland Restoration Effectiveness Monitoring: *Baseline (2010-2011)*

June 2012

Ni-les'tun Tidal Wetland Restoration Effectiveness Monitoring *Baseline (2010-2011)*

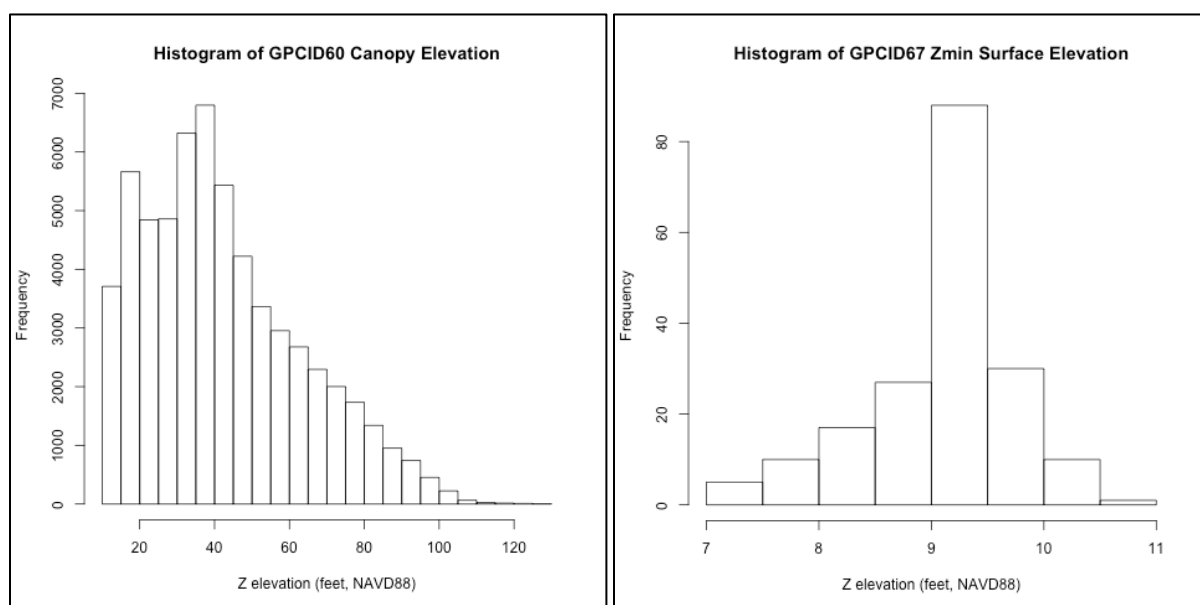
Figure 6. Examples of canopy height histograms created from FUSION canopy model.

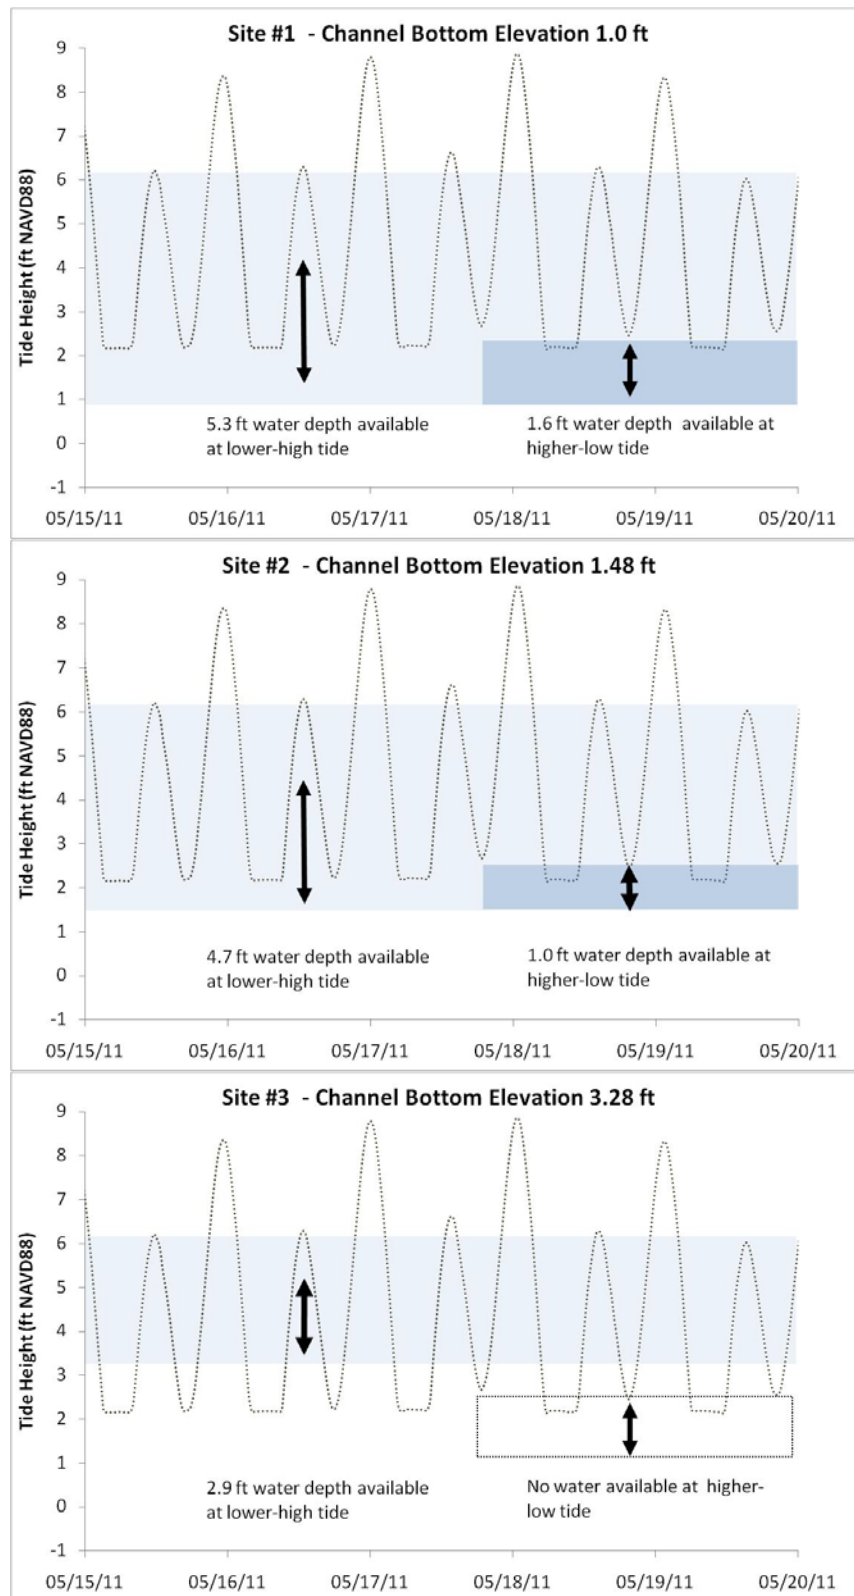
Figure 19. Predicted post-restoration channel water depths for example sites 1, 2 and 3 during a May tidal series.

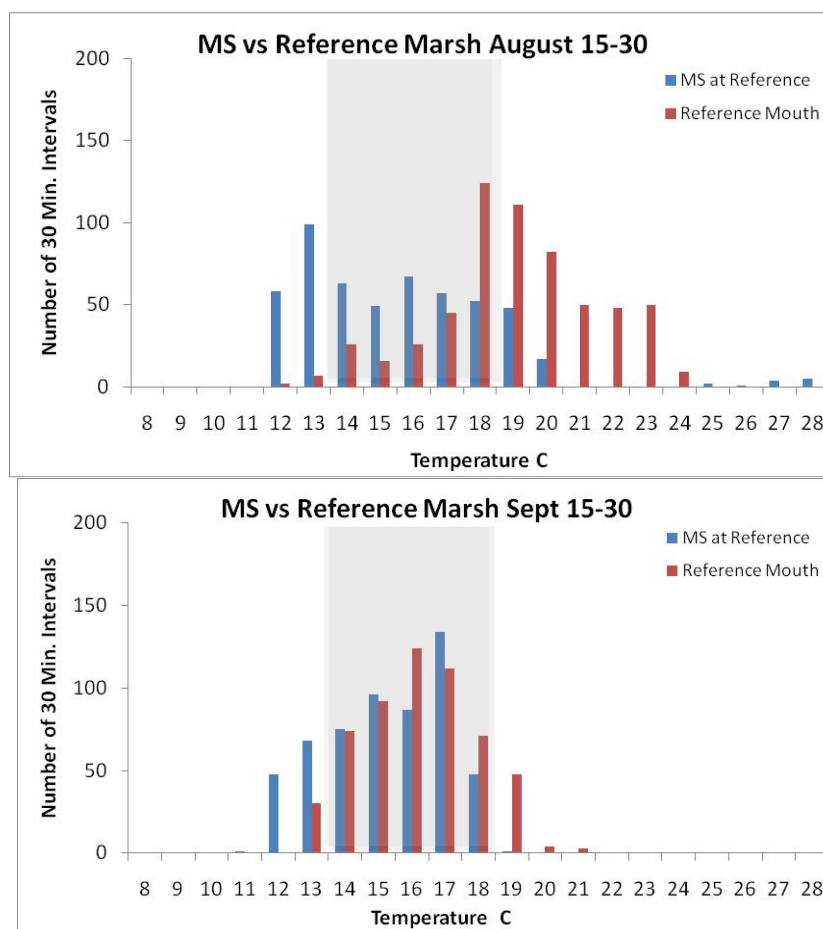
Figure 21. August and September 2011 stream temperatures for the mainstem (“MS at Reference” above; “Ramp T 8228” in Figure A3, Appendix A) and the reference marsh channel itself (“Reference Mouth” above, “Shipwreck A 8238” in Figure A3, Appendix A). Gray block shows temperatures suitable for migration and rearing of juvenile salmonids (Oregon DEQ 1996).

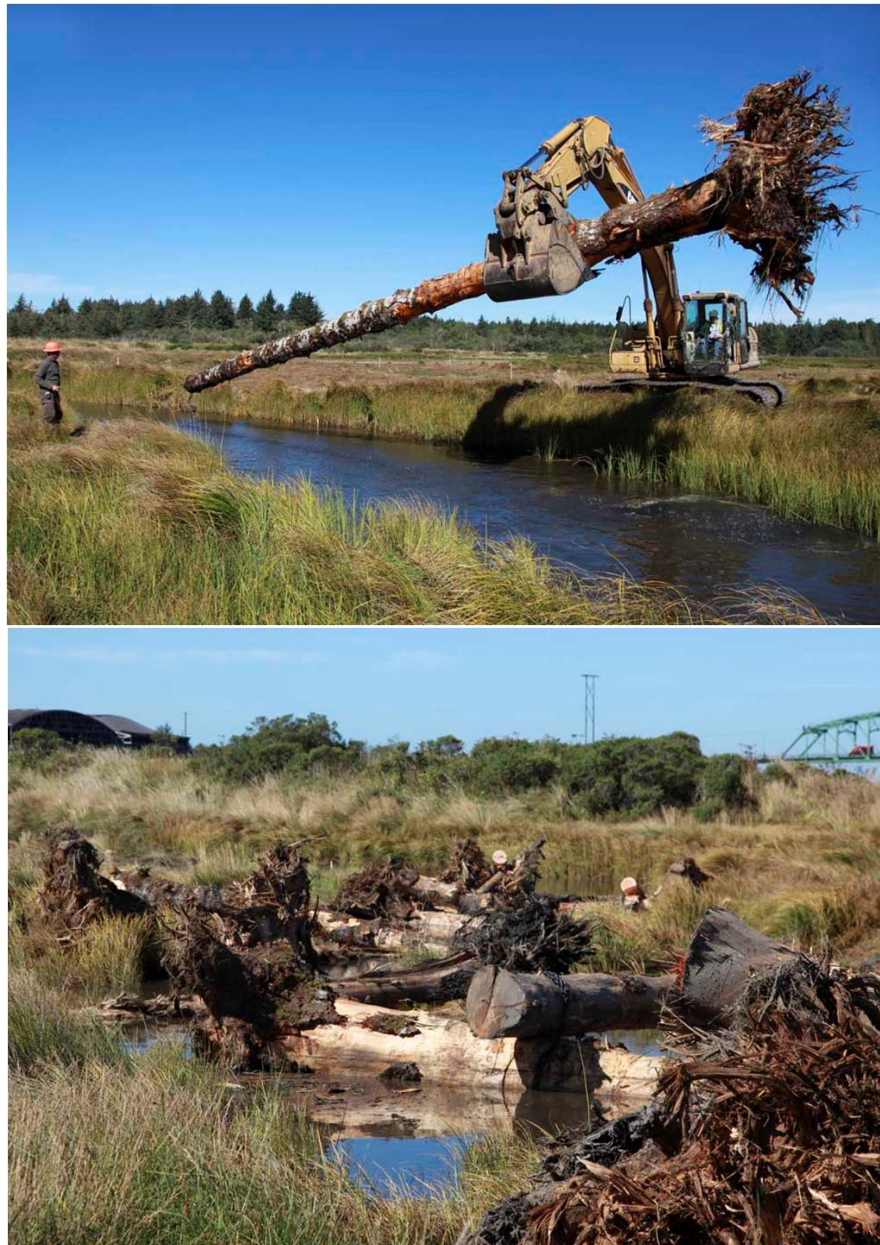
Figure 24. Ground view of restored in-stream wood habitats.

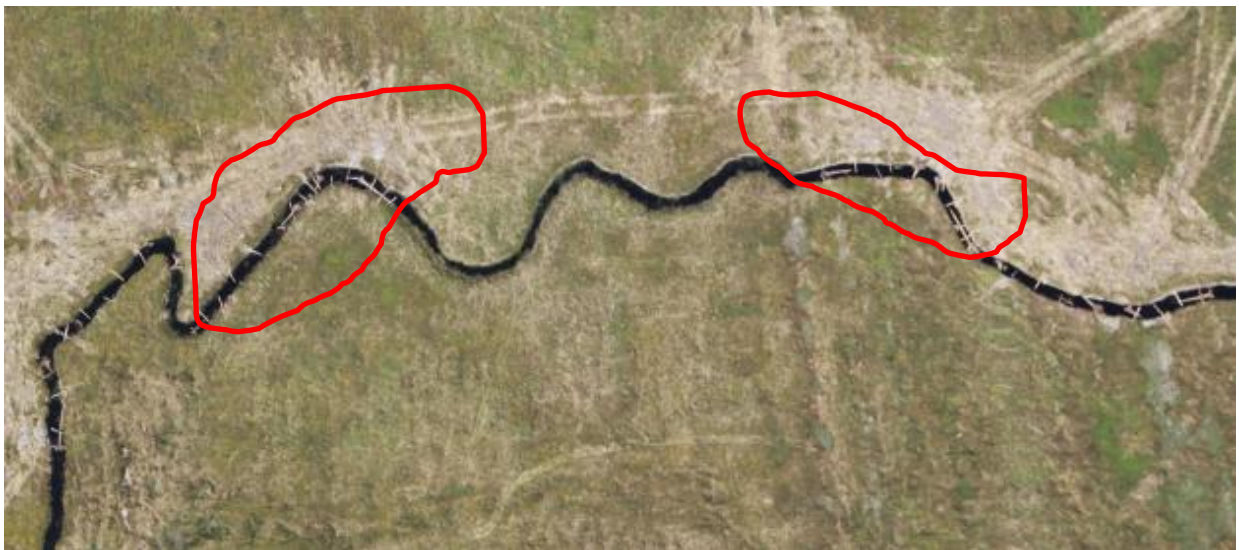
Figure 26. Aerial view of restored in-stream wood habitat monitoring reaches (red polygons).

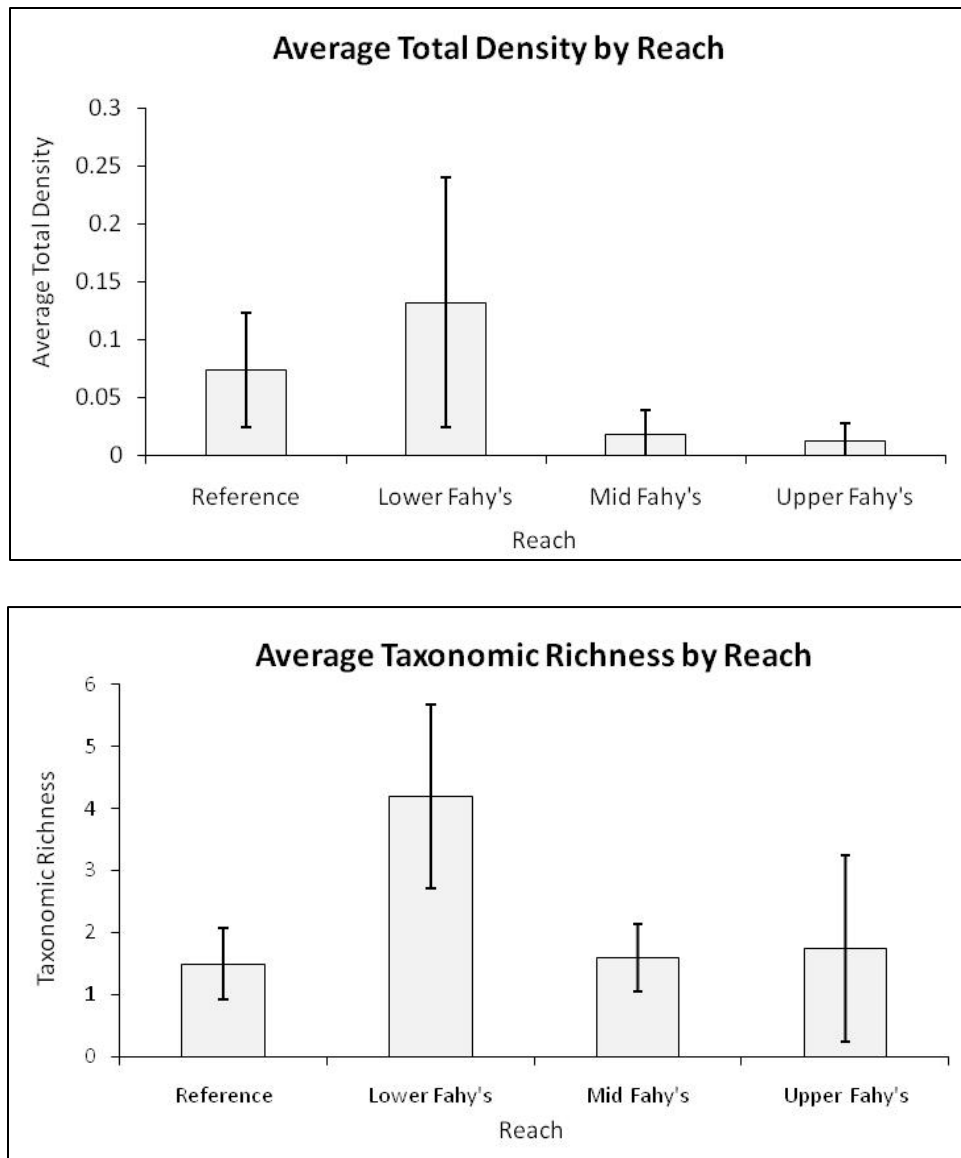
Figure 28. Average total macroinvertebrate density and taxonomic richness for the reference marsh and three Fahys monitored reaches (Lower, Middle and Upper) in 2010.

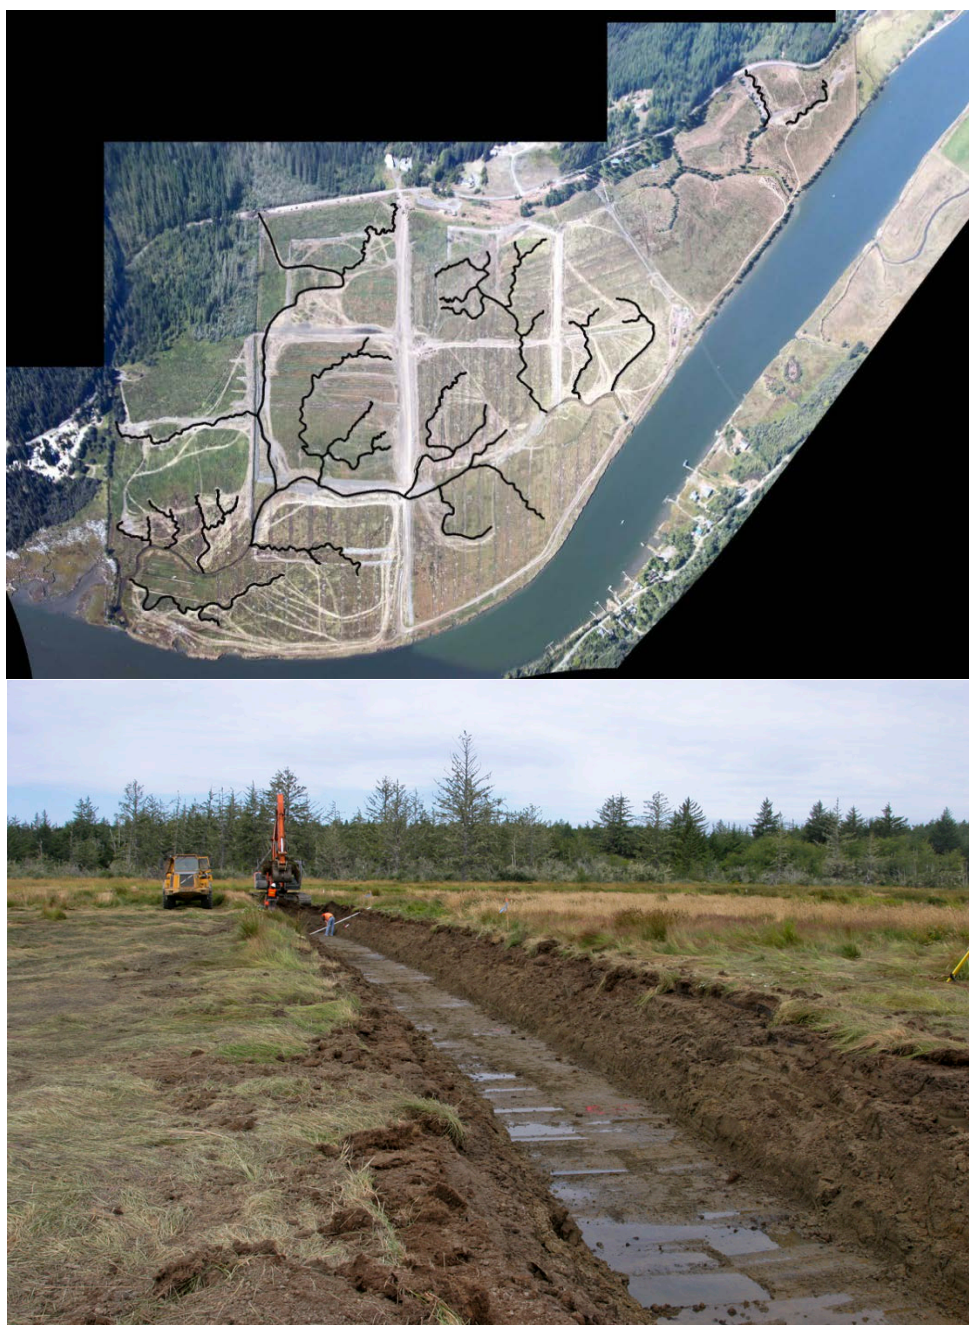
Figure A20. Top: Restored (excavated) marsh channels (black lines). Background is August 2010 aerial by Roy Lowe. Bottom: Newly dug channel form.

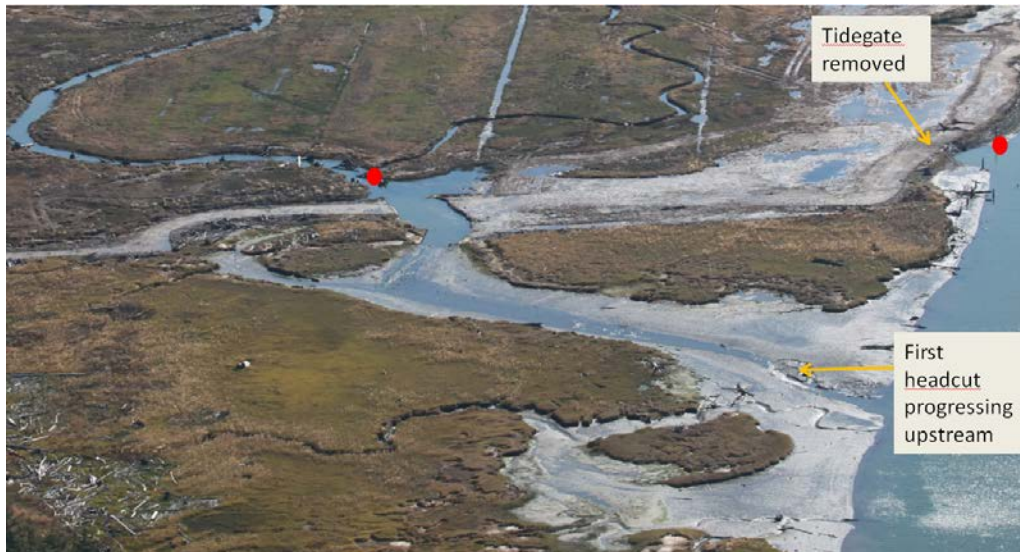
Photo C1. Lower Fahys Creek on September 2, 2011, showing location of inside and outside tide gauges (red dots). Former mouth of Fahys Creek is at upper right ("tidegate removed"). Photo by Bill Bridgeland, USFWS.
