Effectiveness Monitoring at Tidal Wetland Restoration and Reference Sites in the Siuslaw River Estuary: *A Tidal Swamp Focus*

Final Report **June 2009**

Ecotrust
Portland, Oregon

Laura Brophy
Green Point Consulting
Corvallis, Oregon

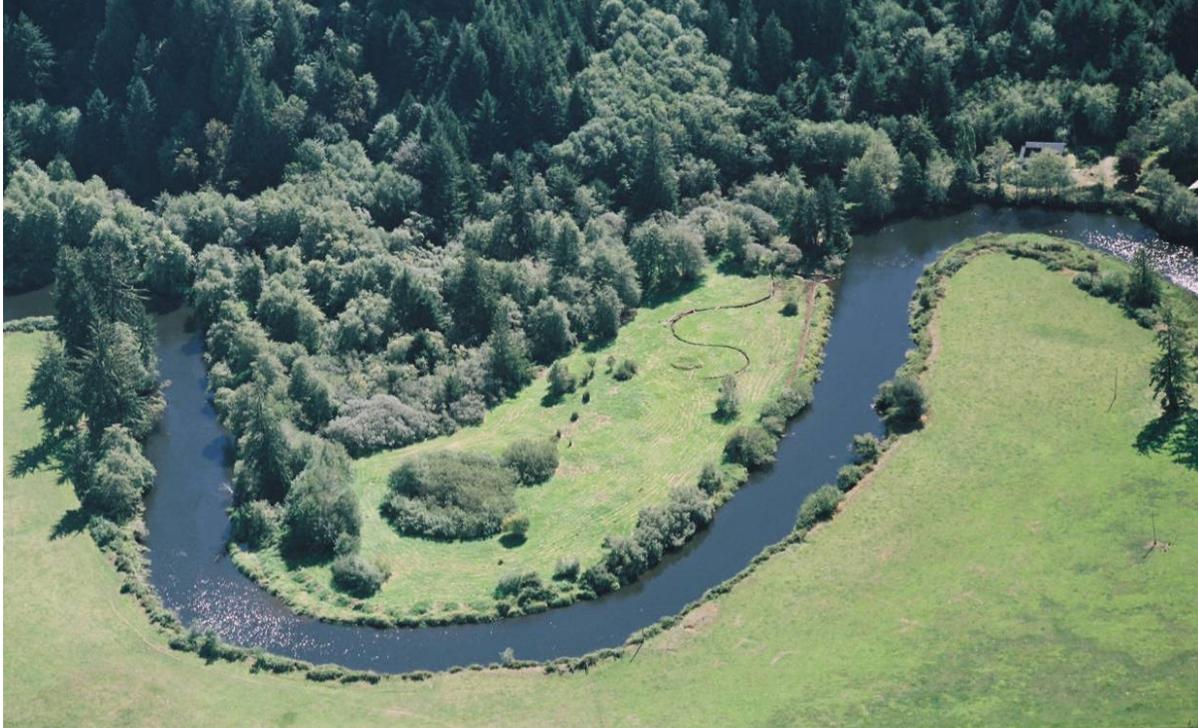
North Fork Siuslaw River Tidal Swamp Restoration (site S65), 1 month after dike breaching and meander construction (9/10/07). Photo courtesy of Oregon Department of Transportation Photo and Video Services.

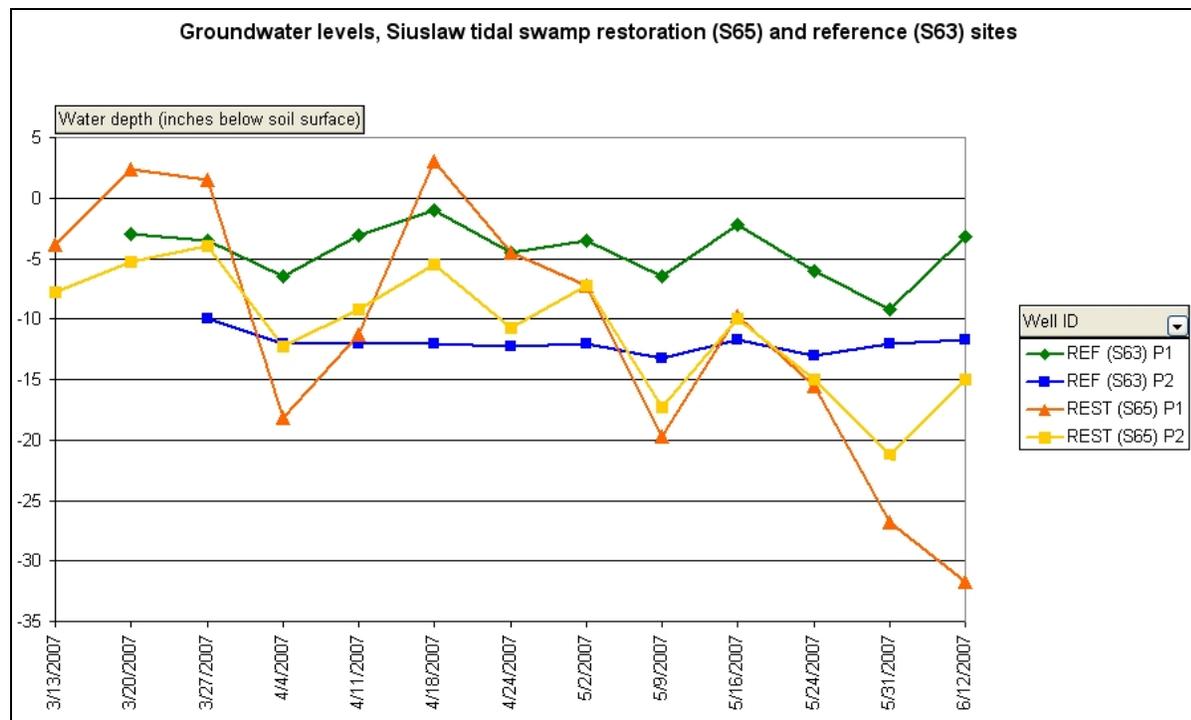
Figure 1 illustrates water table depth at the tidal swamp restoration site (S65) and reference sites (S63 and Y28) during March through June 2006. The data in Figure 1 were obtained from manual water level measurements in groundwater wells; data were collected once a week near low tide. Site S65 had not yet been restored during this observation period, and it had very little tidal influence due to highly restrictive culverts.

Figure 1. Water table depth in March to June 2007 at tidal swamp restoration site S65 (pre-restoration) and reference site S63.

On the groundwater axis, a horizontal gray line shows the soil surface (zero on the groundwater level scale). Wetlands generally have a water table within the top 12 inches of soil (at least seasonally).

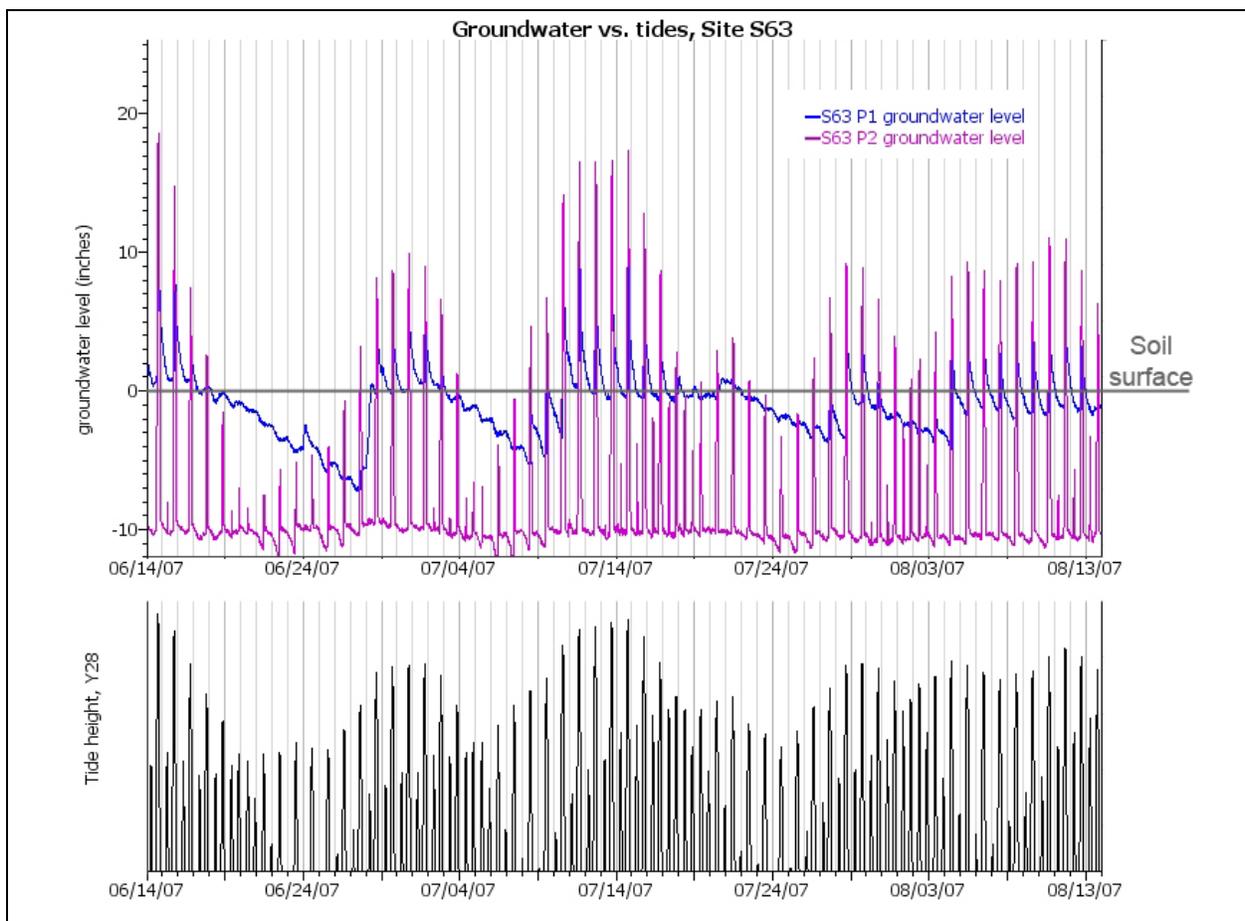
Figure 2. Groundwater fluctuation vs. tide cycles at tidal swamp reference site S63, June-July 2007.

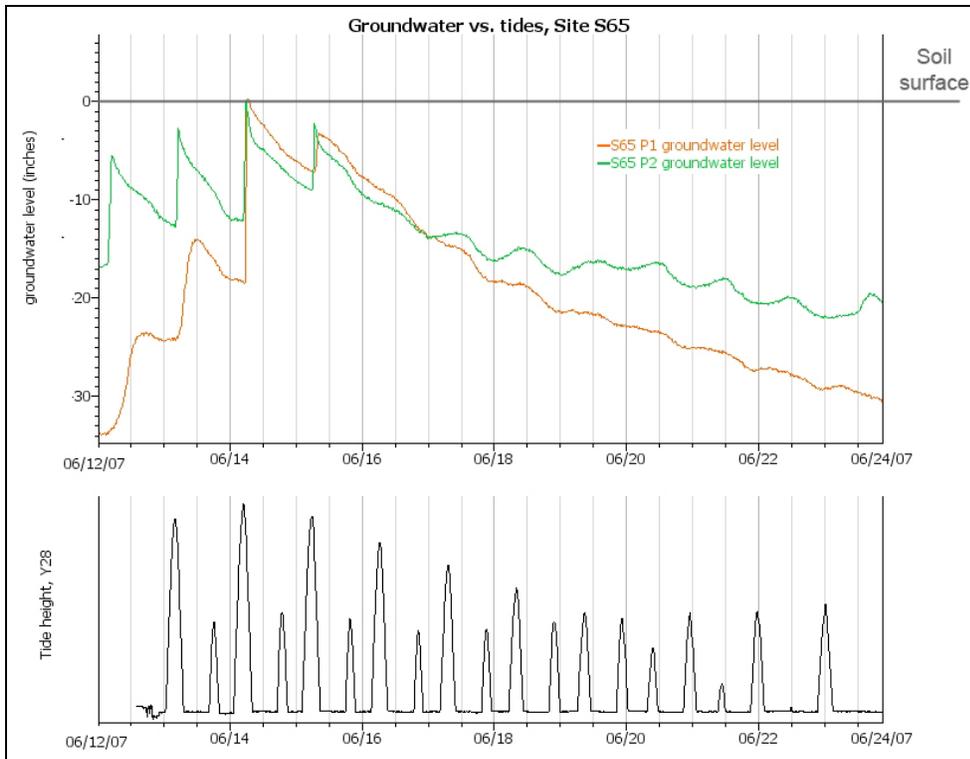
Figure 3. Groundwater fluctuation vs. tide cycles at tidal swamp restoration site S65.

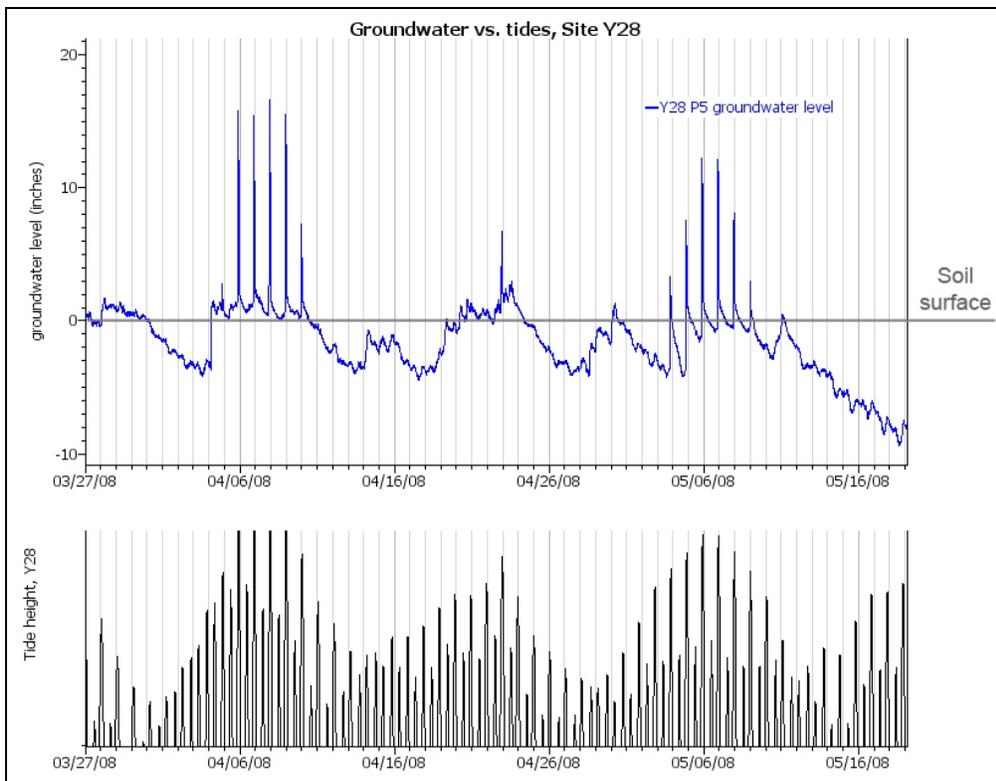
Figure 4. Groundwater fluctuation vs. tide cycles at tidal swamp reference site Y28, spring.

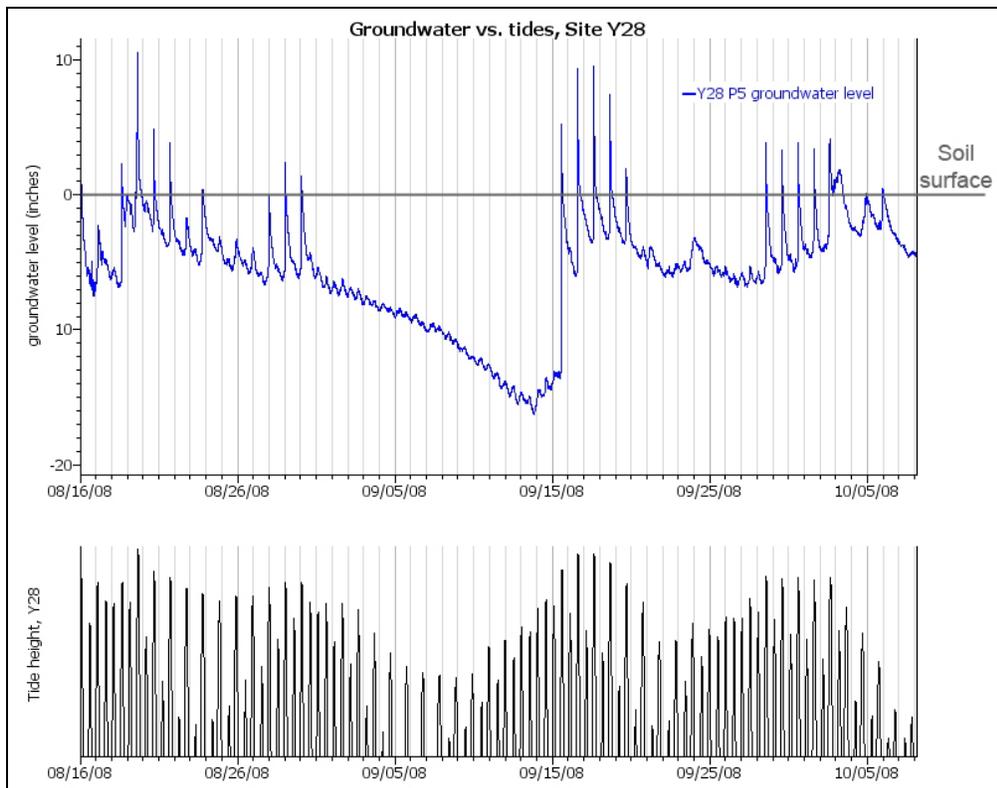
Figure 5. Groundwater fluctuation vs. tide cycles at tidal swamp reference site Y28, late summer.

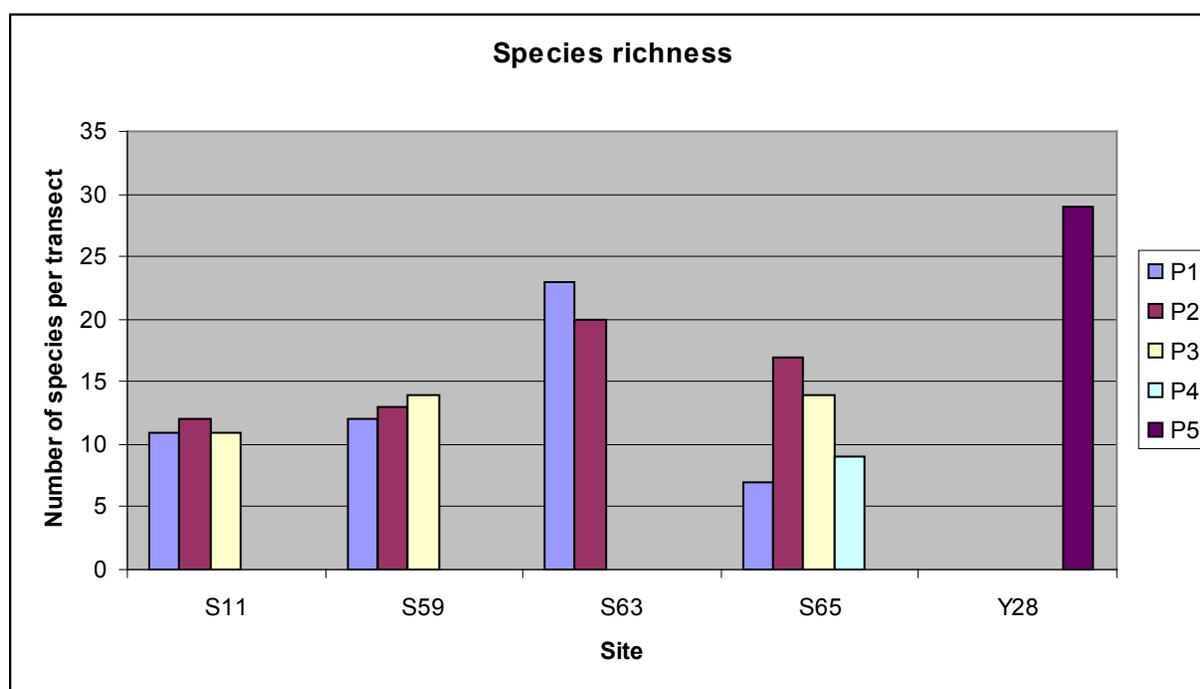
Figure 6 illustrates species richness within study plots.

Figure 6. Species richness for study plots.

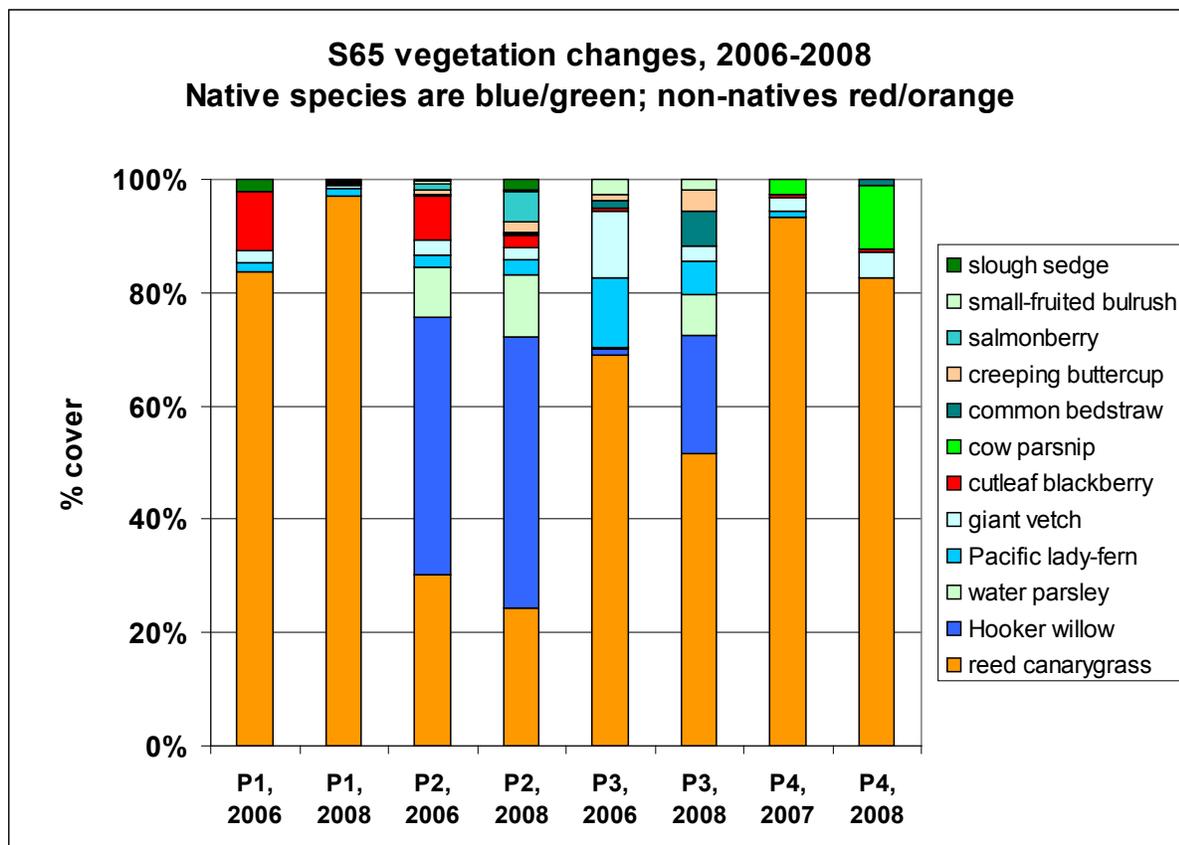
Figure 7 illustrates post-restoration changes in vegetation at site S65. These data were collected and analyzed in a related project (Brophy 2007b, 2008).

Figure 7. Results from related project (Brophy 2007b, 2008): Tidal Swamp Restoration Site S65 plant community composition in sample plots, 2006-2007 (pre-restoration) vs. 2008 (post-restoration Year 1). All species over 2% cover are shown. Native species are symbolized with blue to green; non-native species are orange to red.

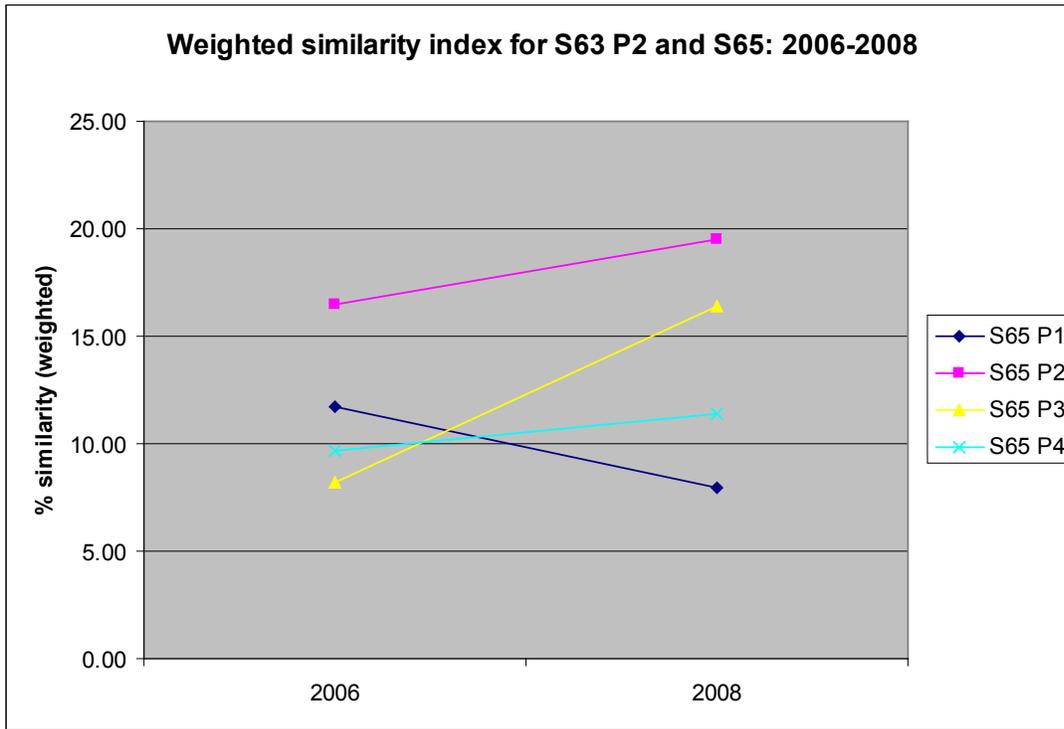
Figures 8 and 9 illustrate the post-restoration change in similarity index at site S65.

Figure 8. Weighted similarity index in 2006 and 2008 for site S65 vs. site S63 Plot 2. Decrease in similarity for P1 is due to weedy species growing in disturbed soil along excavated pilot channel.

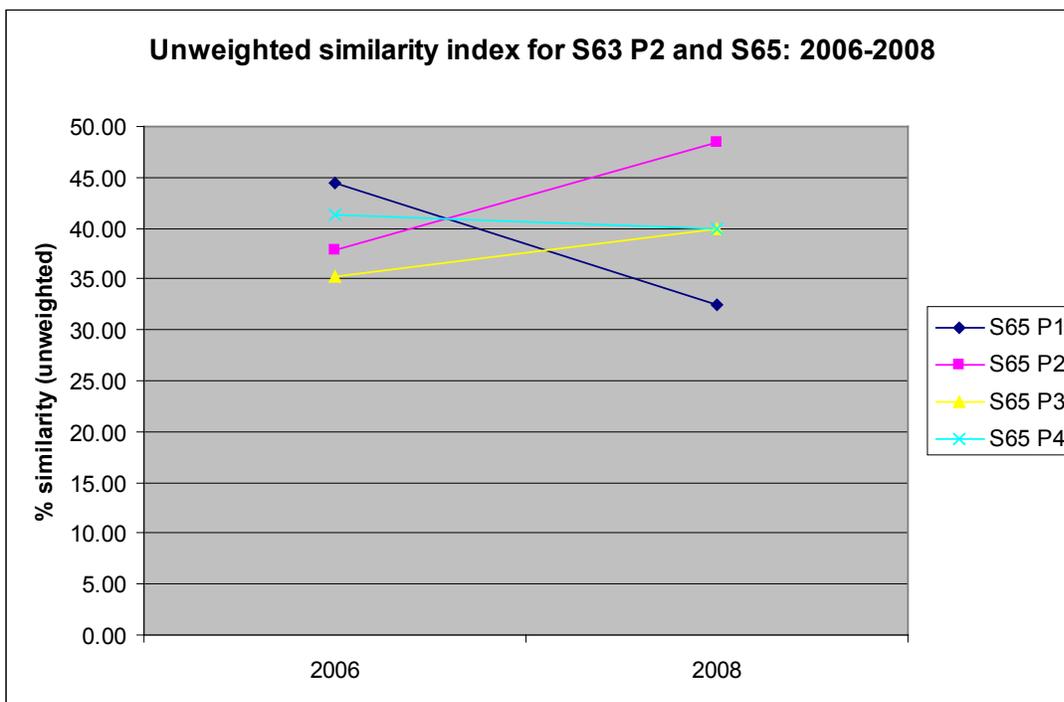
Figure 9. Unweighted similarity index in 2006 and 2008 for site S65 vs. site S63 Plot 2. Decrease in similarity for P1 is due to weedy species growing in disturbed soil along excavated pilot channel.

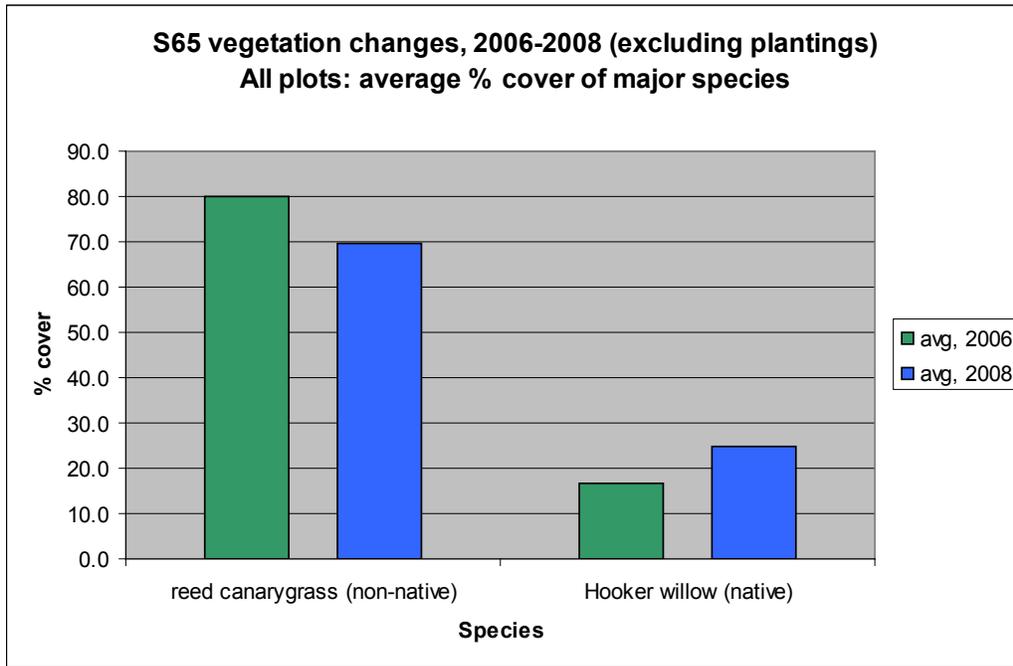
Figures 10 and 11 illustrate post-restoration changes in percent cover of dominant and subordinate species at site S65.

Figure 10. Tidal swamp restoration site S65: Changes in cover for major dominant species, 2006-2008. Data are averaged across all plots.

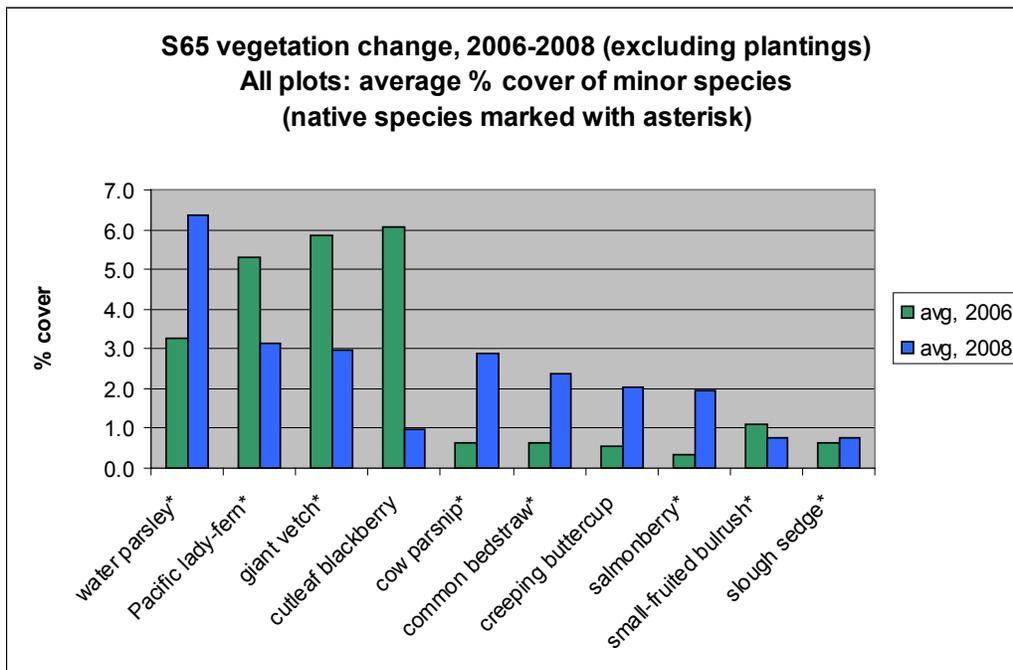
Figure 11. Tidal swamp restoration site S65: Changes in cover for minor species, 2006-2008. Data are averaged across all plots.

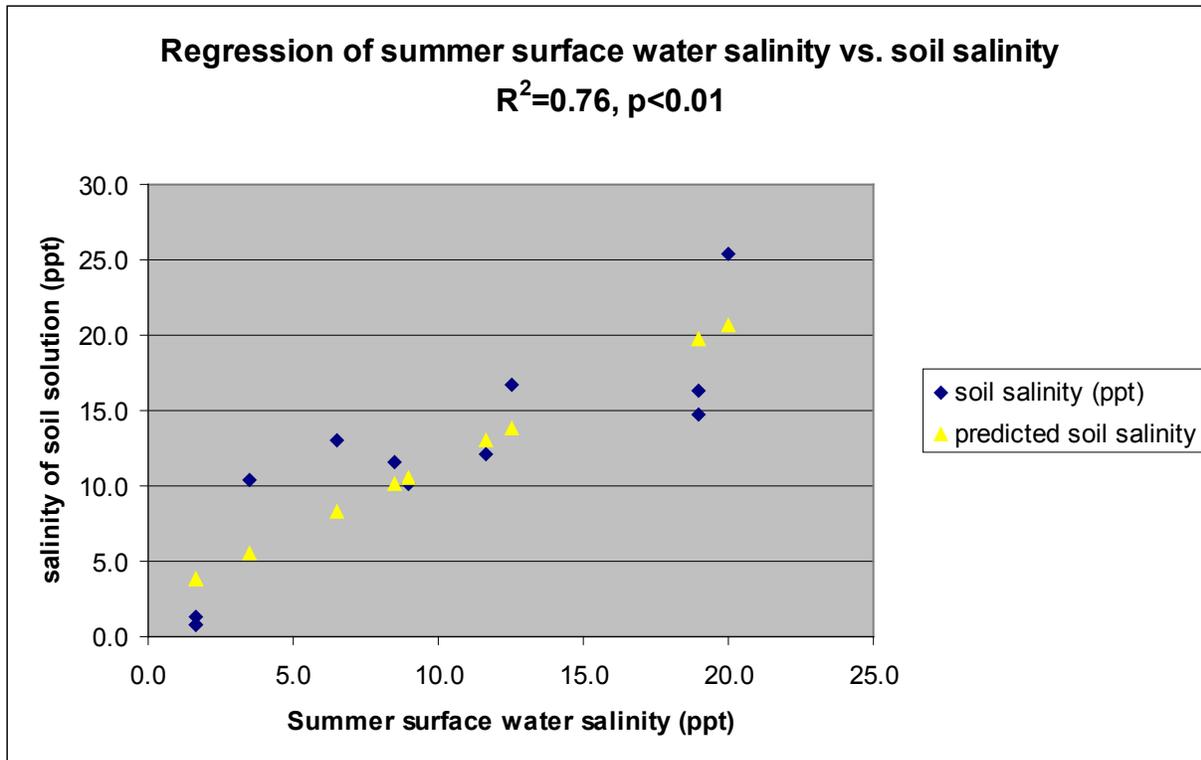
Figure 12. Soil salinity vs. summer surface water salinity vs. at Siuslaw and Yaquina study sites.

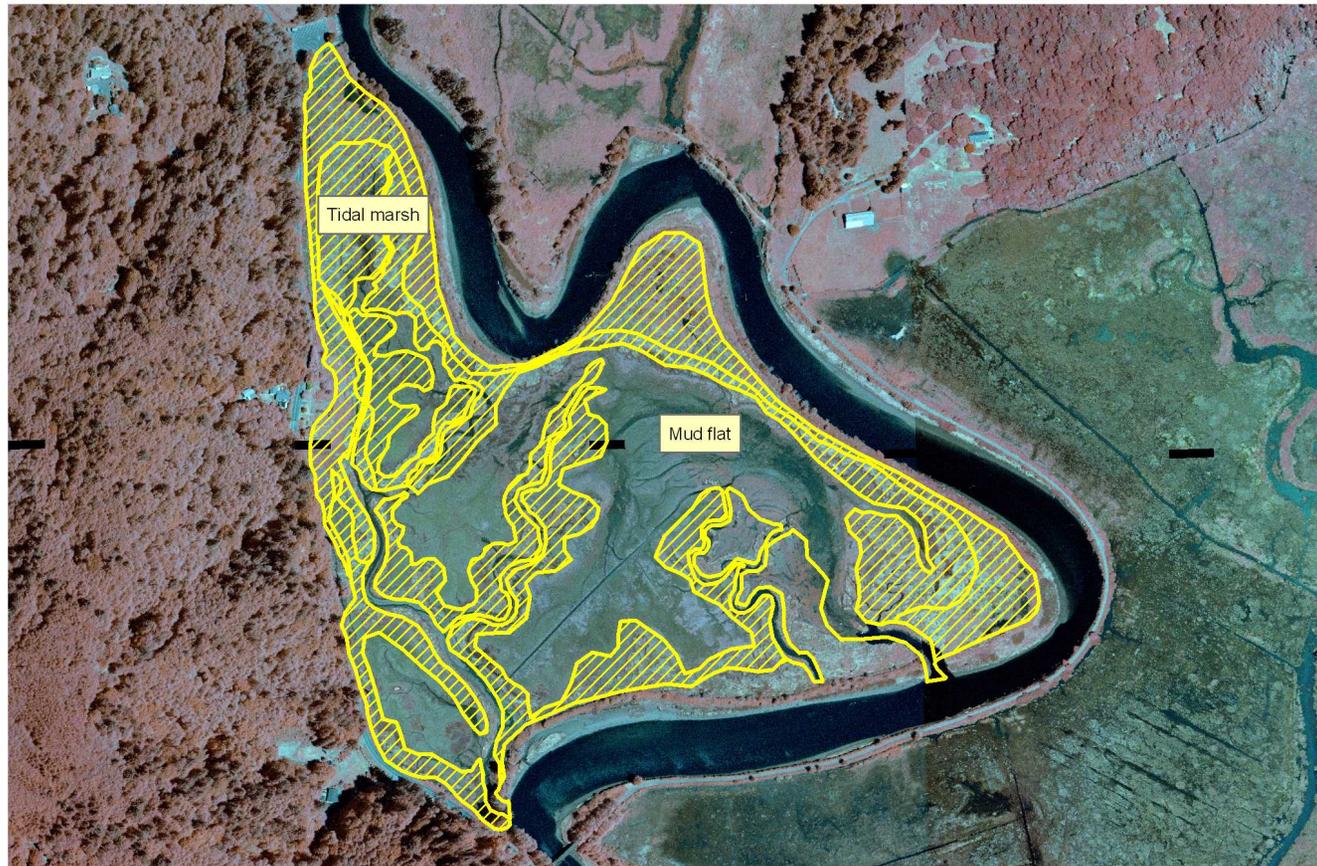
Map 10. Vegetation types at site S59 in 2004, from Scranton (2004). “Tidal marsh” includes areas mapped as low marsh (MSL) and high marsh (MSH) by Scranton; “mud flat” was mapped as “water” by Scranton. Background is a 2005 color infrared aerial orthophoto, provided by the Oregon Department of Land Conservation and Development and U.S. Environmental Protection Agency.

Site S59 vegetation types from Scranton (2004)
Vegetated tidal marsh (as of 2005) is marked with cross-hatching.

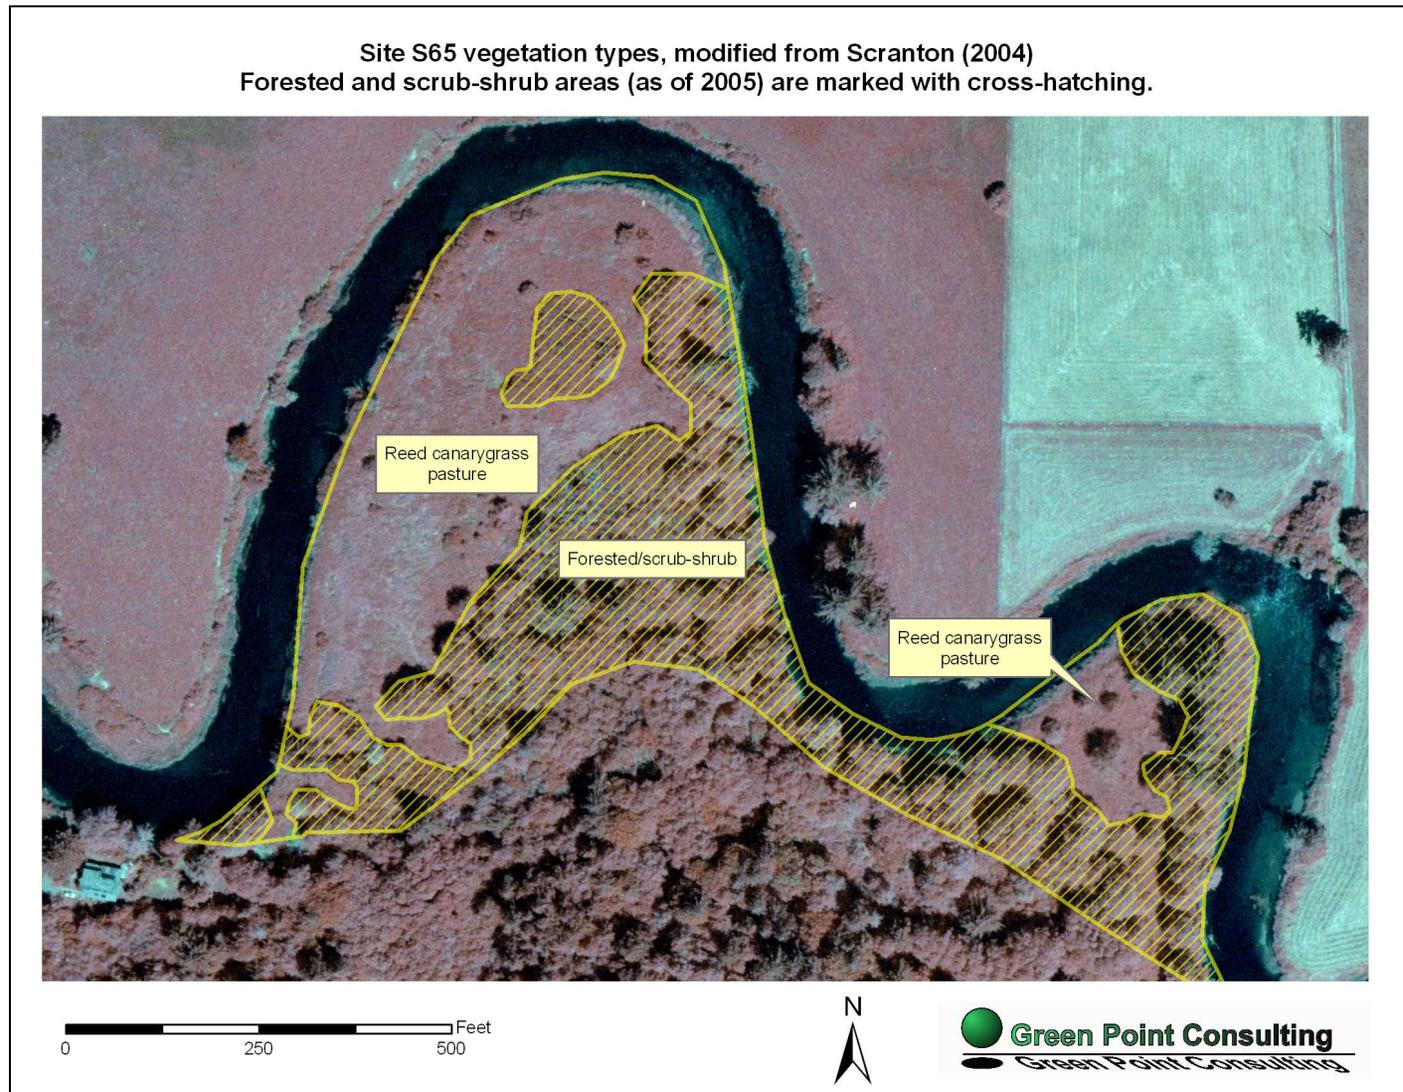
Map 11. Vegetation types at site S65 in 2005 (prior to restoration), modified from Scranton (2004). Boundaries have been refined by heads-up digitization from the background image (a 2005 color infrared aerial orthophoto provided by the Oregon Department of Land Conservation and Development and U.S. Environmental Protection Agency).

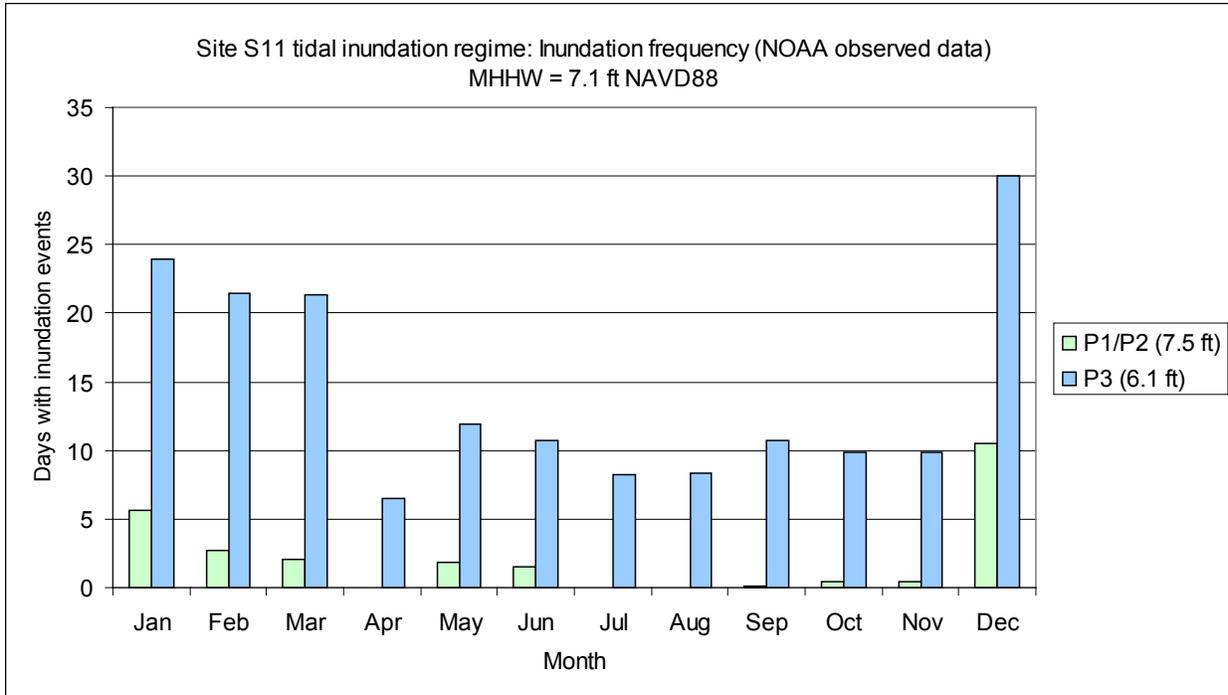
Figure A1. Cox Island reference site (S11): Tidal inundation frequency (days with inundation events), based on NOAA full year record (1933) at nearest tide station (Florence). Plot elevations are NAVD88.

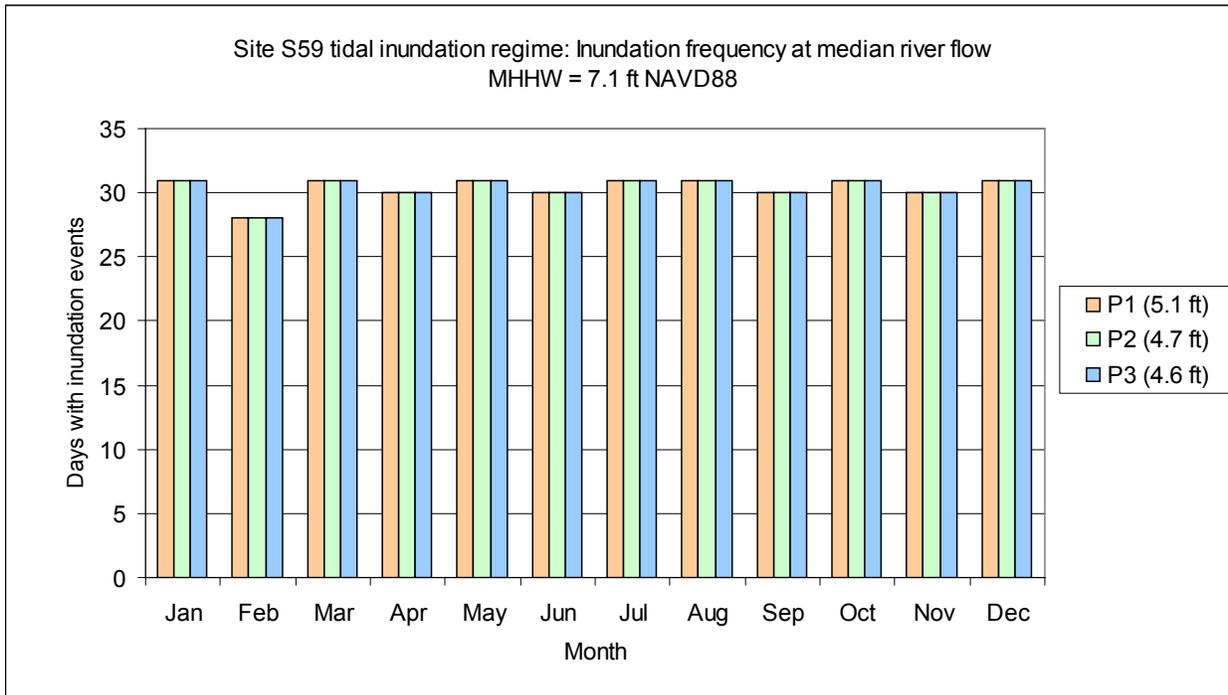
Figure A2. Restoration site S59: Tidal inundation frequency (days with inundation events), based on local inundation model (tide heights plus river flow effect). Plot elevations are NAVD88.

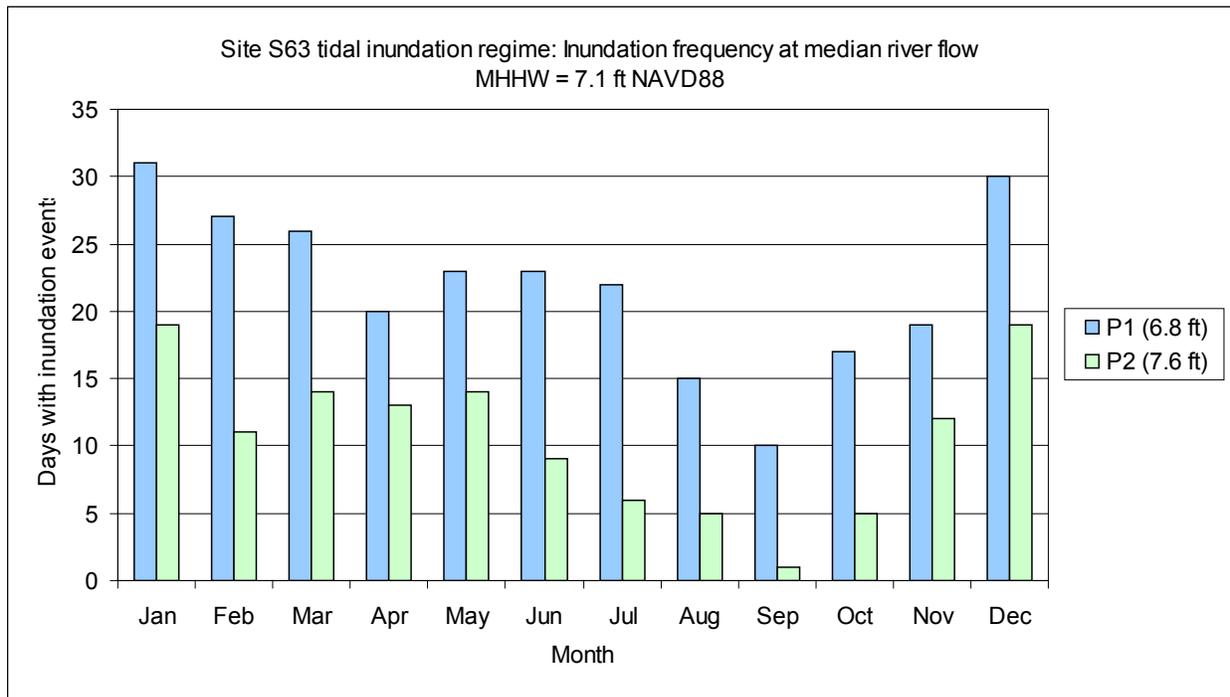
Figure A3. Reference site S63: Tidal inundation frequency (days with inundation events), based on local inundation model (tide heights plus river flow effect). Plot elevations are NAVD88.

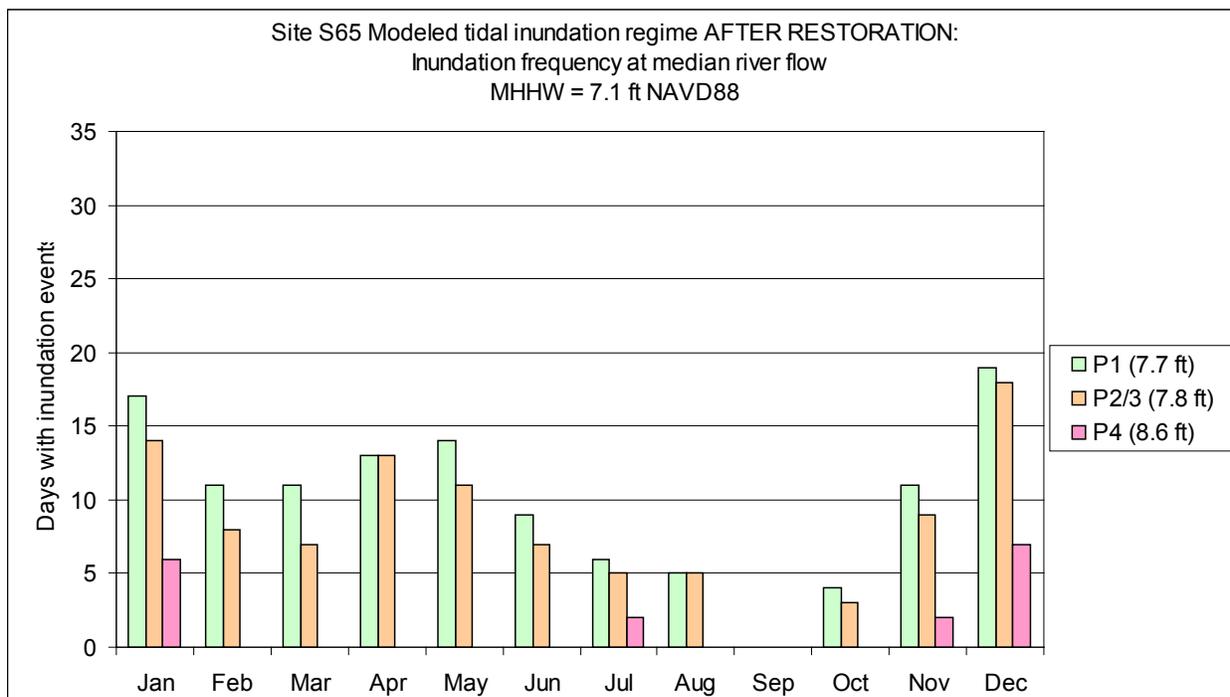
Figure A4. Restoration site S65: Modeled tidal inundation frequency (days with inundation events) after implementation of restoration, based on local inundation model (tide heights plus river flow effect). Plot elevations are NAVD88.

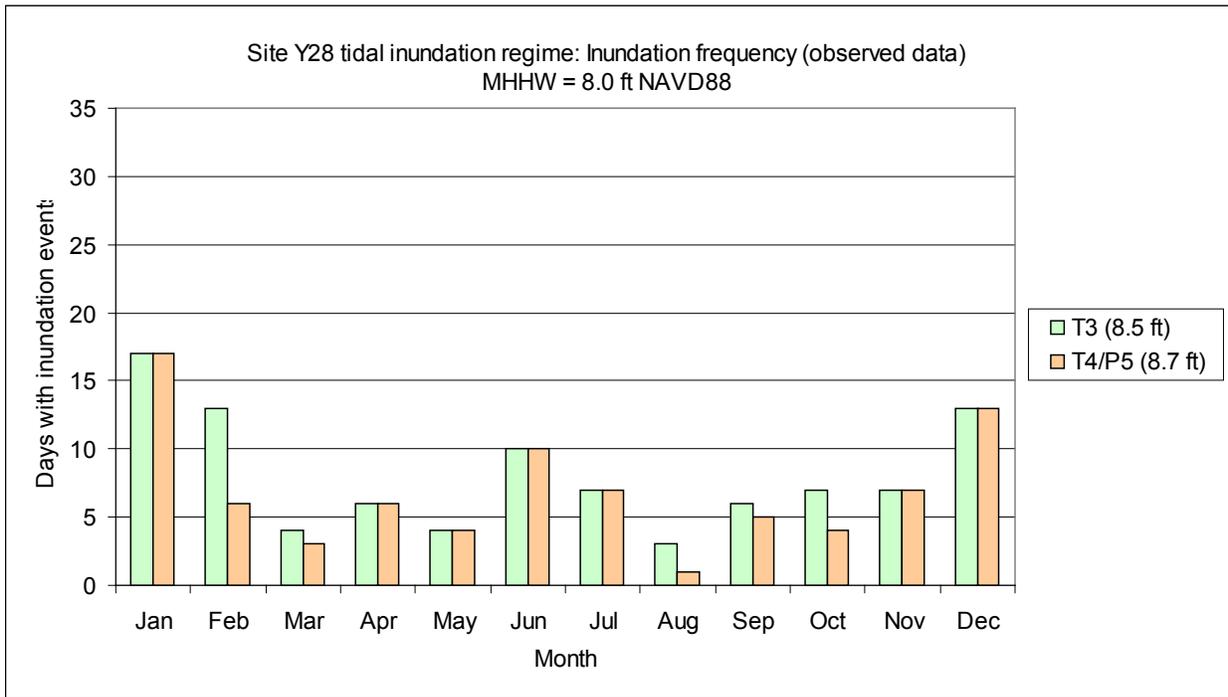
Figure A5. Reference site Y28: Tidal inundation frequency (days with inundation events), based on full-year local tide gauge records during 2007-2008. Plots T3 and T4 were monitored in a separate project (Brophy 2007c); results are shown here for comparison. Plot elevations are NAVD88.

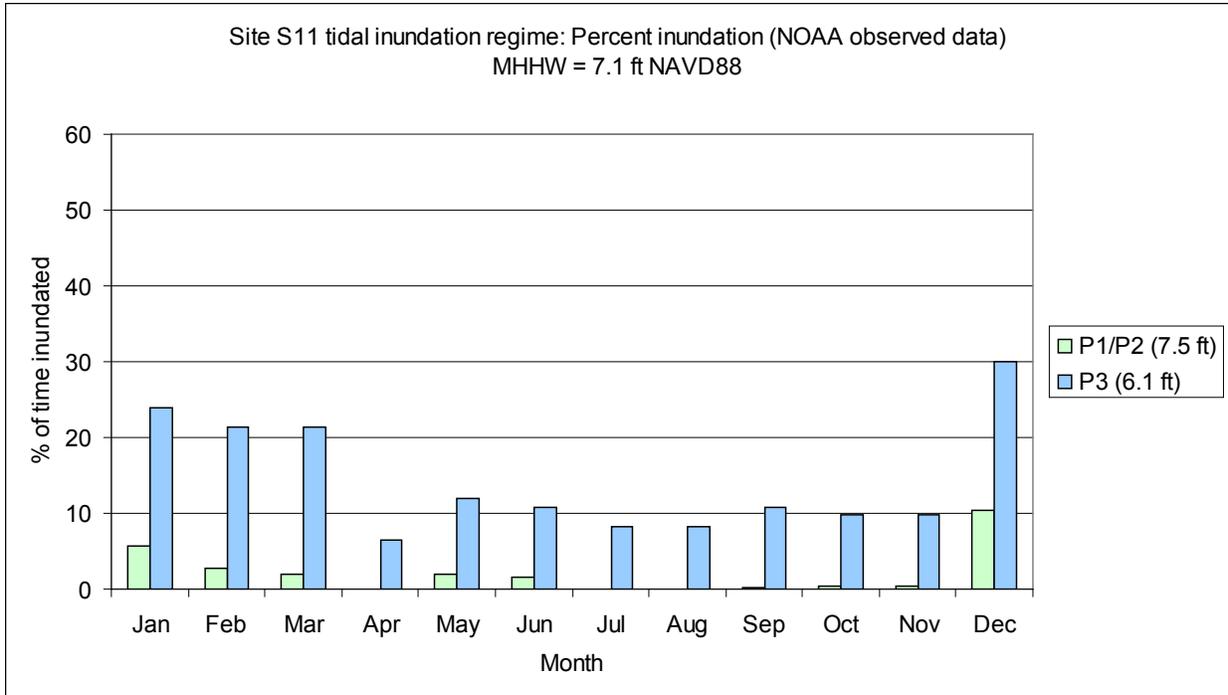
Figure A6. Cox Island reference site (S11): Tidal inundation frequency (percent of time inundated), based on NOAA full year record (1933) at nearest tide station (Florence). Plot elevations are NAVD88.

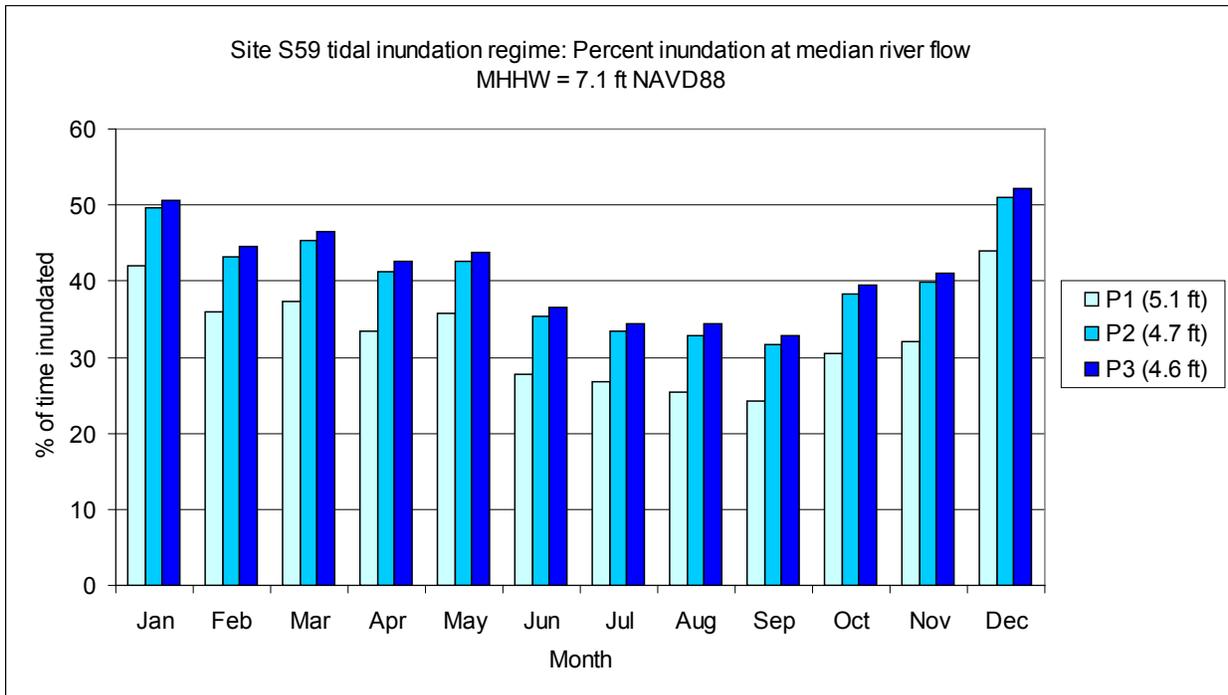
Figure A7. Restoration site S59: Tidal inundation frequency (percent of time inundated), based on local inundation model (tide heights plus river flow effect). Plot elevations are NAVD88.

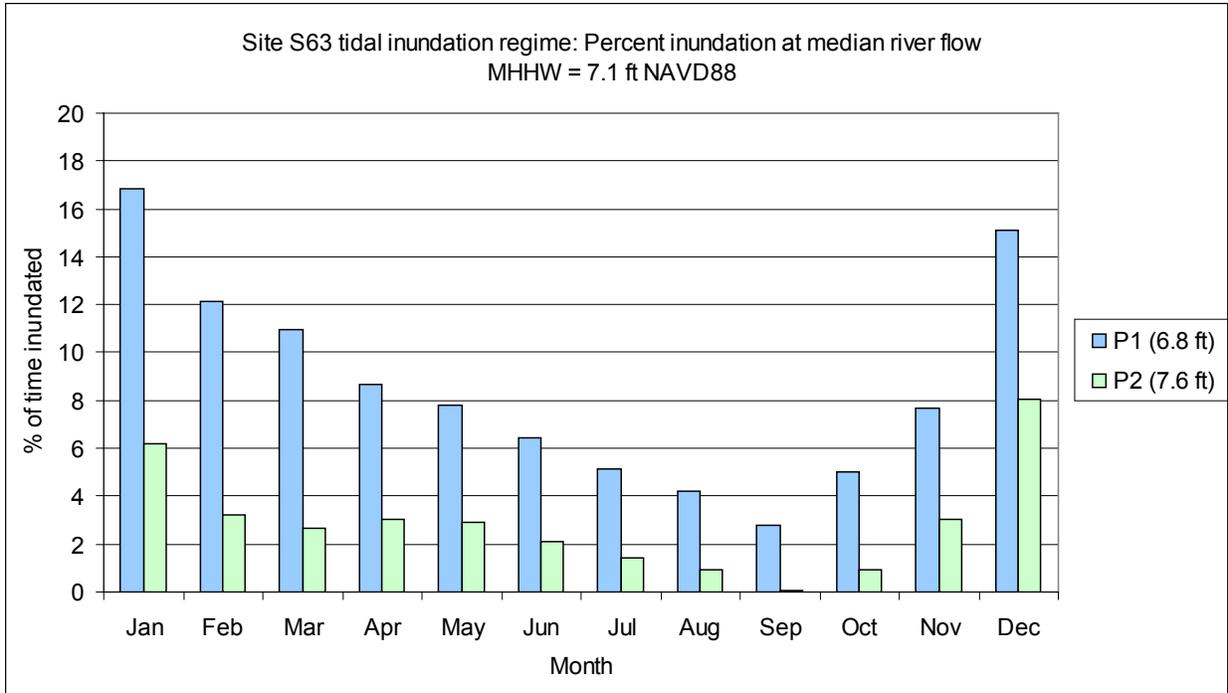
Figure A8. Reference site S63: Tidal inundation frequency (percent of time inundated), based on local inundation model (tide heights plus river flow effect). Plot elevations are NAVD88.

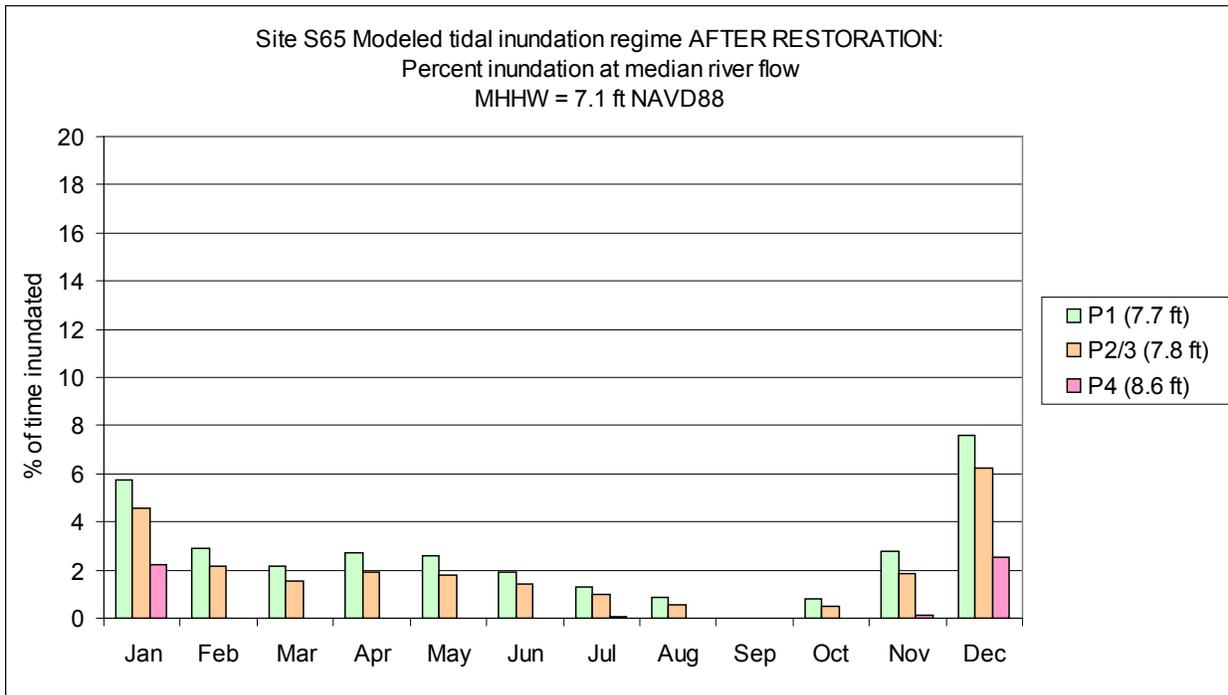
Figure A9. Restoration site S65: Modeled tidal inundation frequency (percent of time inundated) after implementation of restoration, based on local inundation model (tide heights plus river flow effect). Plot elevations are NAVD88.
