Effectiveness Monitoring at Tidal Wetland Restoration and Reference Sites in the Siuslaw River Estuary: *A Tidal Swamp Focus*

Final Report **June 2009**

Ecotrust
Portland, Oregon

Laura Brophy
Green Point Consulting
Corvallis, Oregon

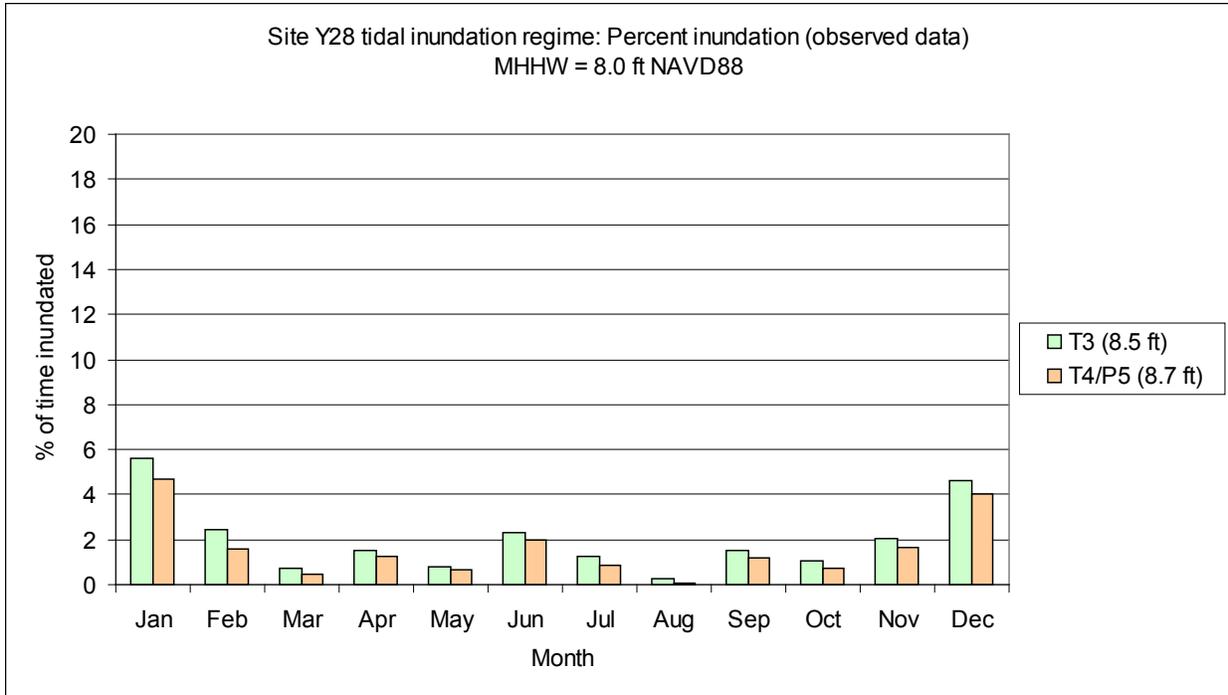
Figure A10. Reference site Y28: Tidal inundation frequency (percent of time inundated), based on full-year local tide gauge records during 2007-2008. Plot elevations are NAVD88.

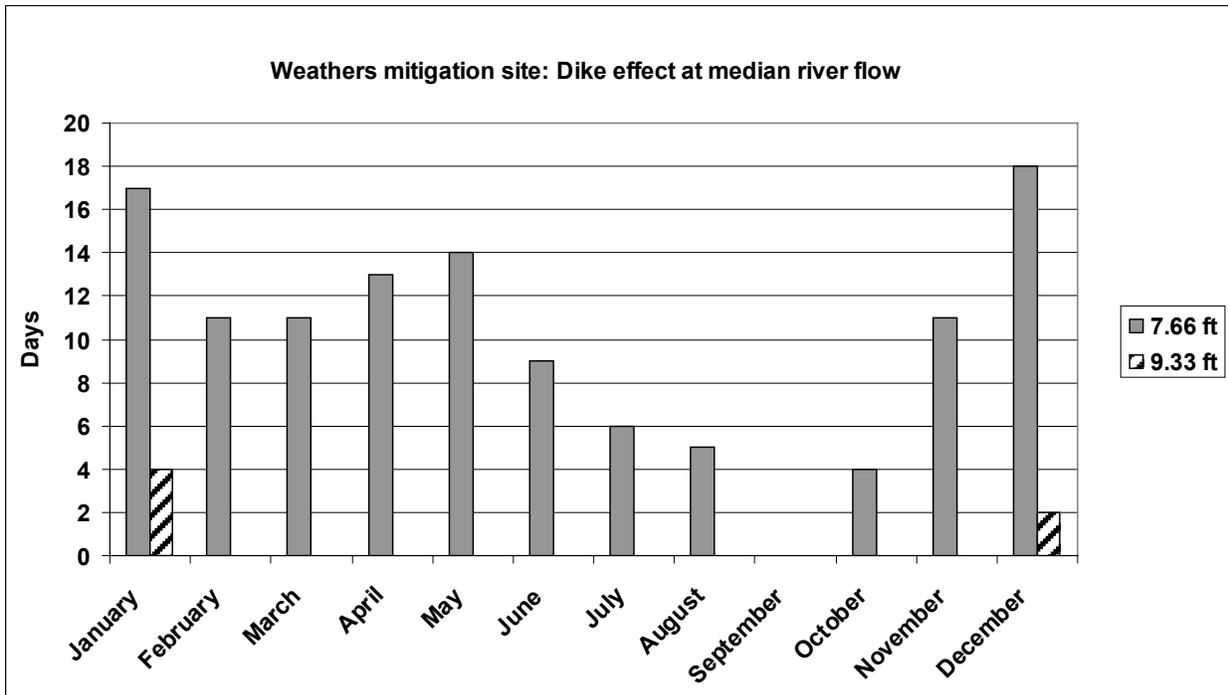
Figure A11. Dike effect at tidal swamp restoration site S65 at median river flows. Striped bars indicate modeled dike overtopping events; gray bars indicate predicted post-restoration tidal inundation regime at Plot 1 after dike breaching. 9.33' = typical dike ht; 7.66' elevation at plot 1. Plot elevations are NAVD88.

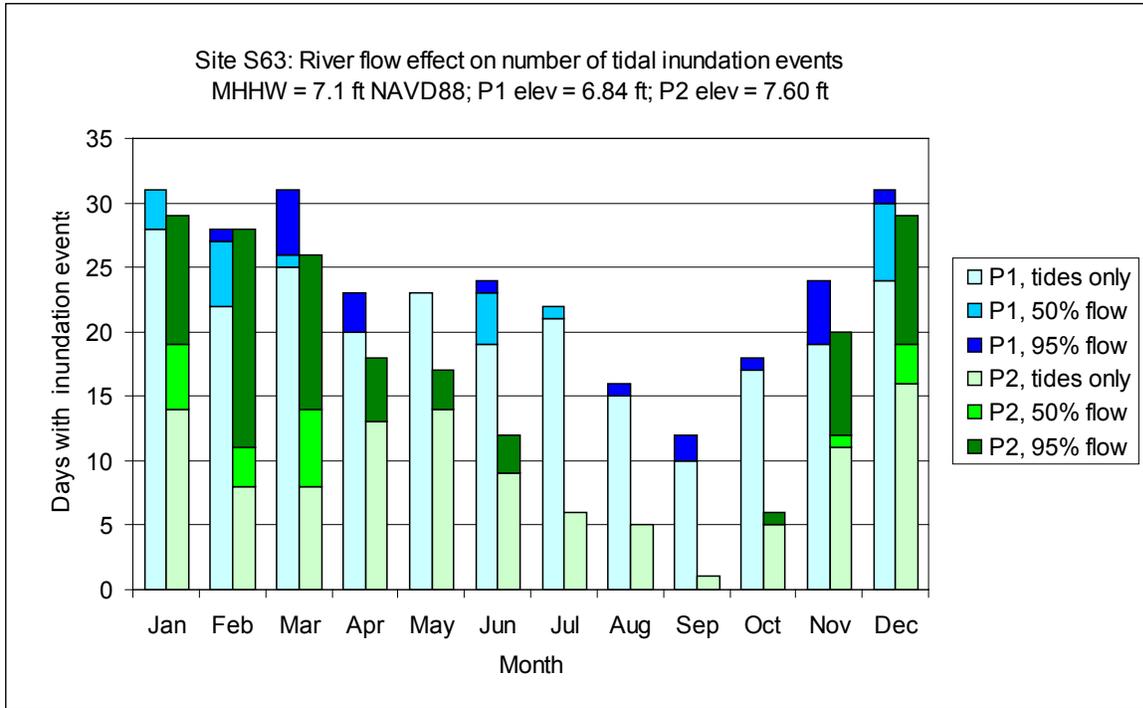
Figure A12. Reference site S63: Effect of river flows on tidal inundation frequency. Inundation frequency is shown for three scenarios: “tides only” (modeled using the master station method); “50% flow” (additional inundation from median river flow levels), and 95% flow (additional inundation from river levels in the 95th percentile of historic records). Plot elevations are NAVD88.

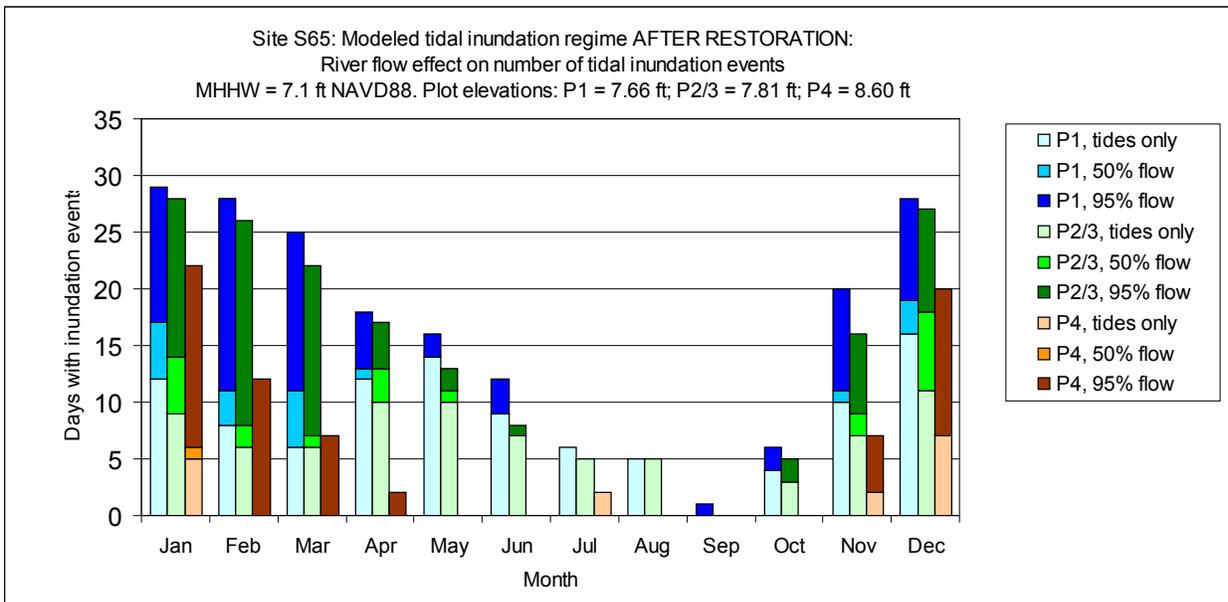
Figure A13. Restoration site S65: Effect of river flows on tidal inundation frequency after implementation of restoration. Inundation frequency is shown for three scenarios: “tides only” (modeled using the master station method); “50% flow” (additional inundation from median river flow levels), and 95% flow (additional inundation from river levels in the 95th percentile of historic records). Plot elevations are NAVD88.

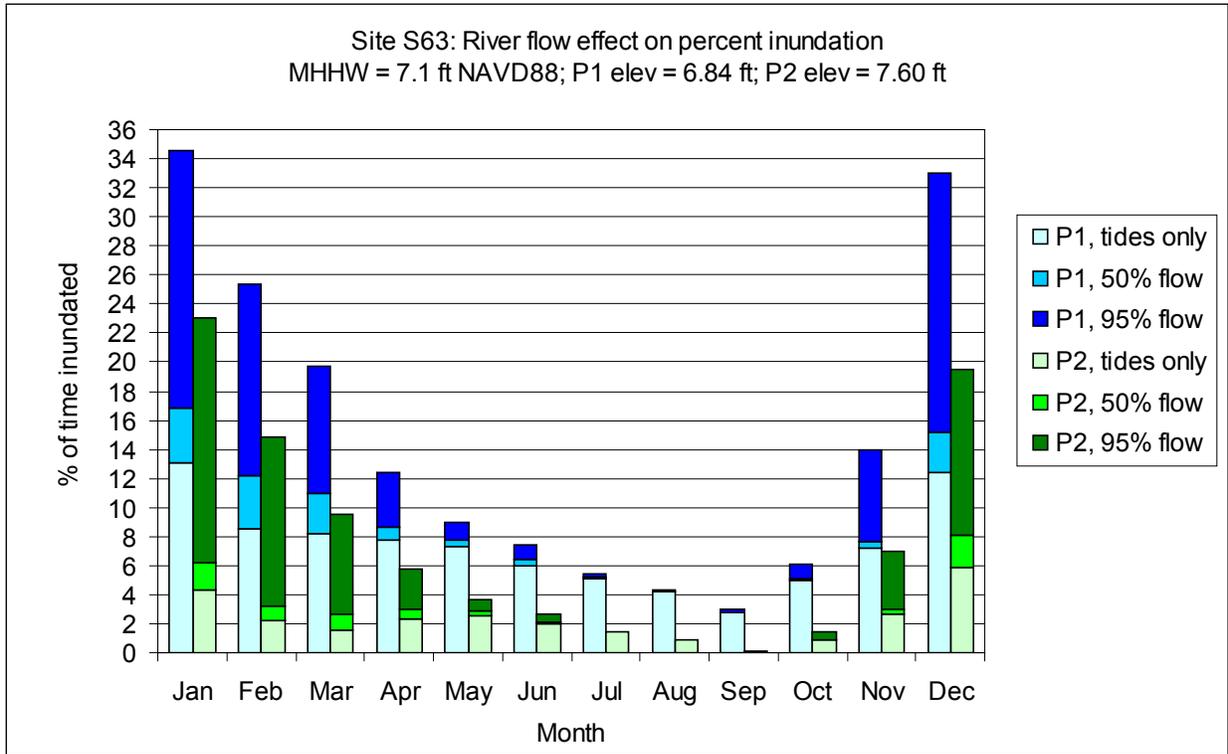
Figure A14. Reference site S63: Effect of river flows on percent inundation. Percent inundation is shown for three scenarios: “tides only” (modeled using the master station method); “50% flow” (additional inundation from median river flow levels), and 95th flow (additional inundation from river levels in the 95th percentile of historic records). Plot elevations are NAVD88.

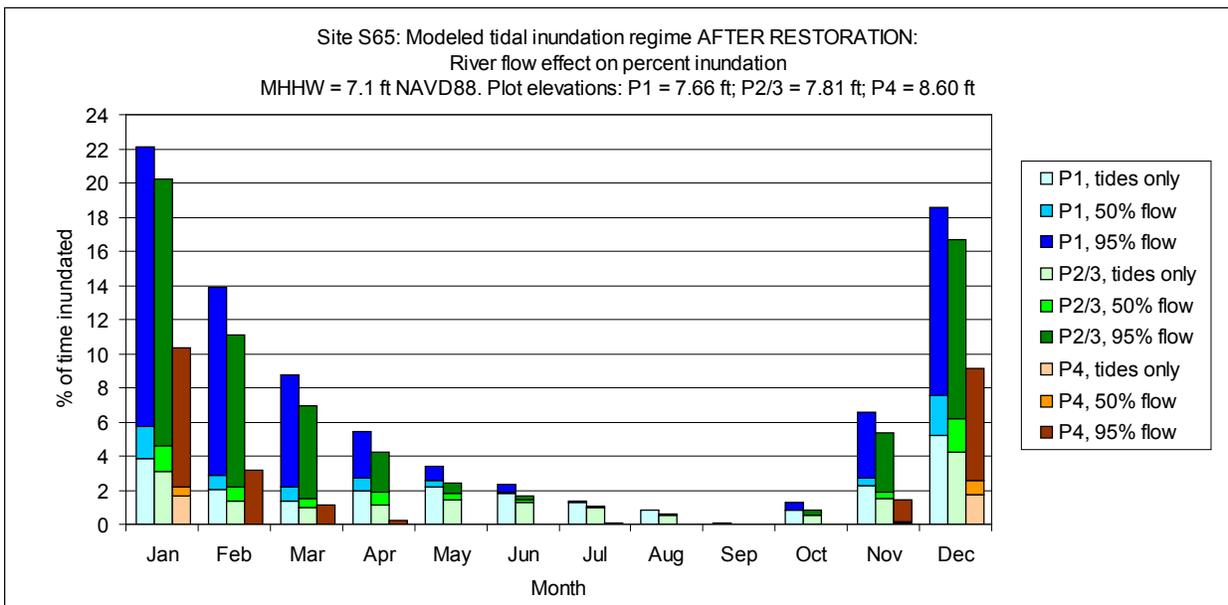
Figure A15. Restoration site S65: Effect of river flows on percent inundation after implementation of restoration. Percent of time inundated is shown for three scenarios: “tides only” (modeled using the master station method); “50% flow” (additional inundation from median river flow levels), and 95th flow (additional inundation from river levels in the 95th percentile of historic records). Plot elevations are NAVD88.

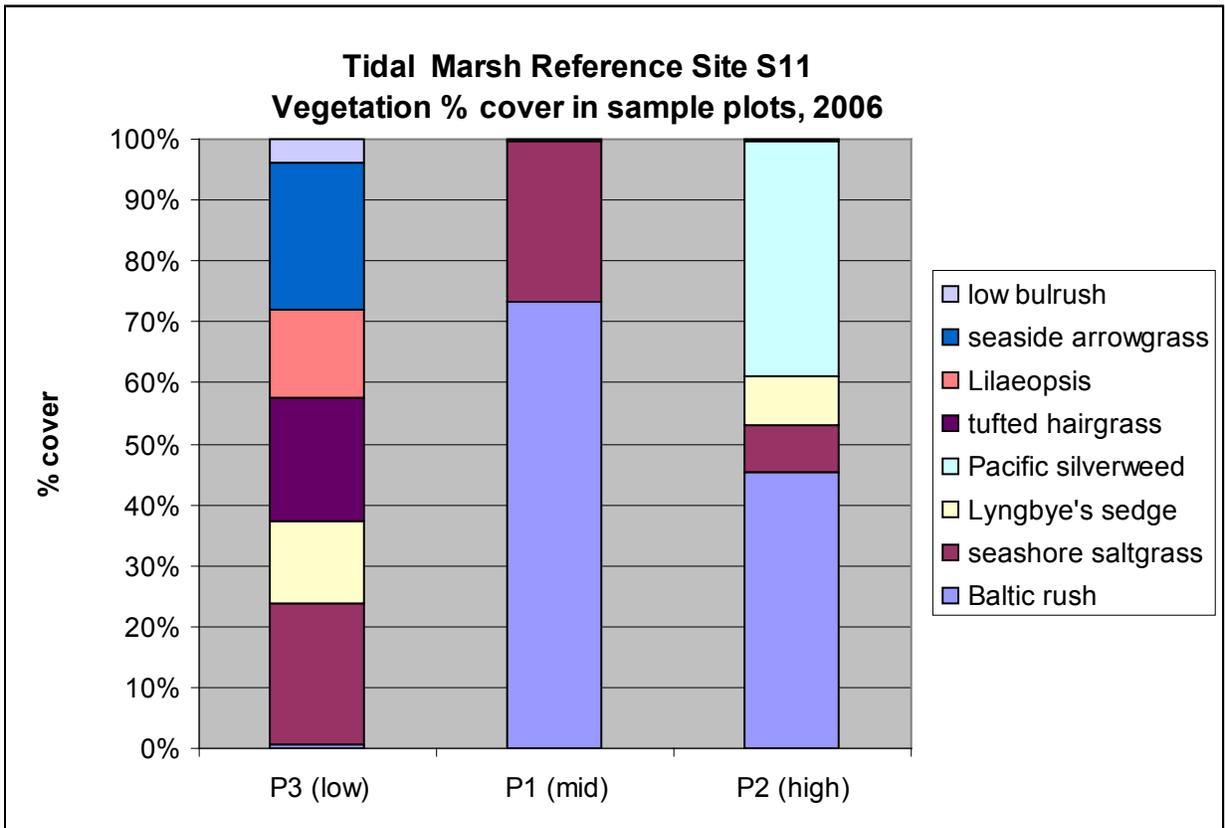
Figure A16. Tidal Marsh Reference site S11 (Cox Island): Plant community composition in sample plots, 2006. All species over 2% cover are shown.

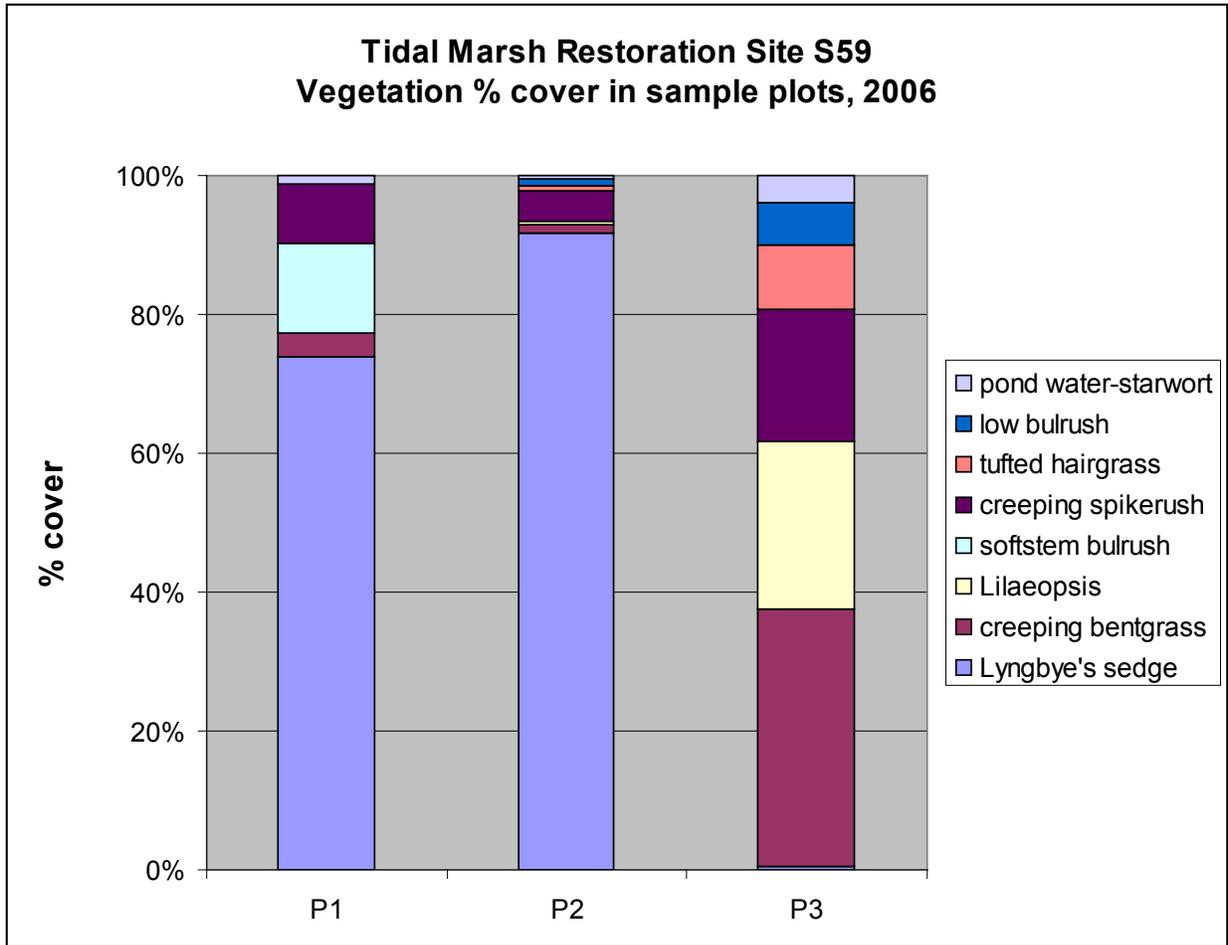
Figure A17. Tidal Marsh Restoration site S59: Plant community composition in sample plots, 2006. All species over 2% cover are shown.

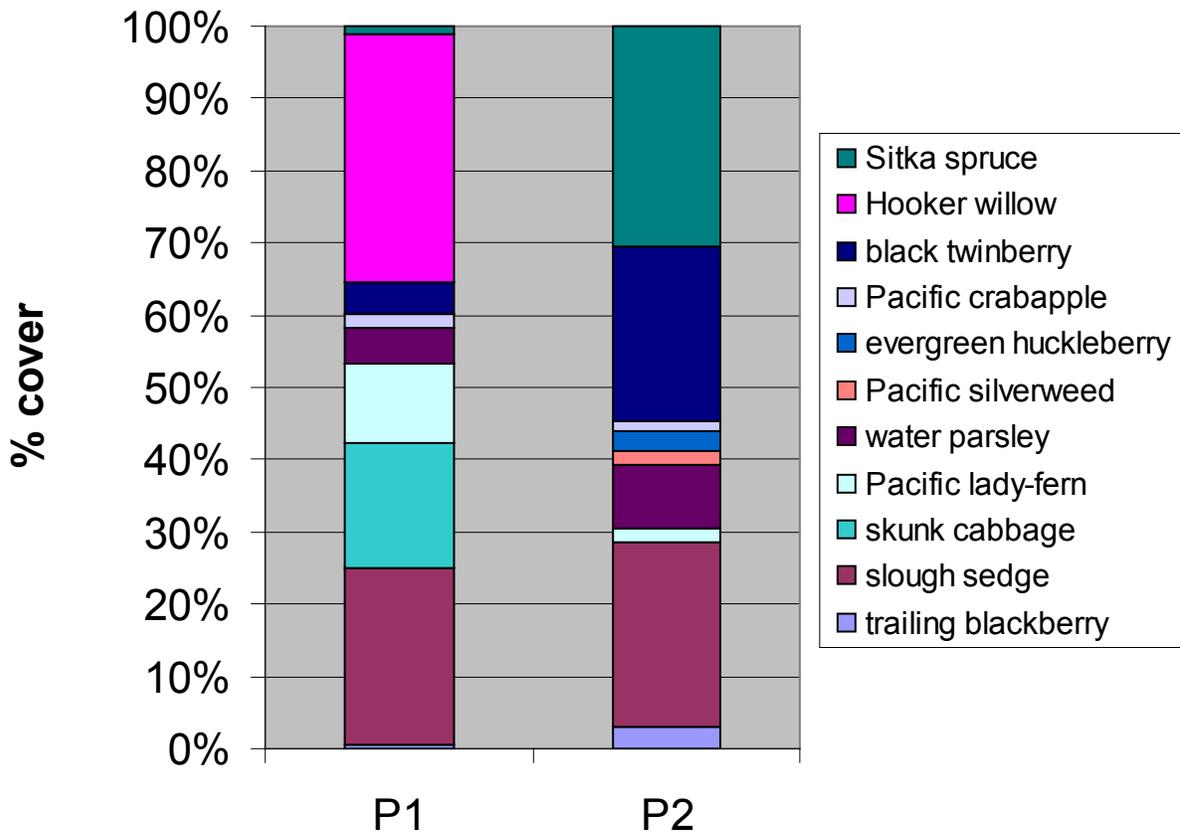
Figure A18. Tidal Swamp Reference site S63: Plant community composition in sample plots, 2006. All species over 2% cover are shown.

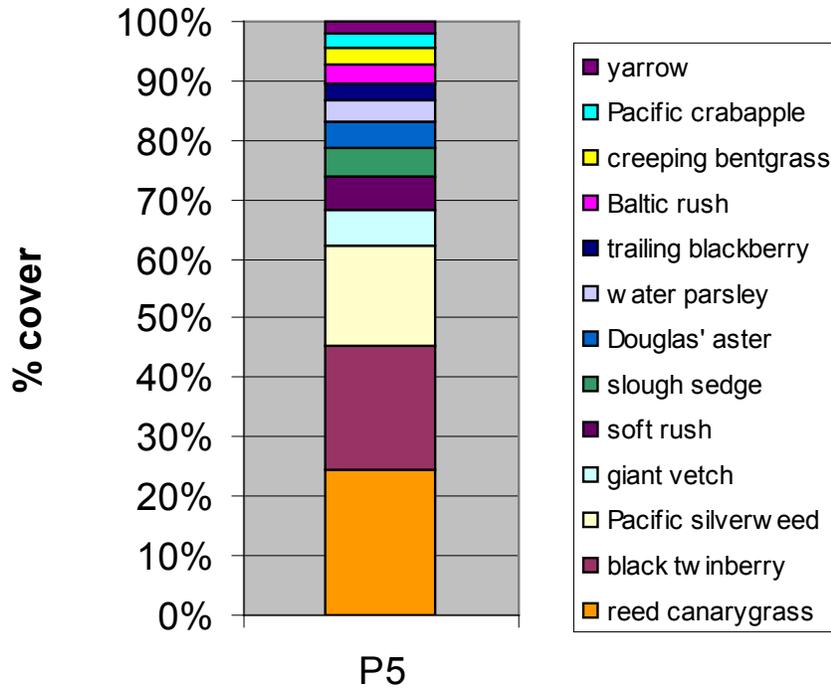
Figure A19. Tidal Swamp Reference Site Y28: Plant community composition in sample plots, 2006. All species over 2% cover are shown.

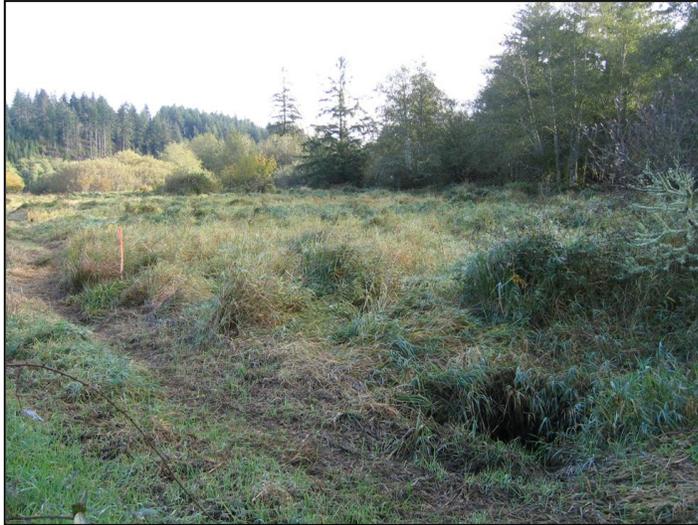
Site S65, Photo Point 1B:
View of pasture, looking NE from dike breach.

October 2006 (pre-restoration)

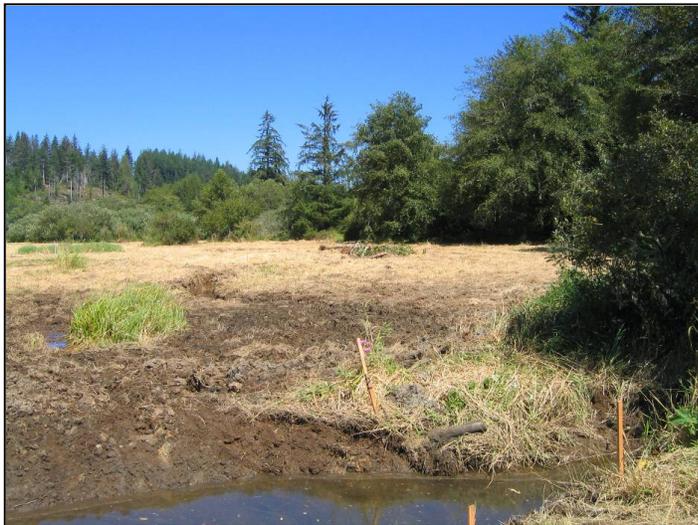
August 2007 (Immediately after restoration earthmoving)

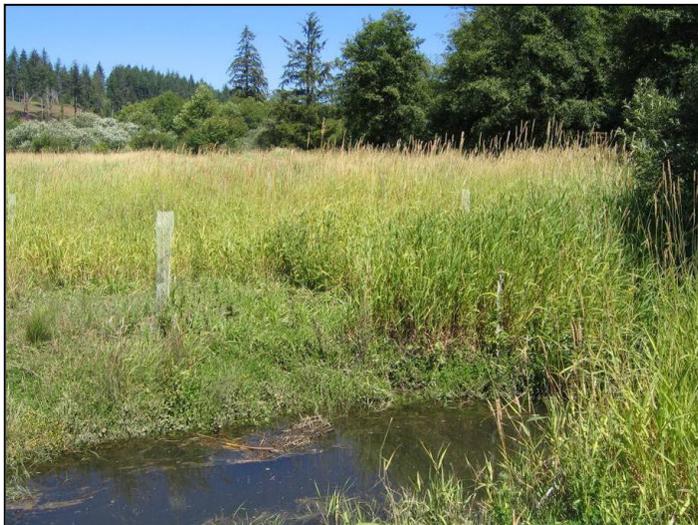
July 2008 (Year 1 post-restoration). White vexar tubes around woody plantings are visible.

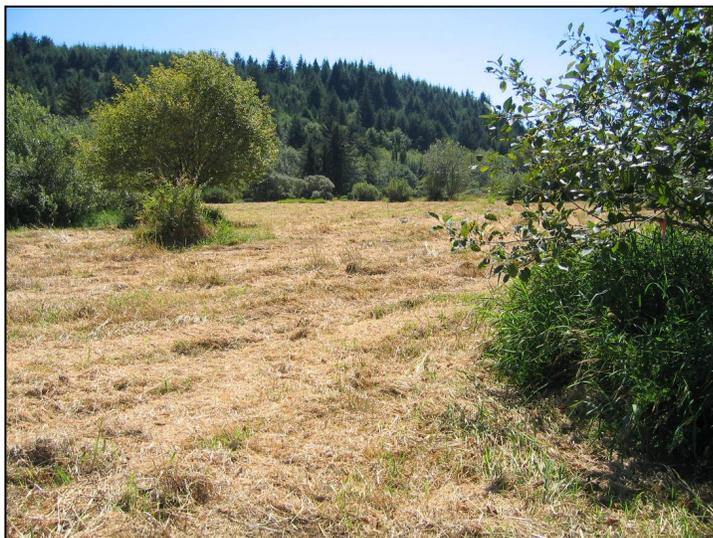
**August 2007 (Immediately after
mowing, preparatory to
restoration earthmoving)**

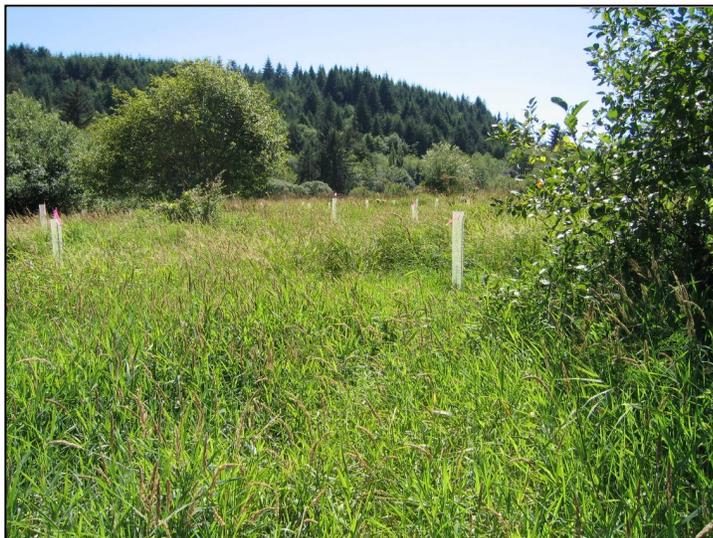
**July 2008
(Year 1 post-restoration). White
vexar tubes around woody
plantings are visible.**

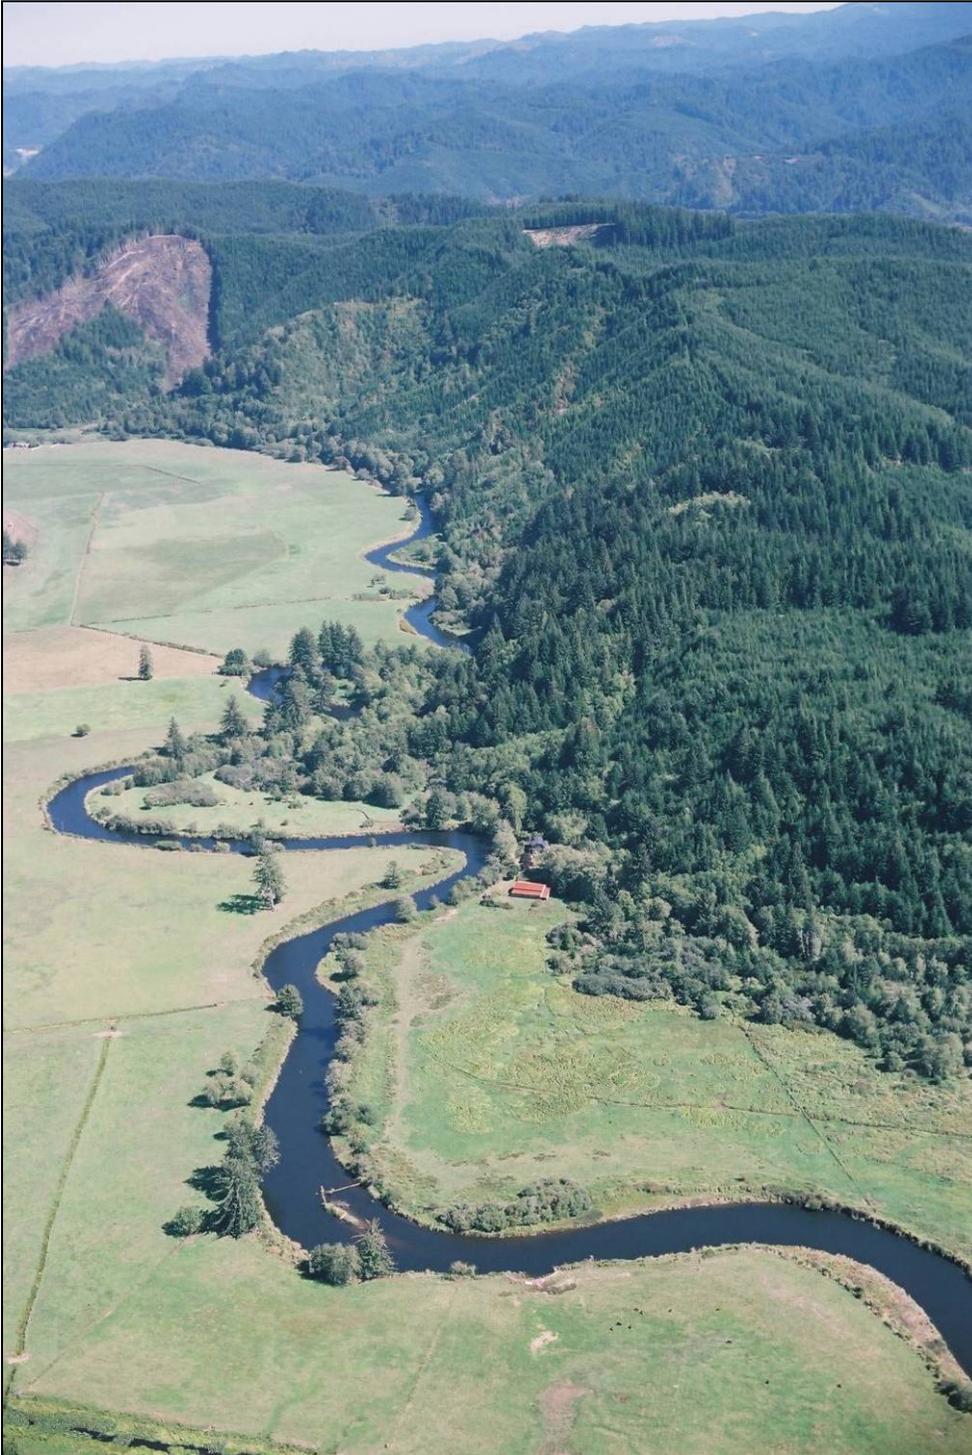
Photo A1. September 10, 2007: Setting of site S65 on the North Fork Siuslaw River (east-facing view). Photo courtesy of ODOT Photo and Video Services.

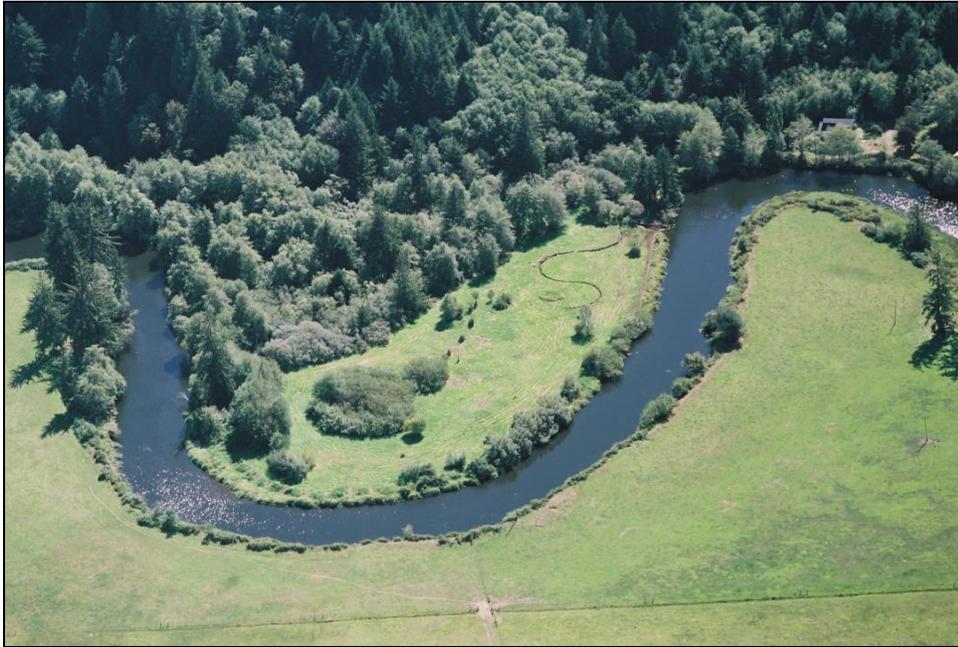
Photo A2. September 10, 2007: South-facing aerial view of site S65 immediately after restoration earthmoving (but before woody plantings had been installed). Photo courtesy of ODOT Photo and Video Services.

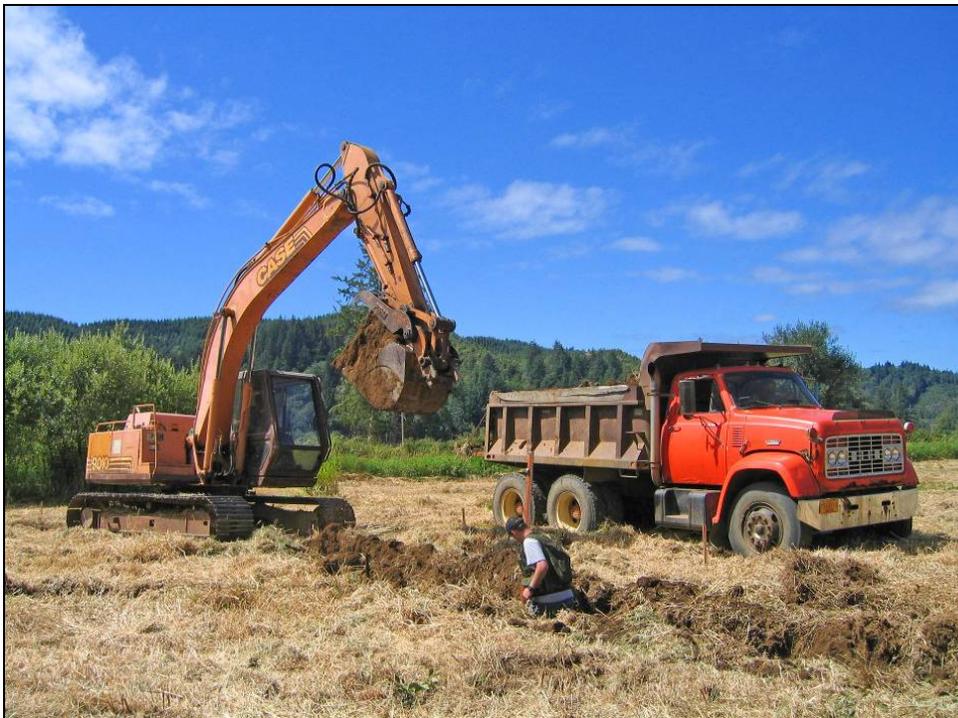
Photo A3. August 14, 2007: Excavation of pilot channel at site S65. Jeffrey Jones measures channel depth while Nathan Large operates the excavator. Photo by Laura Brophy.

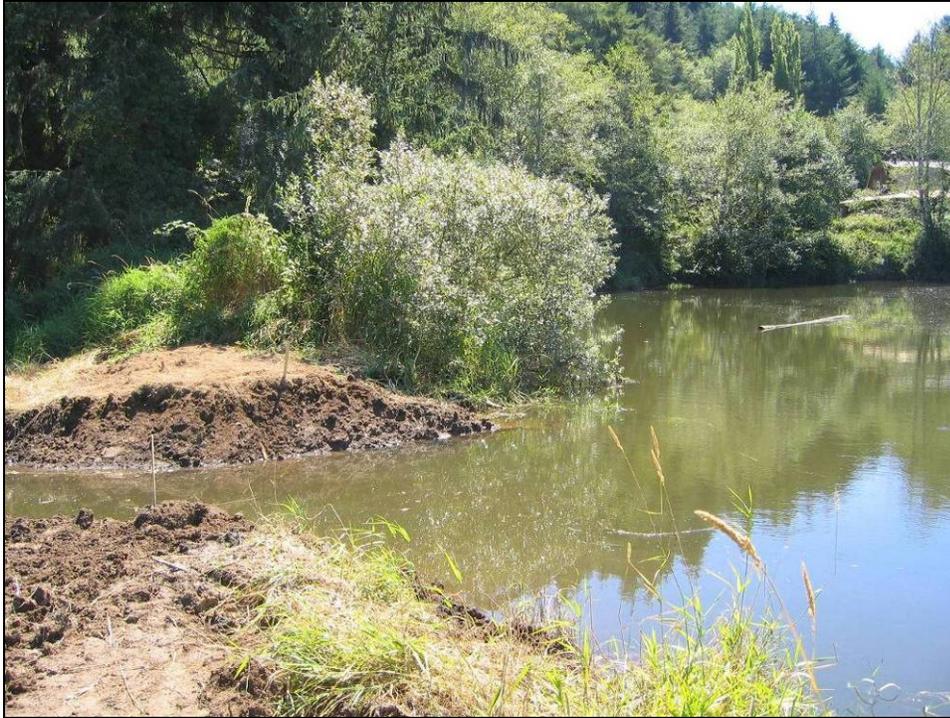
Photo A4. August 14, 2007: Rising tide fills the dike breach at site S65. Photo by Laura Brophy.

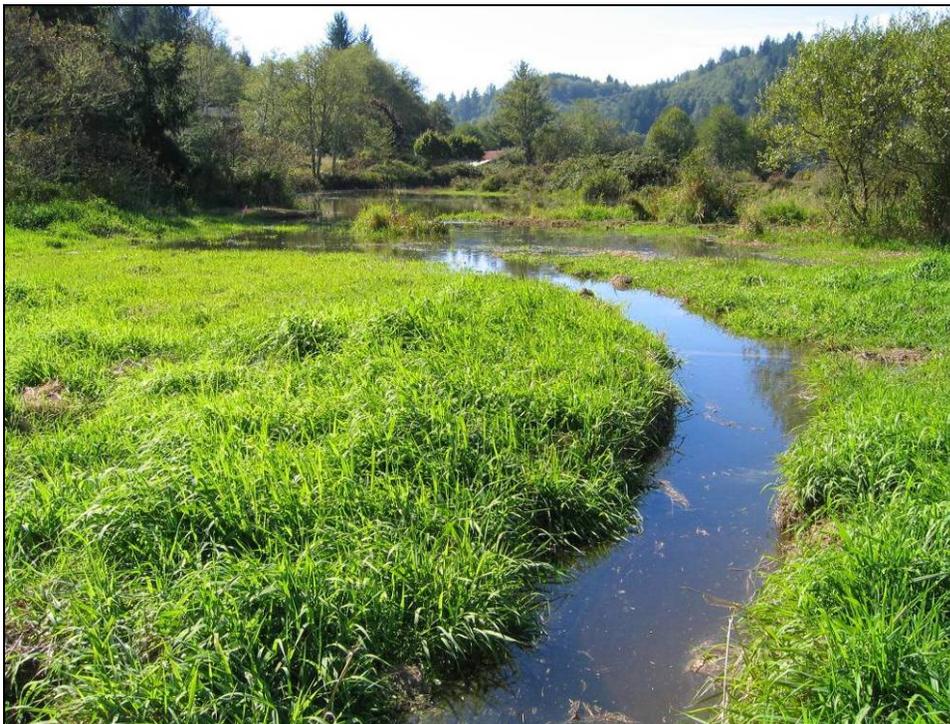
Photo A5. September 27, 2007: Spring high tide fills the pilot channel and dike breach area. Photo by Laura Brophy.

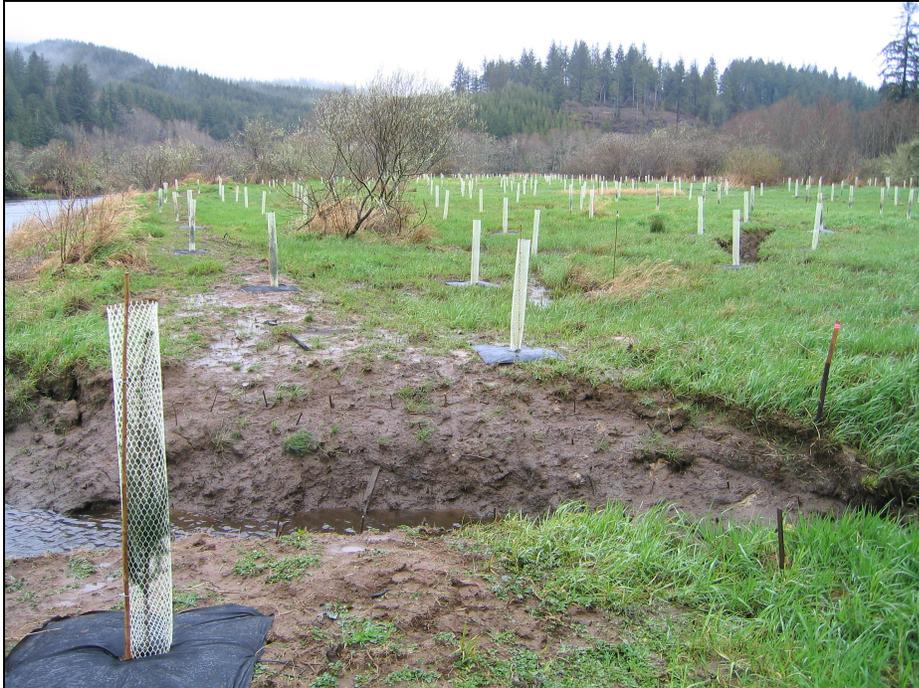
Photo A6. March 17, 2008: Site S65 north-facing view of dike breach and former pasture; partial dike removal and extensive shrub and tree plantings can be seen (white Vexar tubes). Photo by Laura Brophy.

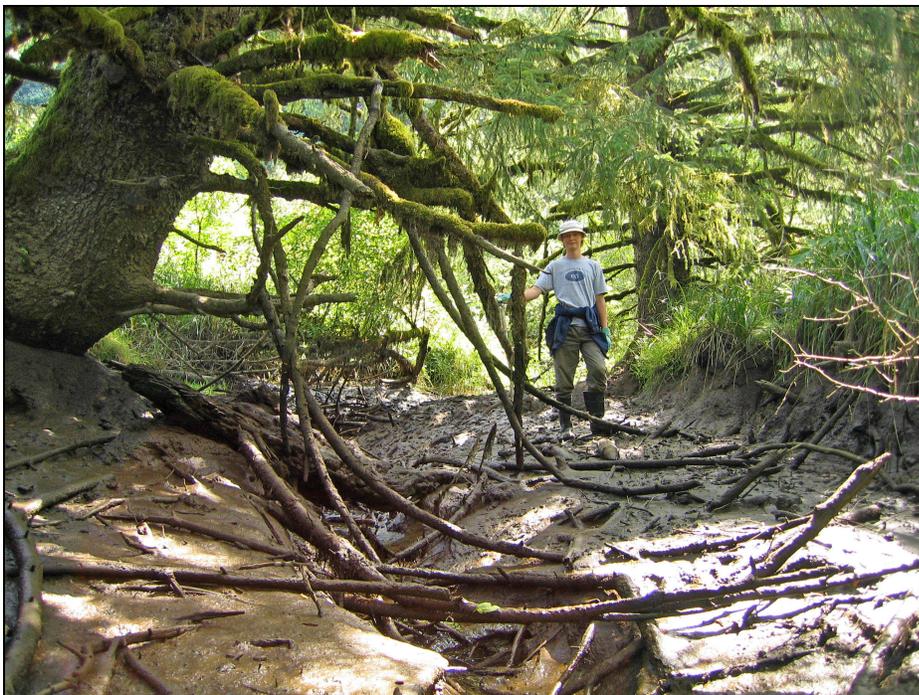
Photo A7. August 3, 2006: Student volunteer Sam Waterhouse stands in tidal channel in Y28 spruce swamp (low tide) Photo by Laura Brophy.

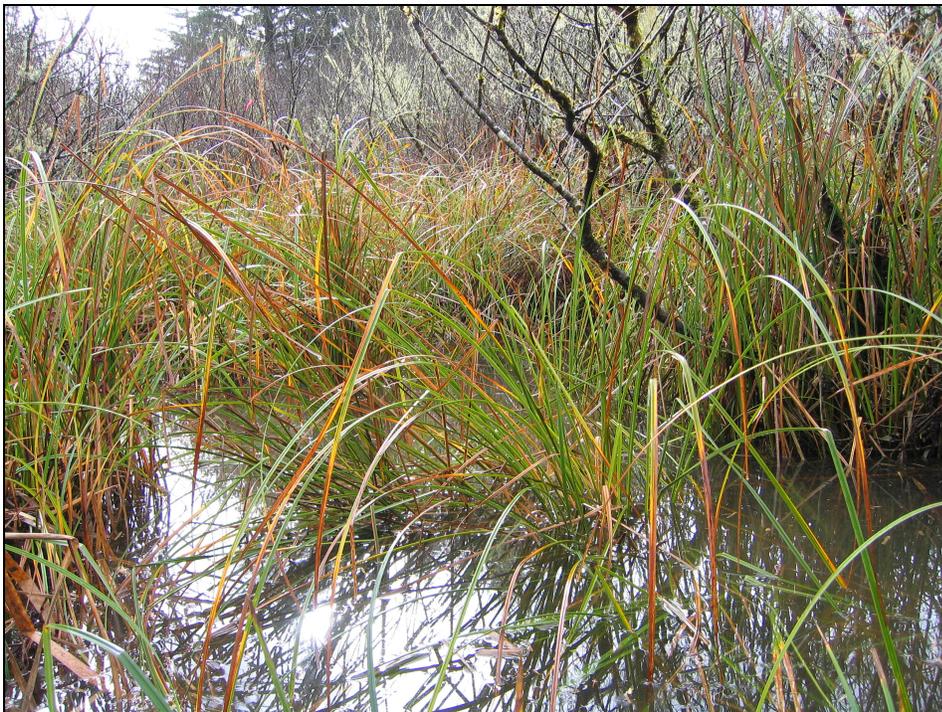
Photo A9. January 4, 2007: Willow scrub-shrub tidal wetland, site S63 Plot 1, during wintertime high tide. Inundation depth is about 1 ft. Photo by Laura Brophy.

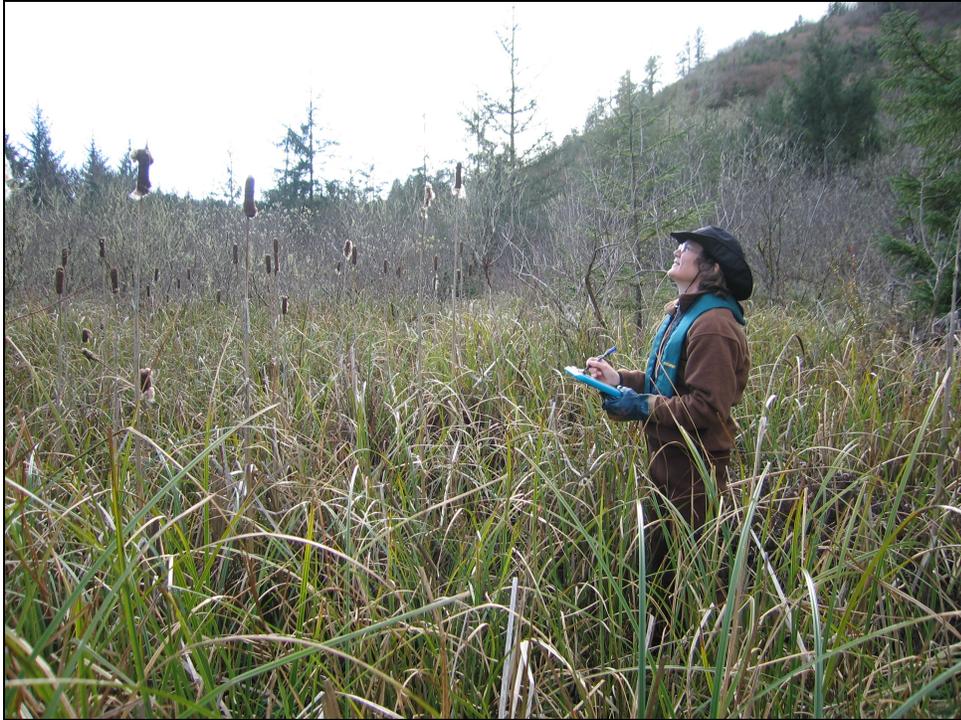
Photo A10. February 20, 2006: Laura Brophy conducts initial site reconnaissance in a cat-tail opening in willow scrub-shrub tidal wetland, site S63 (north of Plot 1). Photo by Jeff Jones.

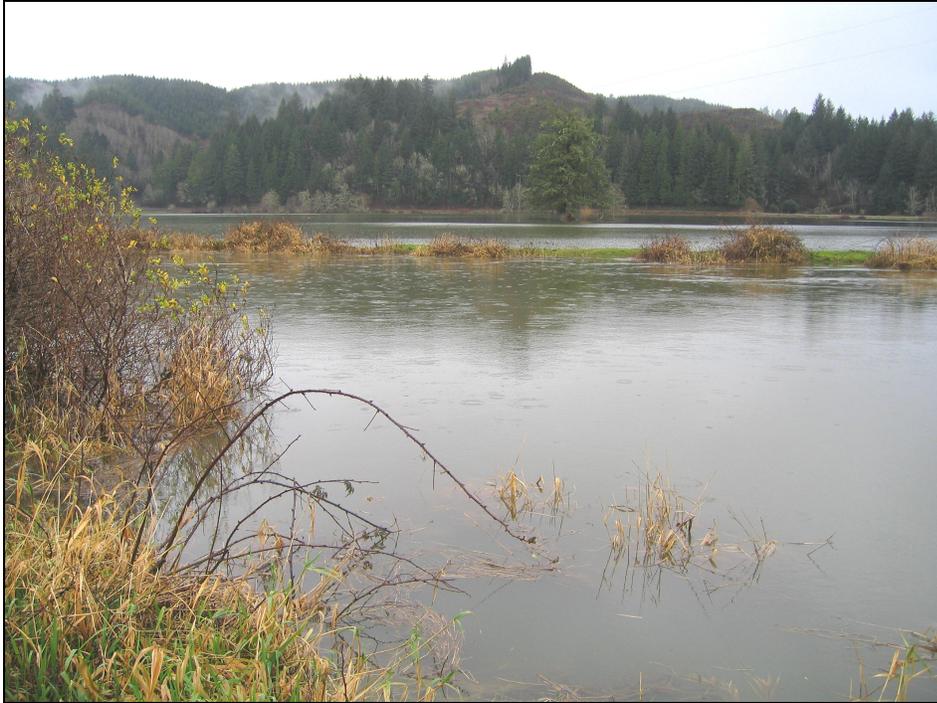
Photo A12. January 4, 2007: Diked pastures on the North Fork Siuslaw River, winter high tide during a high river flow event. Pastures are completely flooded; only the tops of dikes are above water. Photo by Laura Brophy.

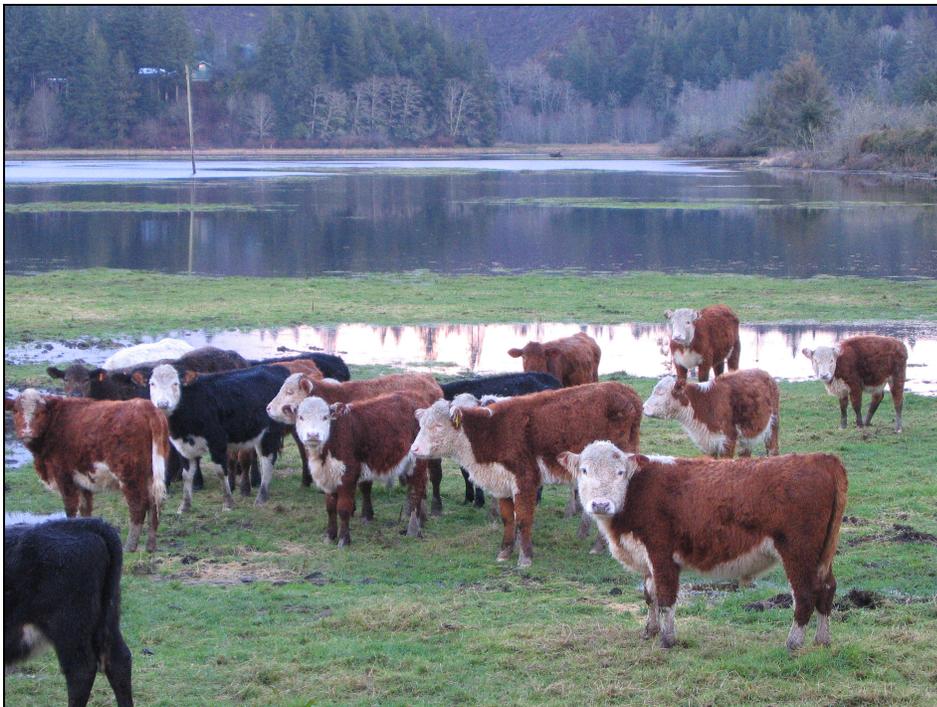
Photo A13. January 4, 2007: Cattle move to high ground in flooded pastures on the North Fork Siuslaw River during a winter high river flow event. Photo by Laura Brophy.

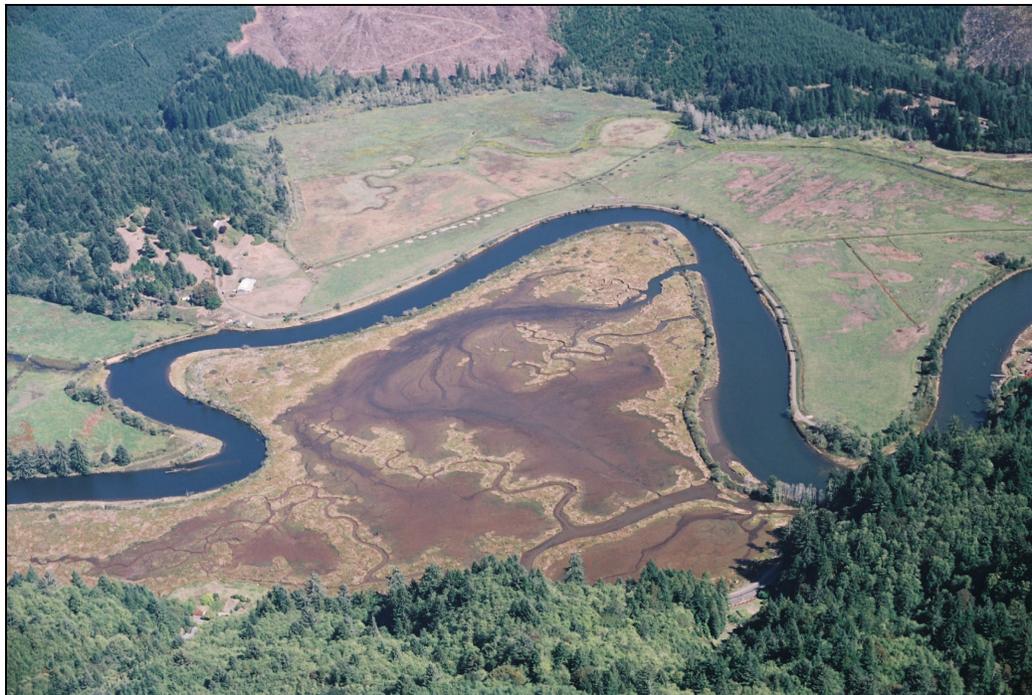
Photo A15. September 6, 2007: East-facing aerial view of site S59. Photo courtesy of ODOT Photo and Video Services.
