Restoration Research and Monitoring in Bayland Wetlands of San Francisco Bay: The Tolay Creek Restoration Project *2004 Progress Report*

**Restoration Research and Monitoring in Bayland Wetlands
of San Francisco Bay: The Tolay Creek Restoration Project**

2004 Progress Report

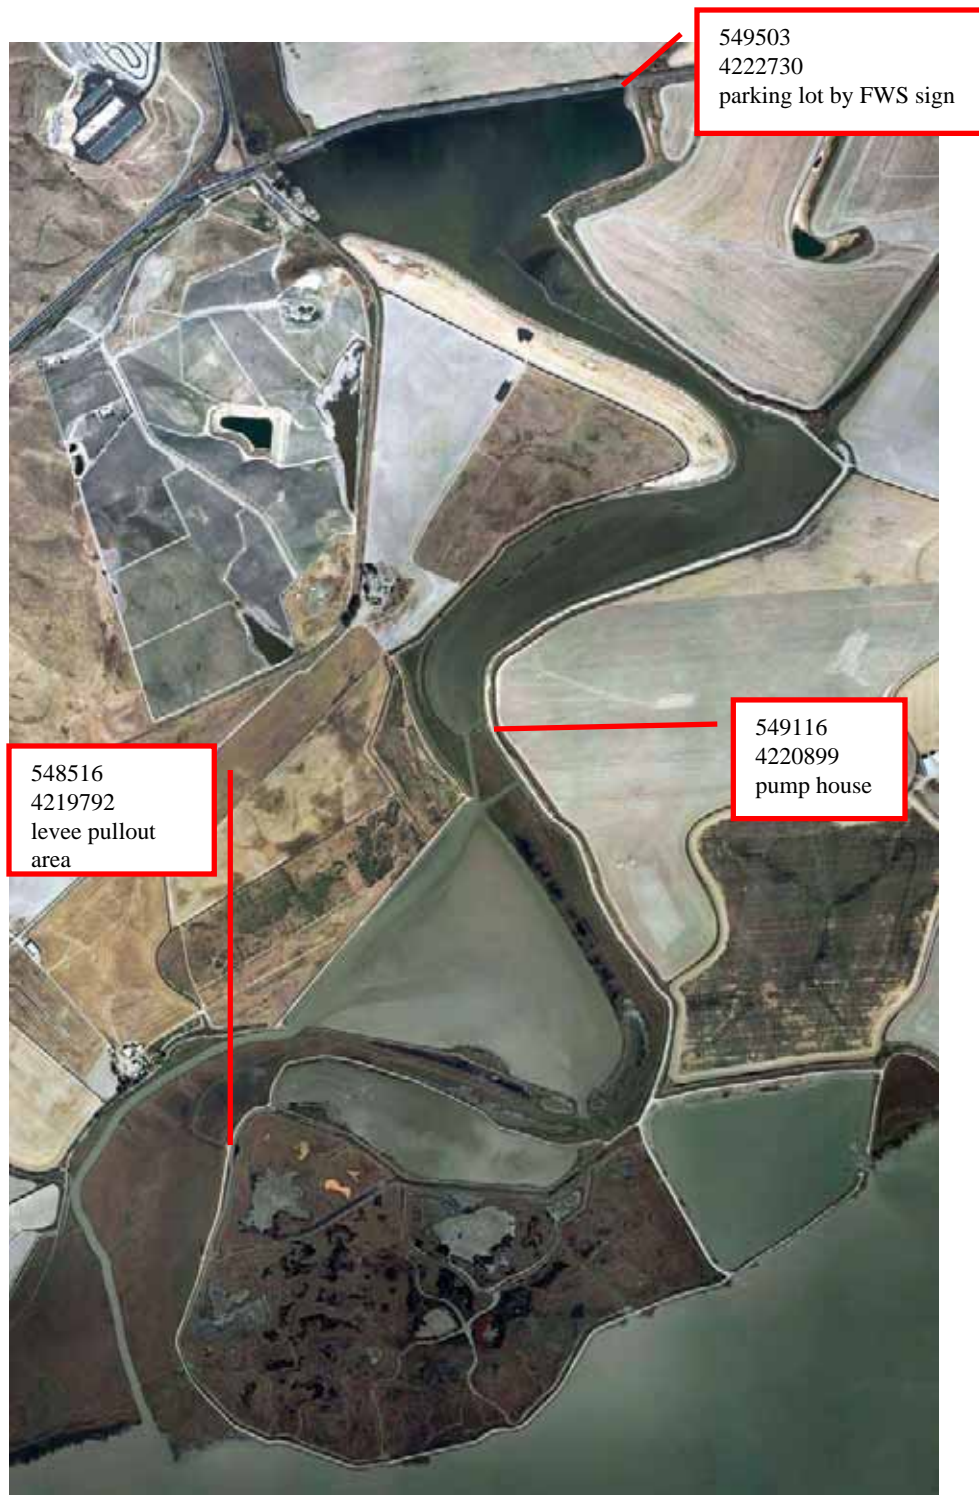
Figure 3. Location of benchmarks at Tolay Creek. Benchmarks were resurveyed in May 2003 by Shoreline Engineering. All GPS coordinates are recorded in NAD27 Zone 10 North. Several more benchmarks will be added and surveyed in 2005.

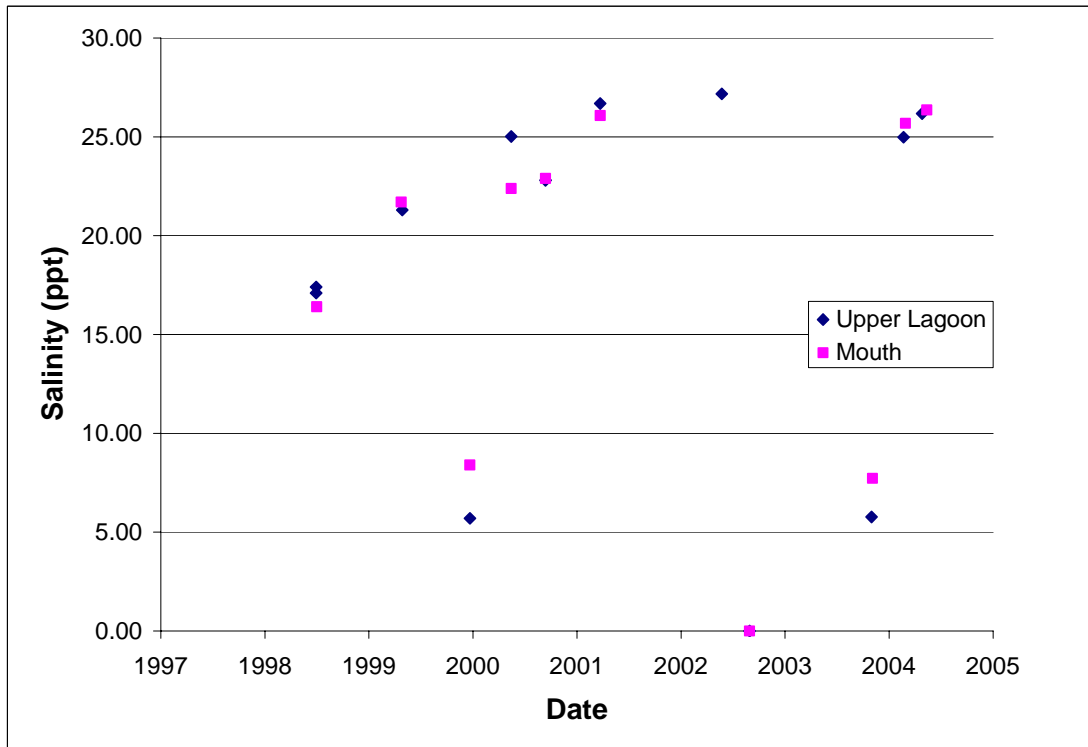
Figure 5. Salinity (a) and pH (b) measurements of the Upper Lagoon and Mouth of Tolley Creek. Prior to 2002, readings were taken as spot measurements on each respective date. From 2002 on, measurements represent the mean value from a 2-5 day continuous collection period. Water quality was not measured in 2003. Note that salinity is much lower in March of 2000 and 2004, likely influenced by rainfall.

Pre-beach tidal flow was restricted in sections of the Mid Channel of Tolay Creek, an area that had formerly been farmed and was subsided. Initial conditions were highly acidic in the upper reach of the creek (Fig. 5) and compared closely with our initial pH readings of 3.3 in the subsidized farmlands and oxidized peat soils of the Cullinan Ranch unit (Takekawa et al. 1999b). The pH values throughout Tolay Creek increased from wide ranging acidic conditions of 3.6-7.9 in 1998 (pre-breach) to a narrower range of 6.8 – 7.9 (Fig. 5) seven months after the breach. In 2004, pH averaged 7.84 ± 0.01 .

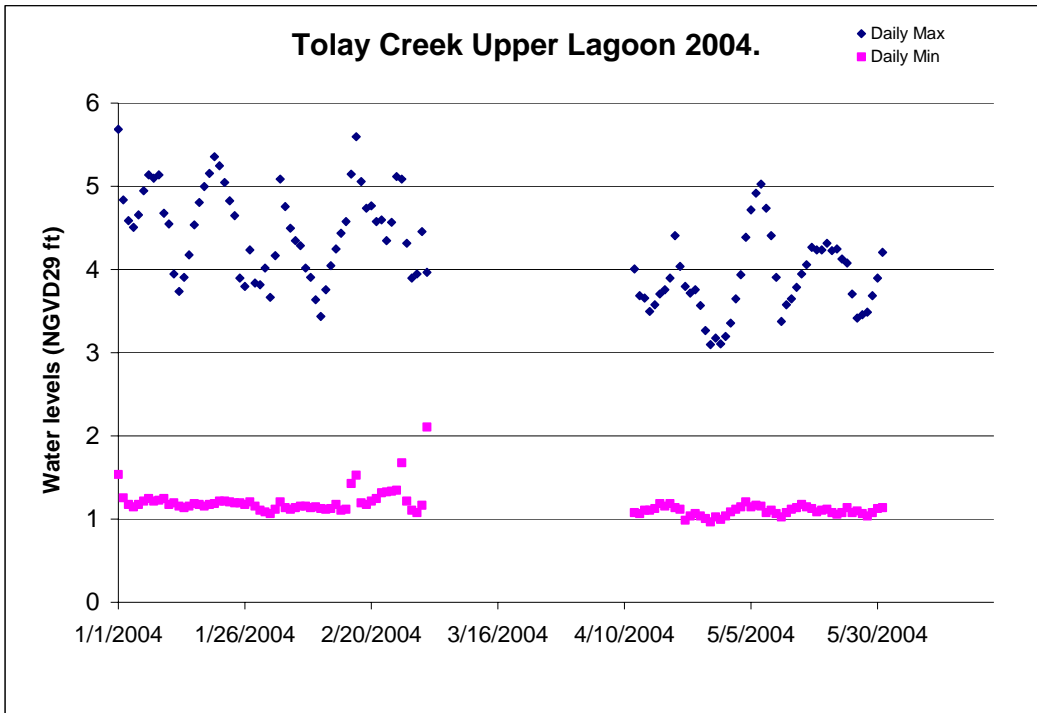
Fig 9. Daily minimum and maximum water levels (NGVD 29, feet) at the Upper Lagoon (a) and Mouth (b) of Tolay Creek from January to May of 2004. Fluctuations in water levels reflect tidal patterns.

Over 6 years, we have observed increased tidal range and period at the Mouth and Upper Lagoon of Tolay Creek compared with the Sonoma Creek tide station (Figs. 7, 8, 9). After the restoration of tidal influence in December 1998, initial water levels exceeded predicted values. Water level loggers were installed in late January 1999 and verified that corrective channel dredging in the spring of the same year increased tidal flow and stabilized water levels.

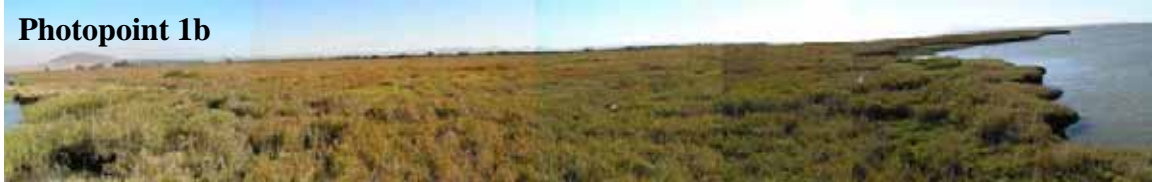
Photopoint 1b

Figure 10. Panoramic views at photo points throughout the Tolay Creek project, October/November 2004.

Digital photographs were taken throughout the project to track qualitative changes (Fig. 10). These photos were taken in the fall after the growing season to provide reference points for levee erosion, channel width changes, and changes in vegetation. An increase in pickleweed cover is documented from photopoints taken at the same location in 2000 to 2004 (Fig. 11).

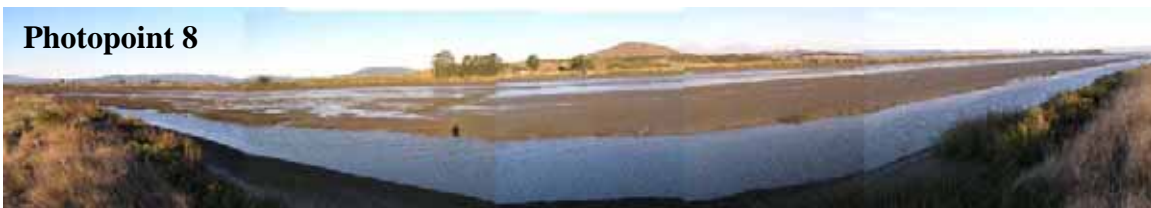
Photopoint 8

Figure 10. Continued.

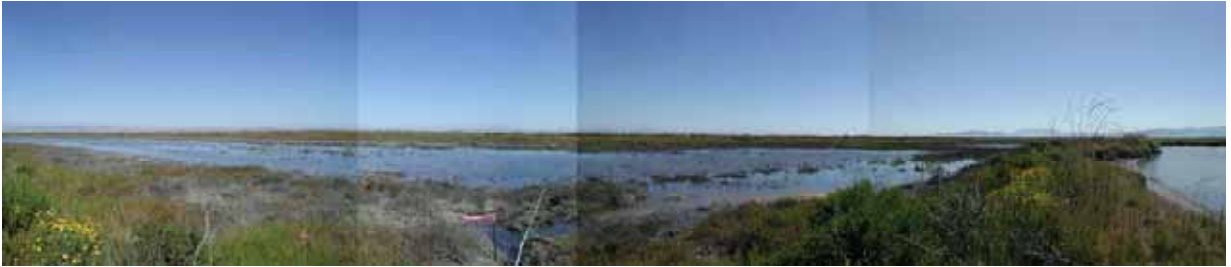
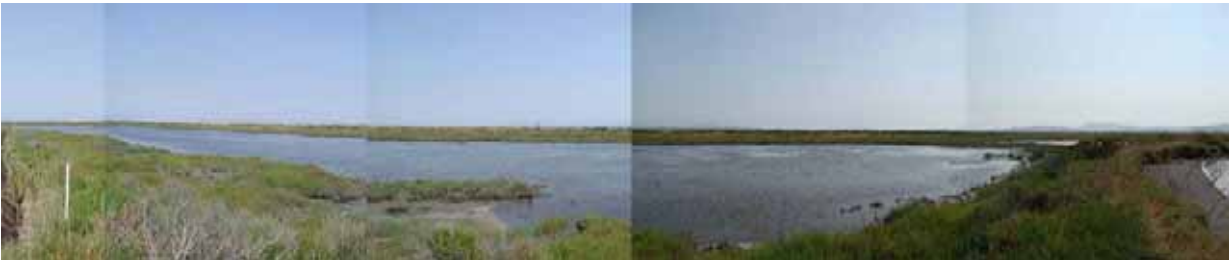
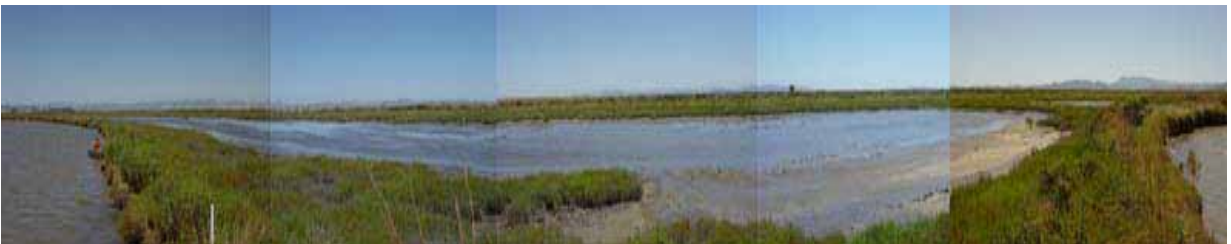
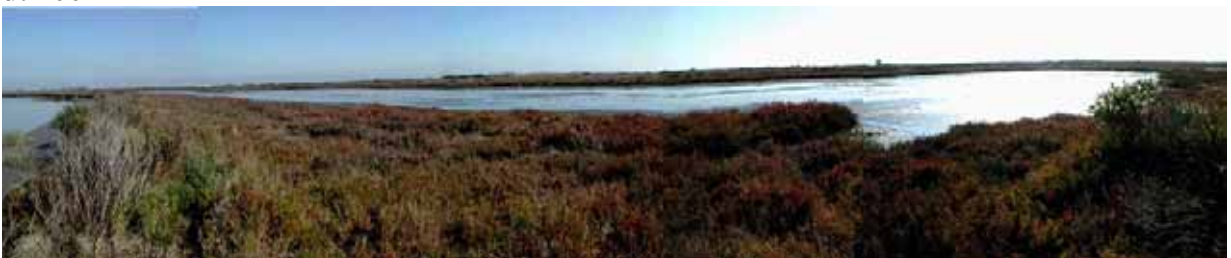
Figure 11. Comparison of panoramic views from photo point #5B in 2000 (a), 2002 (b), 2003 (c) and 2004 (d) (a photo was not taken in 2001) providing evidence of qualitative change. Here we document increased pickleweed cover from 2000 to 2004.

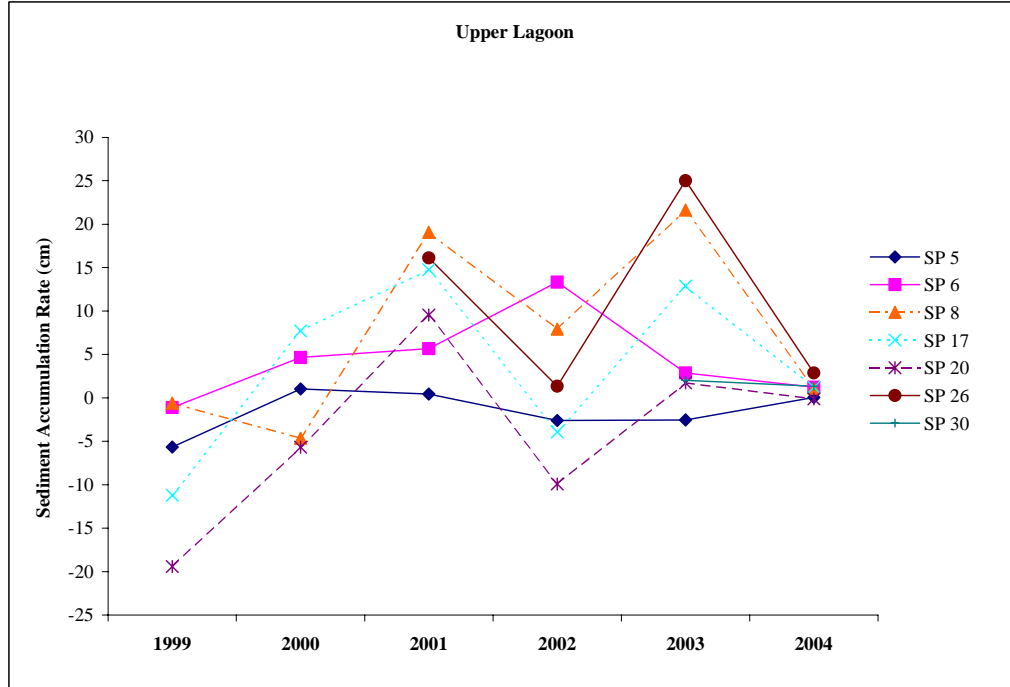
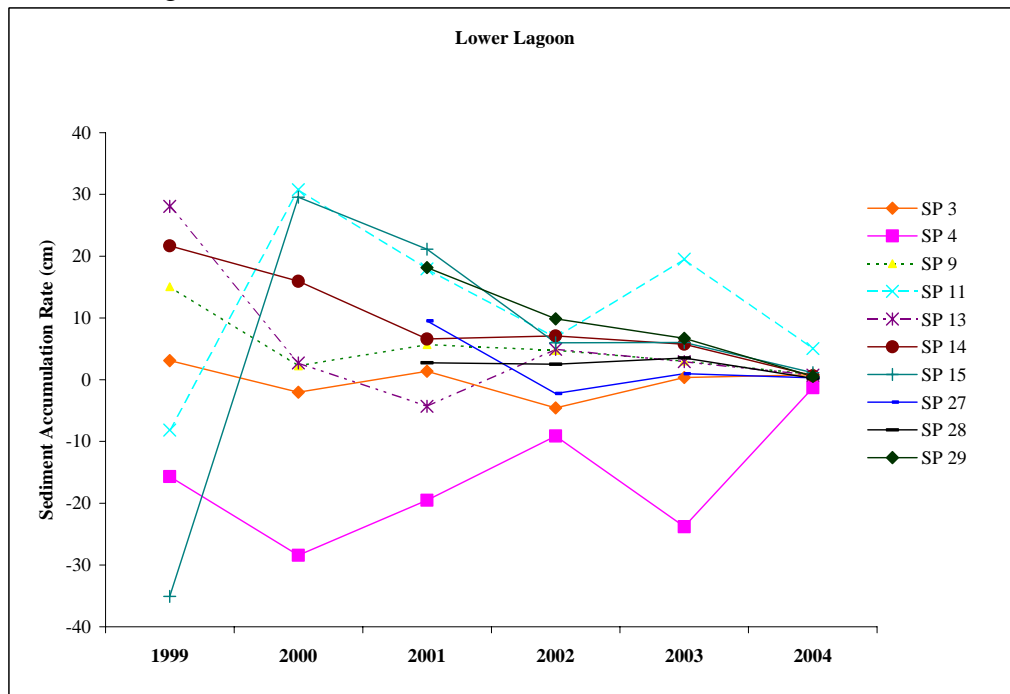
Figure 13. Annual sediment accumulation rate (mean daily accumulation (cm) x 365 days) for sediment pins in the Upper (a) and Lower (b) Lagoons. In the Upper Lagoon, four of the six sediment pins (8, 17, 20, 26) show similar annual variation of accumulation and loss between 2001 to 2004, with all seven sediment pins recording almost no change in 2004. Initial sediment accumulation and loss in the Lower Lagoon was dramatic in 1999 and 2000, but has consistently evened out to almost no change in 2004. This trend observed in both lagoons may indicate that sediment levels are stabilizing in Tolay Creek.

Circular clumps of *S. foliosa* have colonized in the Lower Lagoon; however, annual sediment accumulation data indicates that the rate of accumulation for most sediment pins in the Lower Lagoon has decreased since 2002 (Fig. 13). A similar pattern has been observed in the Upper Lagoon with lower accumulation rates in 2004 (Fig. 13). This trend observed in both lagoons may indicate that sediment levels are stabilizing in Tolay Creek, especially in the Lower Lagoon. Future monitoring is necessary to determine if this trend

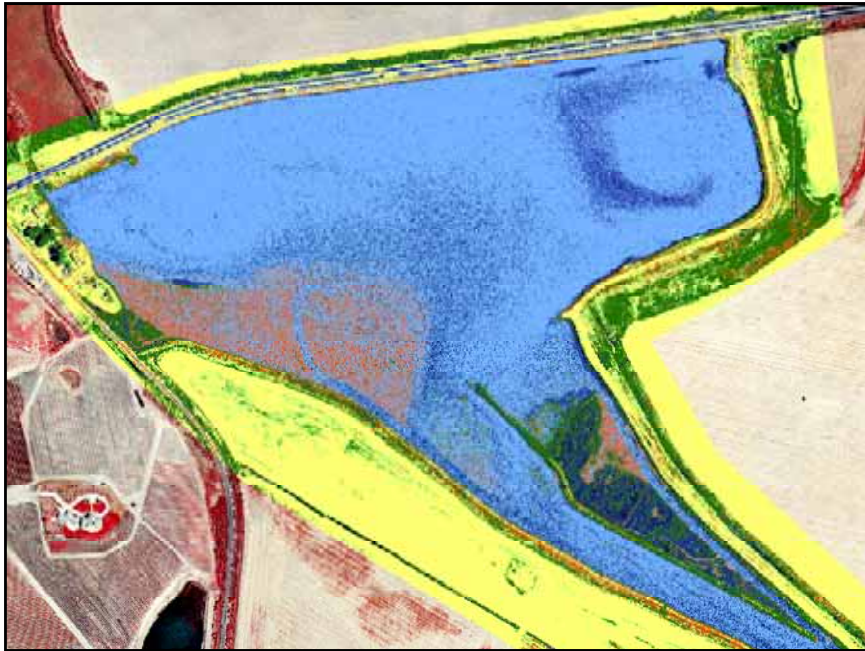
Figure 15. September 2004 unsupervised classification of Tolay Creek Upper and Lower Lagoons. Refer to Fig.15 for classification methods. Development of mudflat is evident in both lagoons, especially the lower. *Spartina foliosa* is colonizing the southwestern corner of the Lower Lagoon and vegetation is present on the island south of the Upper Lagoon.

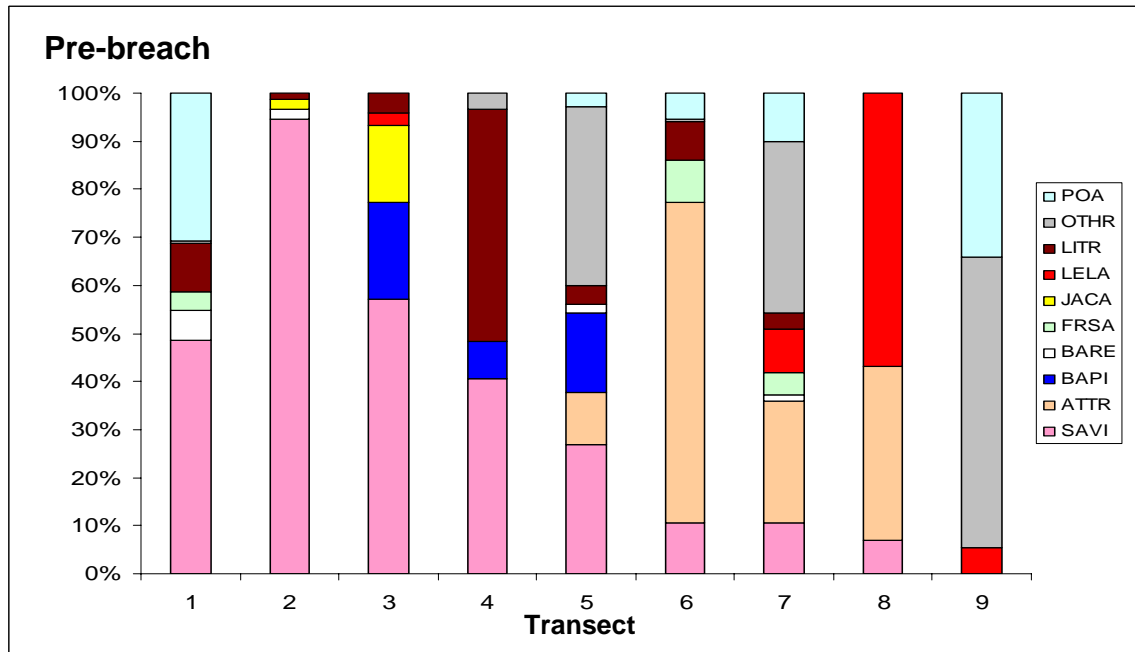
Figure 17. Relative percent cover of major plants species (transect surveys), pre-breach (a) versus post-breach (b). Due to the reintroduction of tidal influence, there is an obvious increase in water inundation in post-breach surveys. Plant codes include: *Poaceae Sp.* (POA), other (OTHR), dead plants (LITR), *Lepidium latifolium* (LELA), *Jaumea carnosa* (JACA), *Frankenia salina* (FRSA), areas without plants (BARE), *Baccharus pilularis* (BAPI), *Atriplex triangularis* (ATTR), *Grindelia stricta* (GRST), *Salicornia virginica* (SAVI), and inundated with water (OPWA). Refer to Table 2 for species included in other (OTHR) categories pre- and post-breach.

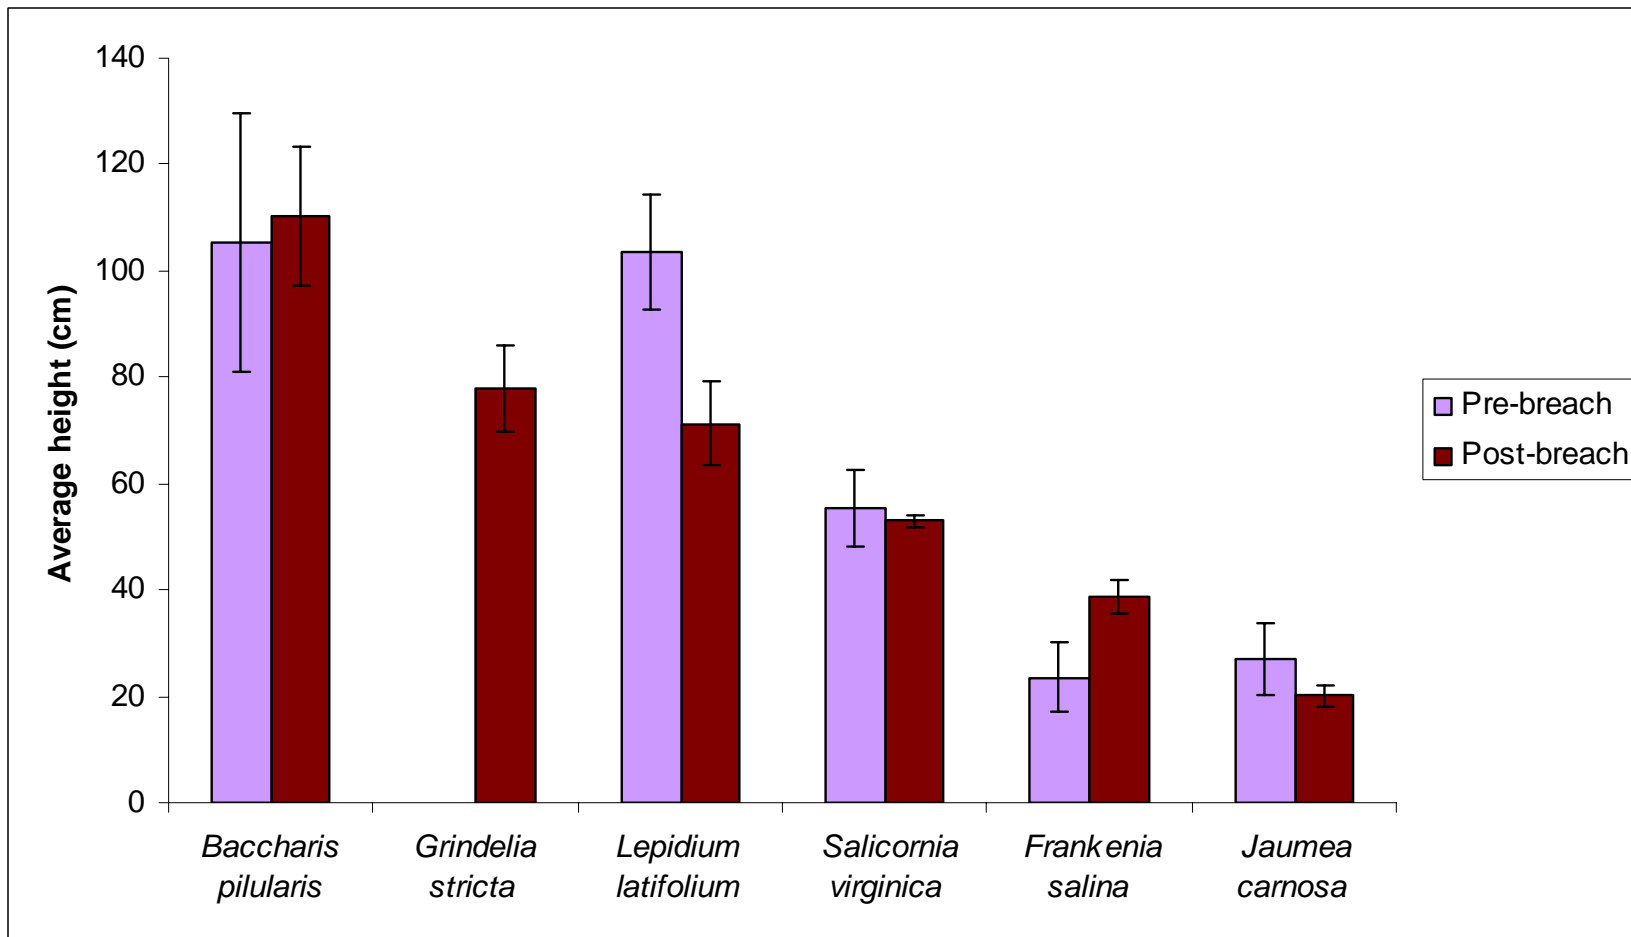
Figure 19. Average height of major plants, pre-breach (1999) and post-breach (1999-2004) at 9 transects in the Tolay Creek Restoration Project. Plant codes include: *Lepidium latifolium* (LELA), *Frankenia salina* (FRSA), *Atriplex triangularis* (ATTR), *Jaumea carnosa* (JACA), *Grindelia stricta* (GRST), *Baccharus pilularis* (BAPI), and *Salicornia virginica* (SAVI).

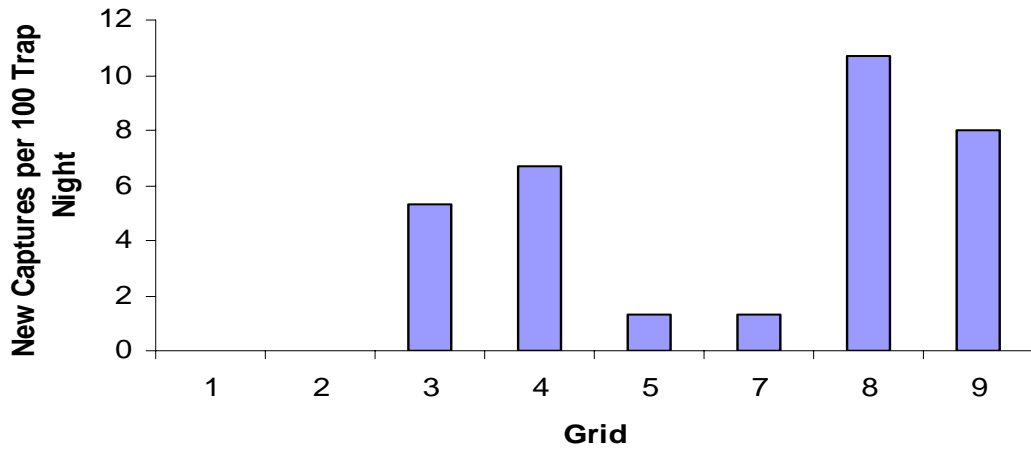
Figure 29. Abundance index (new captures/ 100 trap nights) of the salt marsh harvest mouse (*Reithrodontomys raviventris*) in the Tolay Creek Restoration Project across trapping grids, pre-breach (1998-1999) and post-breach (1999-2004).
